CMU 3/1 - QUARRY JETTY

CMU 3/3 LLANDDULAS WASTE TIP

CMU 3/2 B - LLANDDULAS BEACH

CMU 3/2 A - LLANDDULAS REVETMENT

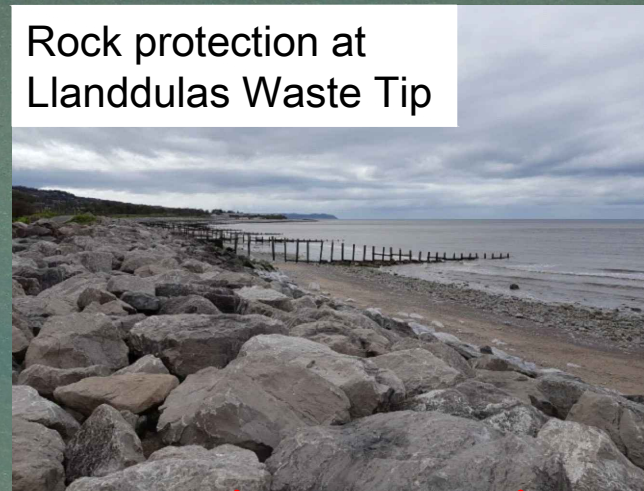
Rock protection at Llanddulas Waste Tip

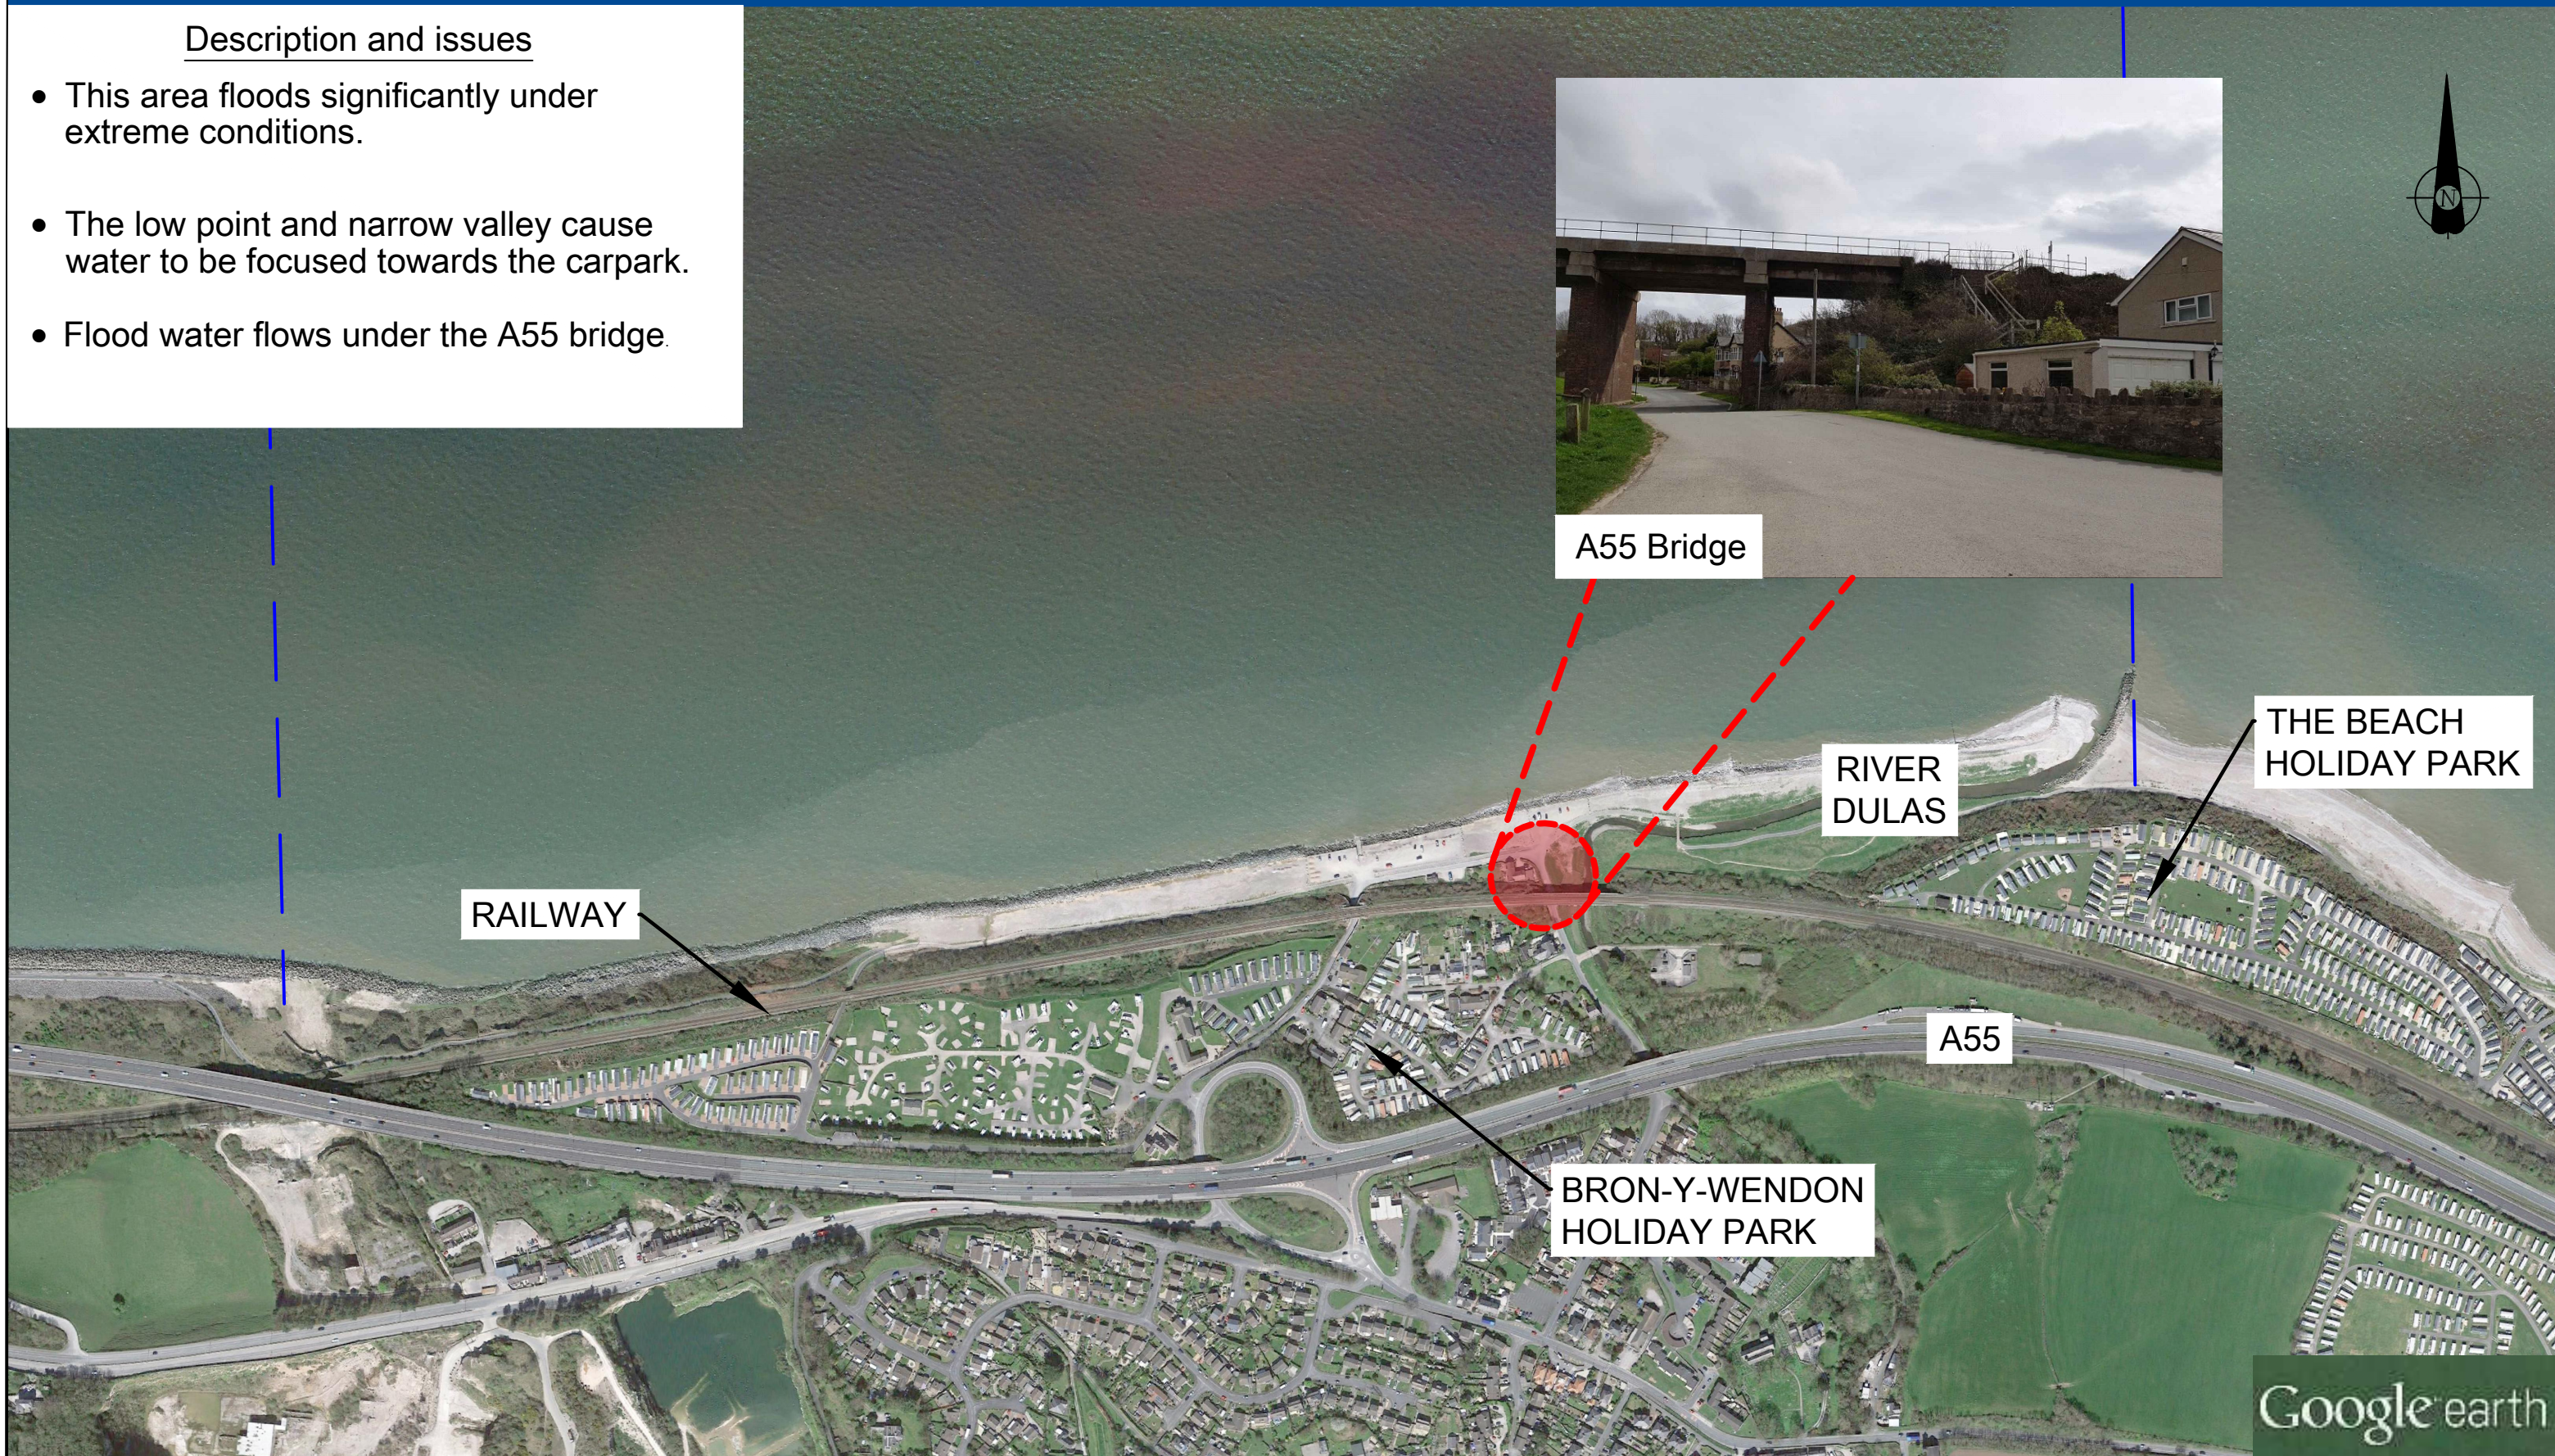
- This area floods significantly under extreme conditions.
- The low point and narrow valley cause water to be focused towards the carpark.
- Flood water flows under the A55 bridge.
