Safety Improvements

Highway Safety

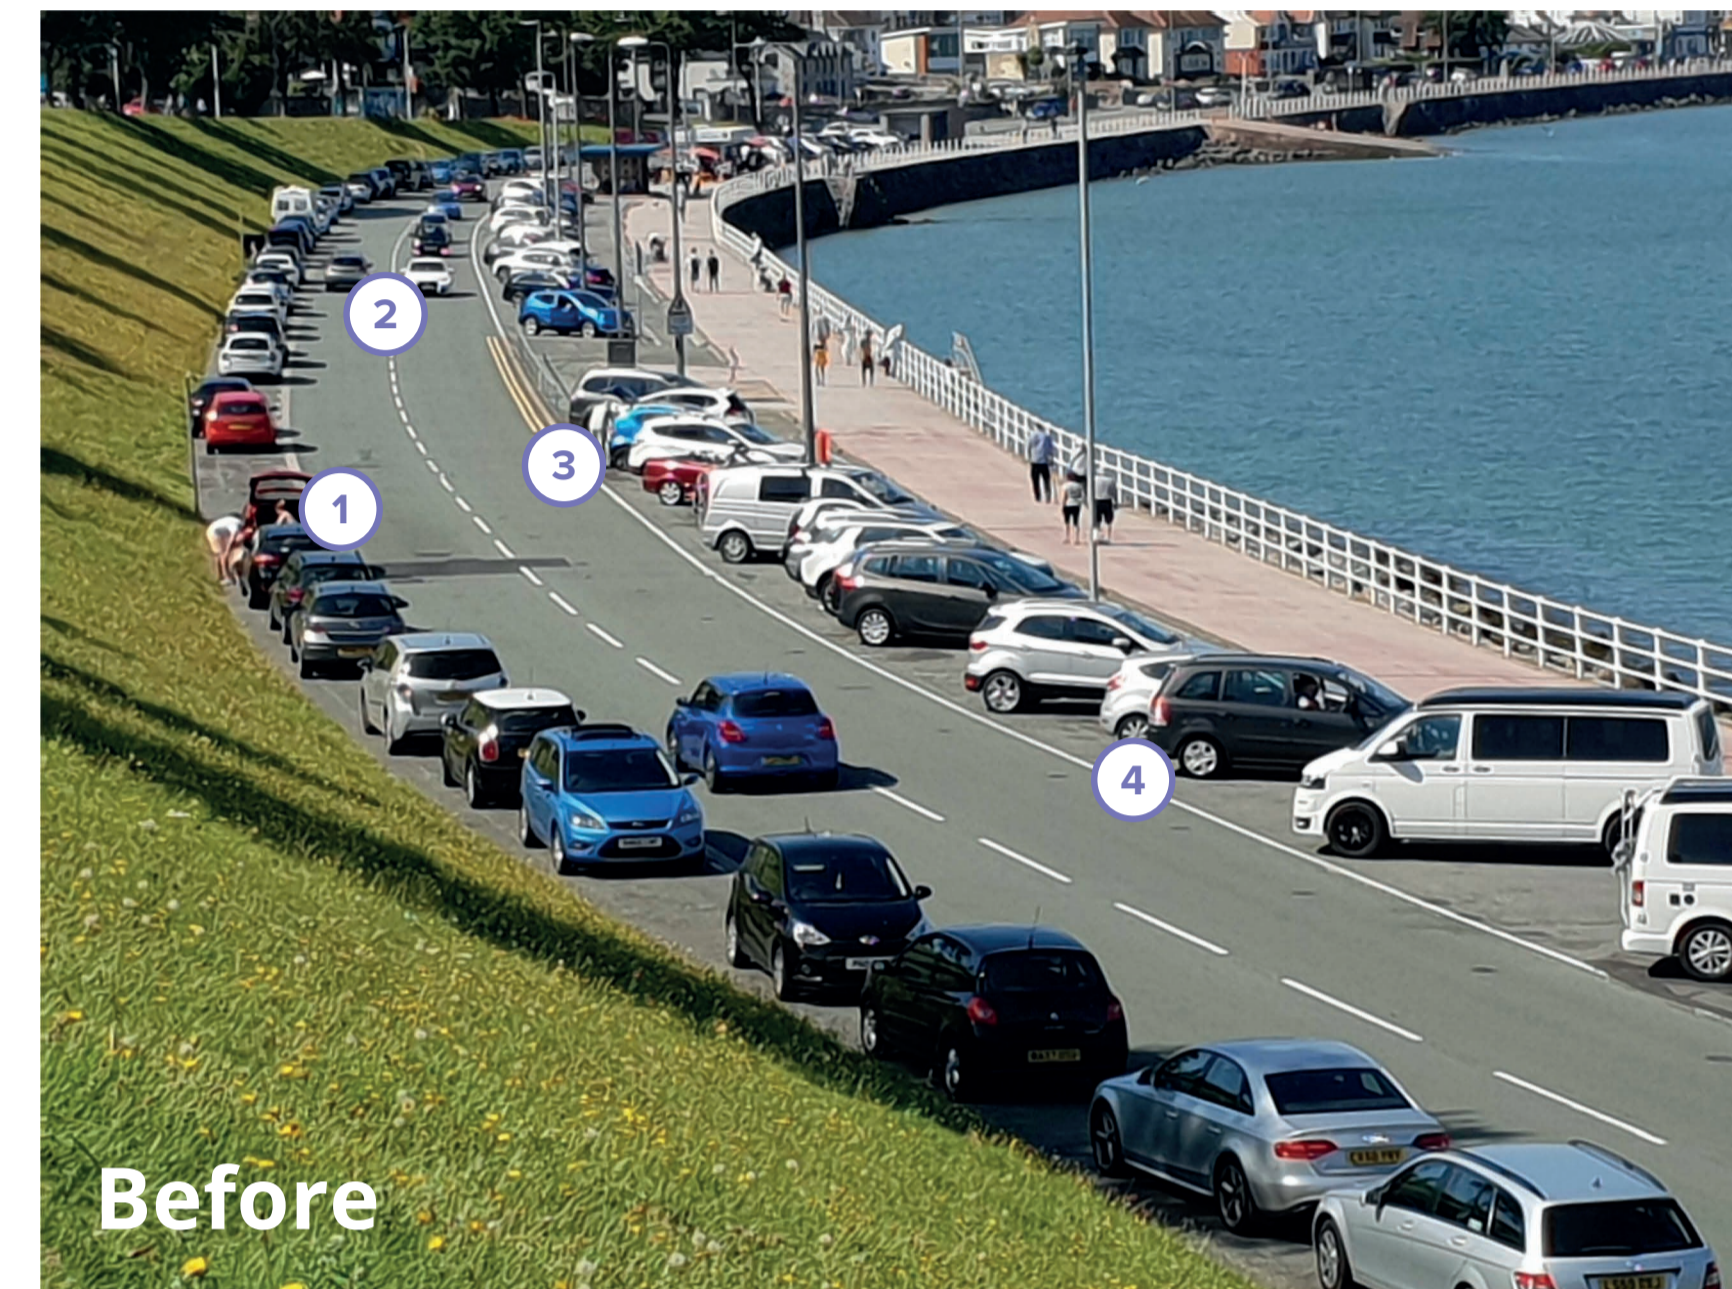
1 Problem - The parking on the Cayley Embankment side is narrow and immediately next to the live traffic lane.

1 Solution - Formal parking spaces with a 'safety buffer zone'. This provides extra safe space to enter, exit and move around parked vehicles.

2 Problem - There are currently no crossing facilities to cross over to the promenade area.

2 Solution - Formal crossings at regular spacings and reducing the road to a single lane with a 20mph speed limit reduces the risk significantly.

3 Problem - People parking in the diagonal spaces cannot access their boots without standing in or very close to the live traffic lane.

3 Solution - The safety buffer zone provides extra width between the parked cars and the passing traffic, providing a safe area to access car boots.

4 Problem - Vehicles parked in the diagonal spaces have to reverse out directly into the oncoming 30mph traffic, with limited visibility.

4 Solution - The safety buffer zone provides extra visibility and reducing the speed limit to 20mph improves safety even more.

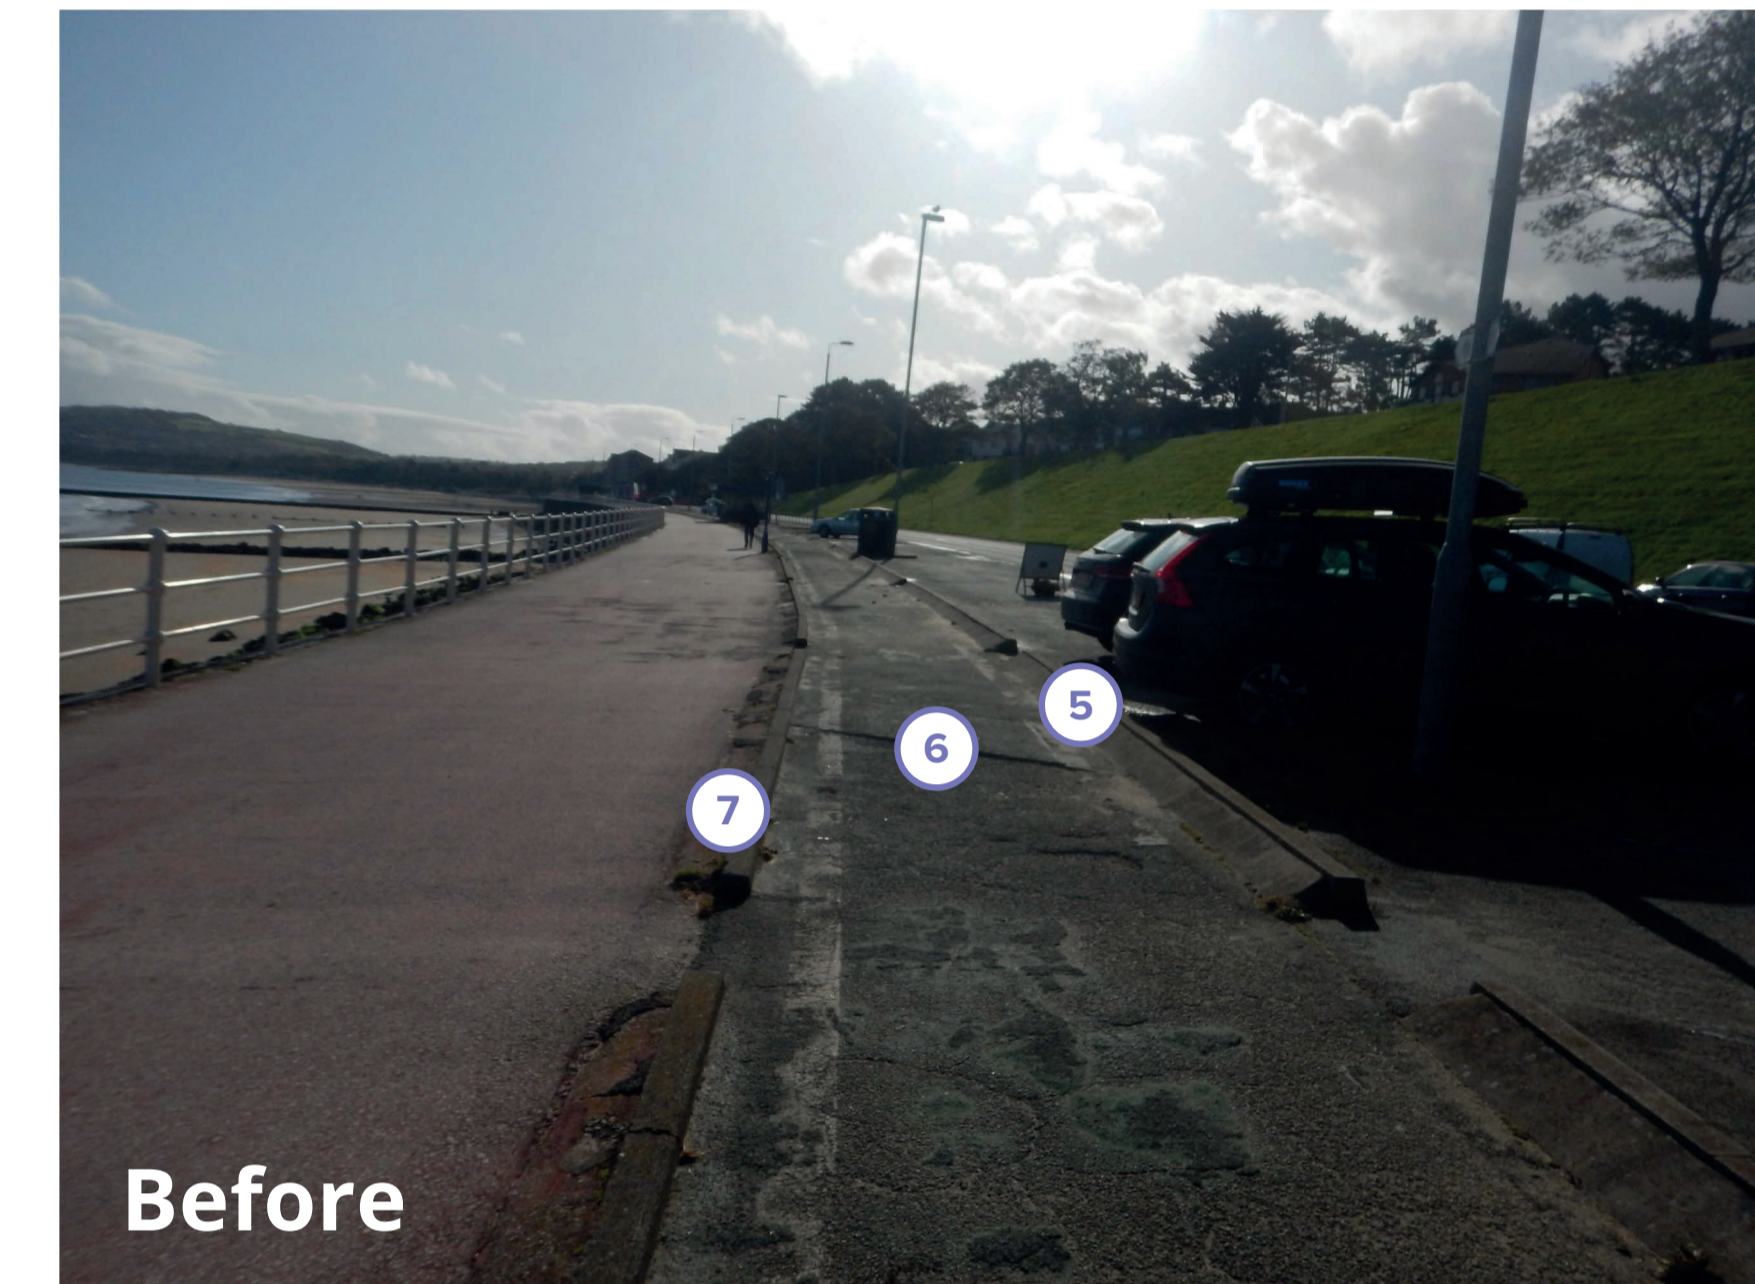
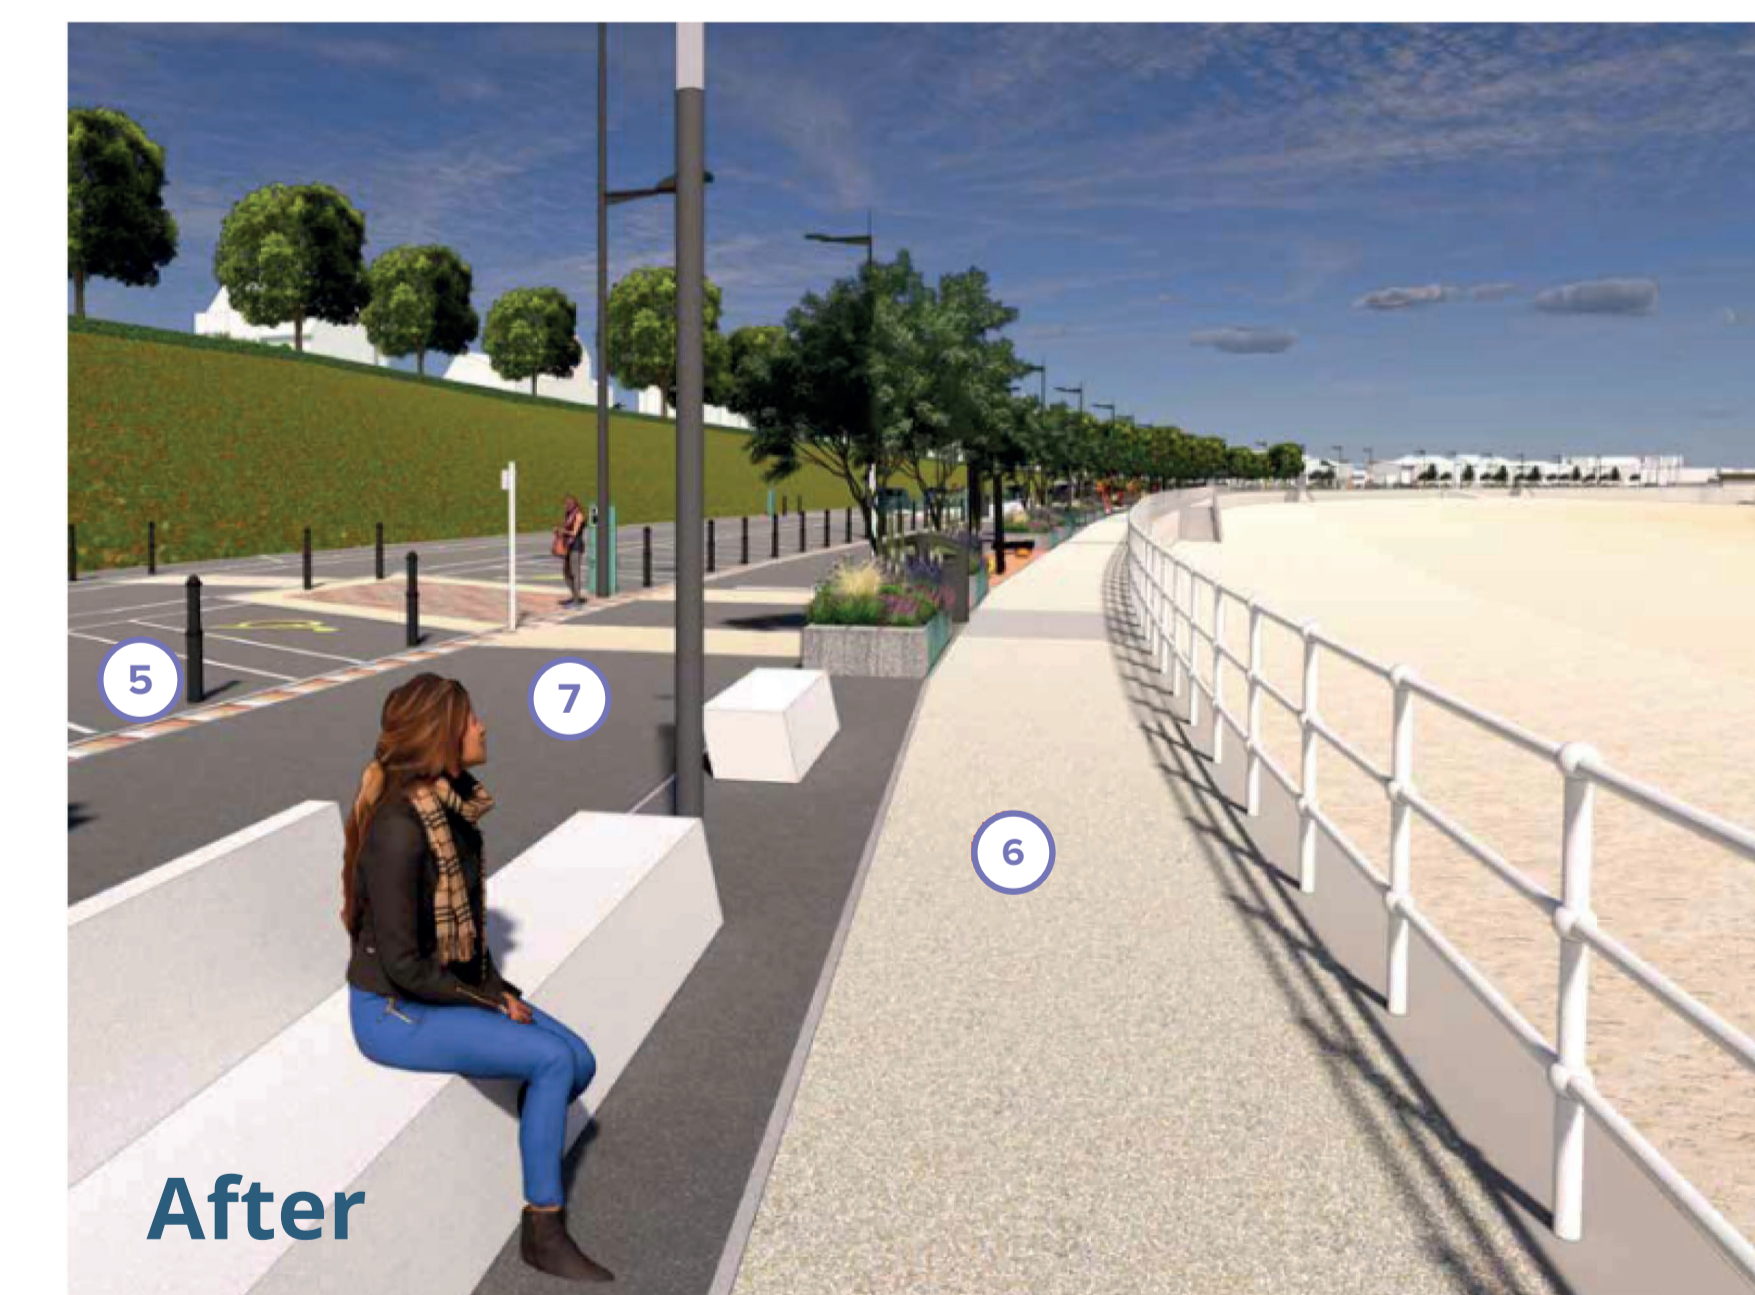
Promenade Safety

5 Problem - There is limited protection to prevent vehicles from entering the promenade area.

5 Solution - Bollards mounted centrally in each parking bay provide physical protection to avoid vehicles coming into contact with pedestrians and cyclists.

6 Problem - Segregated cycleway between promenade and parking area gives some cyclists the confidence to travel at higher speeds, with potential for collisions.

6 Solution - A 4m wide 'share with care' active travel route and a narrower pedestrian-only strip alongside the hand railings.

7 Problem - The cycleway is marked on both side by kerbs in several areas along the promenade, causing tripping hazards.

7 Solution - Remove the kerbs between the parking area and the active travel route. The activity zone along the seaward side creates a barrier without trip hazards.
