**Ysgol Dolgarrog, Dolgarrog**  
**Preliminary Protected Species Survey**

**21<sup>st</sup> February 2017**  
**Amended 10<sup>th</sup> April 2017**

**Ysgol Dolgarrog  
Ffordd Llanrwst  
Dolgarrog  
Conwy  
LL32 8QE**

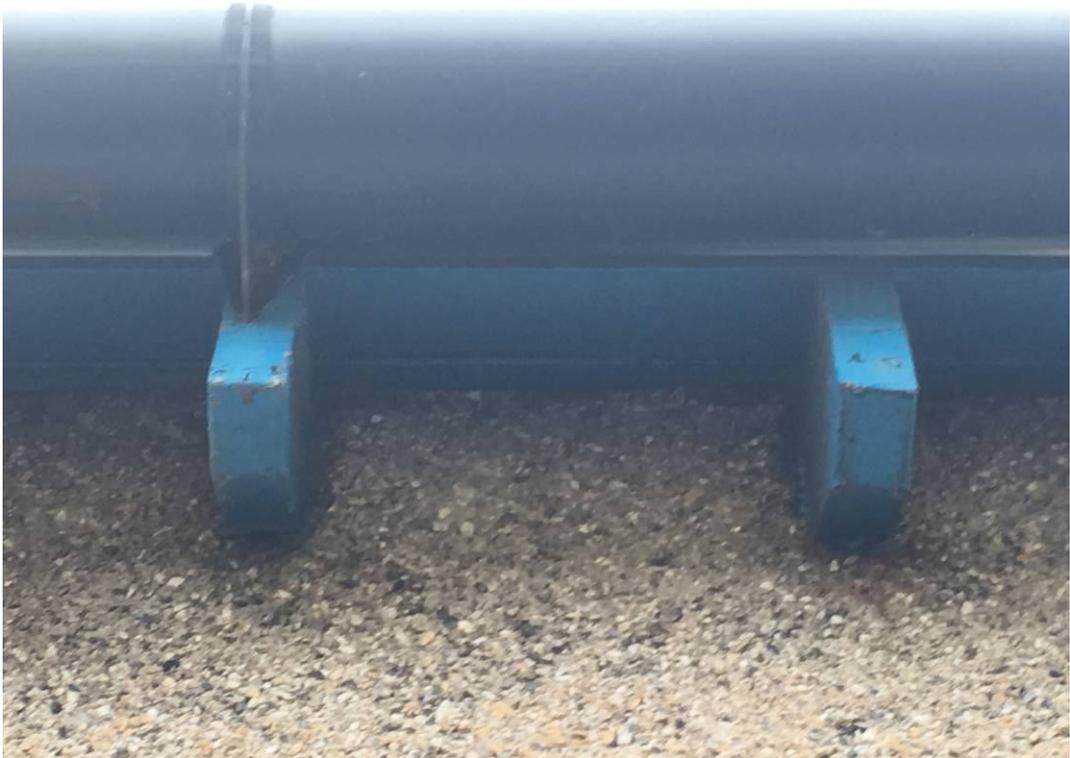
The exterior walls of the main school building were pebble dashed, with no cracks or crevices. Wall tops were well sealed, but there were gaps under occasional raised slates, over dormer window gables and dormer roof joints, and on porch slating edges. These features offer potential roosting opportunities for crevice-dwelling species of bat and may form the entrance points for void dwelling species.

Well sealed wall tops, exposed rafter end roof design

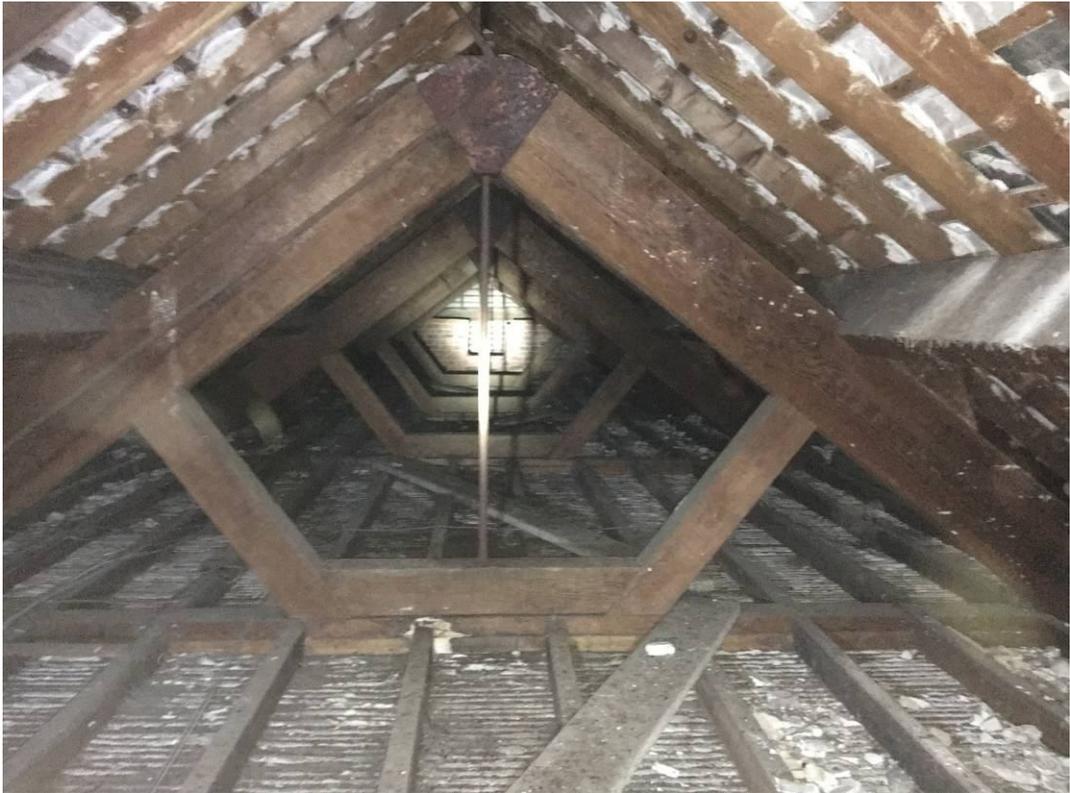
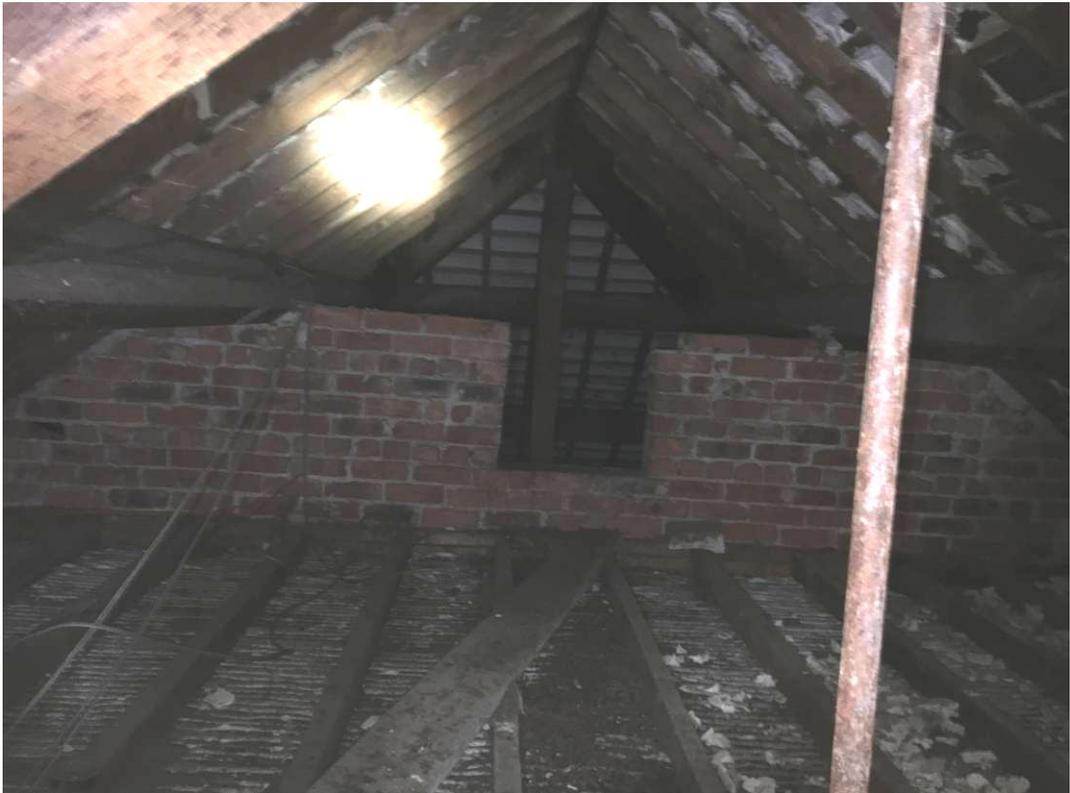
Internal view of roof void 1

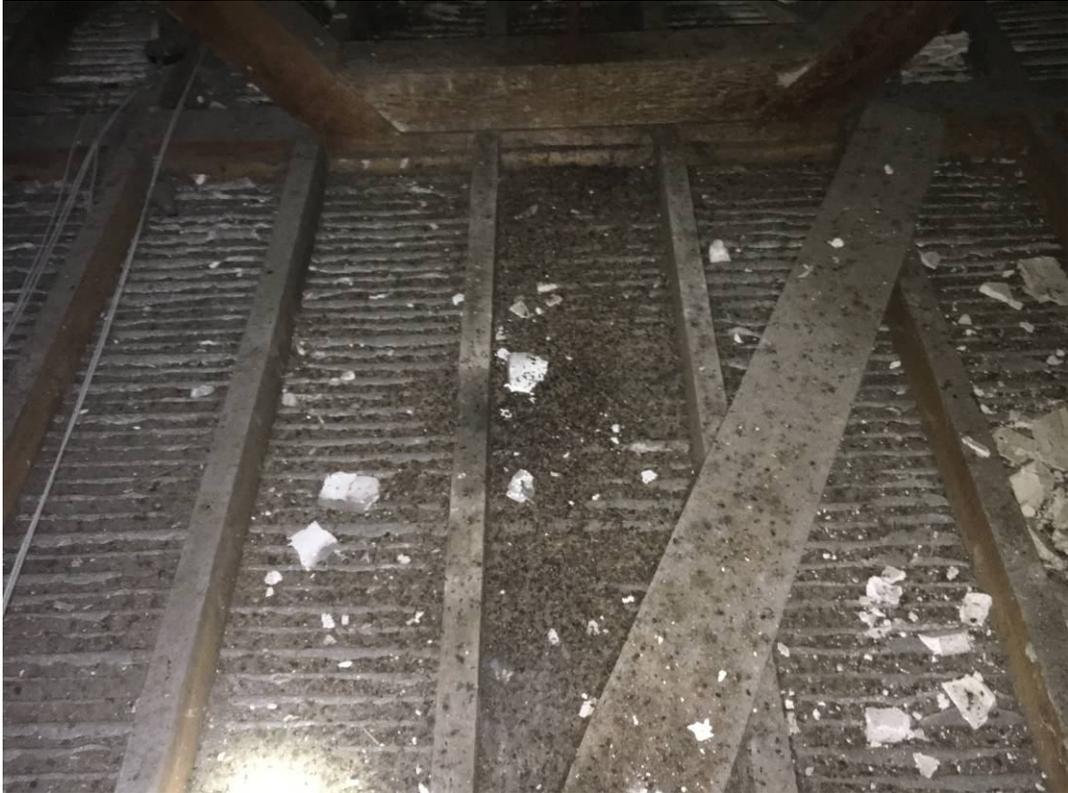
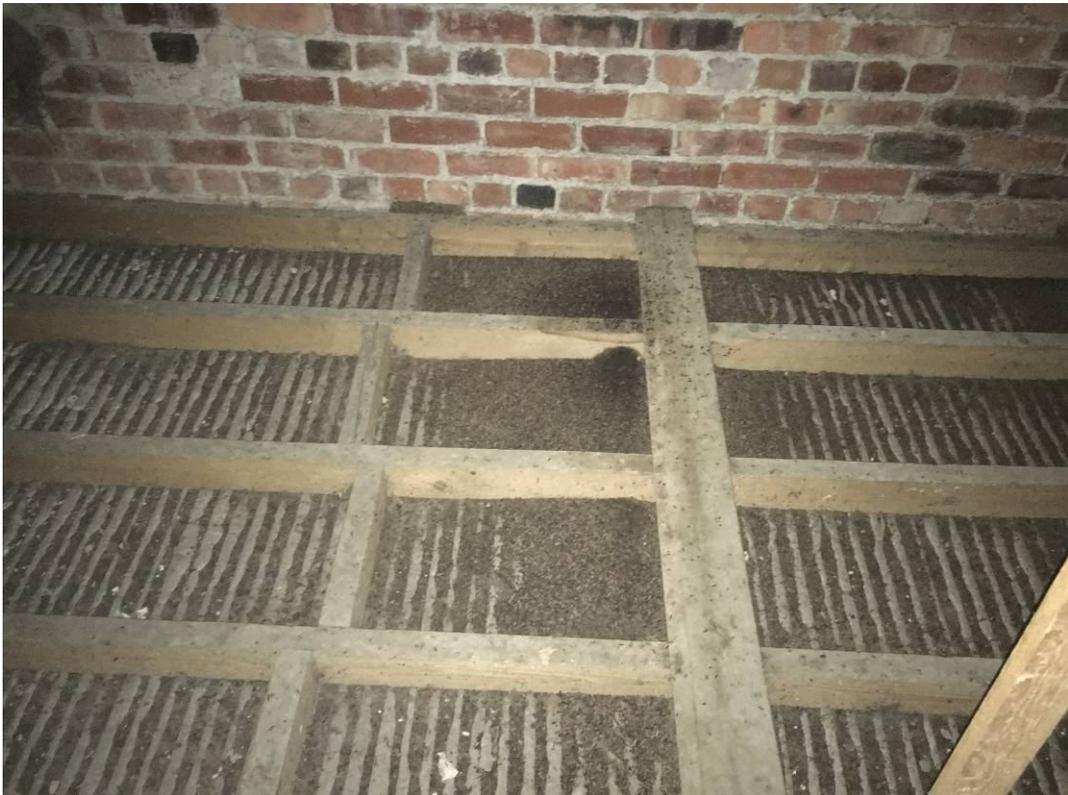
During the initial survey on the 21<sup>st</sup> February 2017, droppings, showing the characteristics of brown long-eared or Natterer's bat (suspected to be brown long-eared but droppings from the two species are easily confused), were found within roof voids 1, 2 and 3. These droppings were scattered throughout the voids, but also found in large accumulations, particularly below the ridge. Numbers of droppings were in the hundreds of thousands and showed a wide age range including droppings from 2016. The roof voids are clearly utilised by a significantly sized maternity roost. During the survey on the 10<sup>th</sup> April a single brown long-eared bat was located in void 3 confirming that the roost is highly likely to be of brown long-eared bats rather than Natterer's, and void 5 showed equal levels of usage by the brown long-eared bats as was in voids 1, 2 and 3. A lower level of usage was also recorded within void 4. There was no obvious access point into the voids for the bats, a number of minor crevices with potential to be the access point were identified, but patterns in dropping locations or staining did not clearly indicate a favoured access point. The same was true in roof void 6 where a small accumulation of approximately 200 droppings consistent with those produced by pipistrelle species or small *Myotis* species bats were located.

Significant quantities of bat droppings consistent with those produced by brown long-eared bats throughout roof voids 1, 2, 3 and 5.

Due to the presence of bat droppings within the roof voids and roosting potential present on the building, at least two emergence surveys will be needed to accurately assess the impact of the proposed demolition and gather data to support the necessary license application to Natural Resources Wales. The emergence surveys should be conducted during the recognised bat survey season between 1st May and 30th September, in appropriate environmental conditions. A minimum of eight surveyors will be required to adequately cover all potential emergence points and elevations.

It must be remembered that bats are protected under both UK and European legislation and a European Protected Species development license will need to be obtained from Natural Resources Wales, before the works can proceed. Mitigation for the demolition and loss of the bat roosts will be required as part of this process and a strategy for this must be developed with the client.

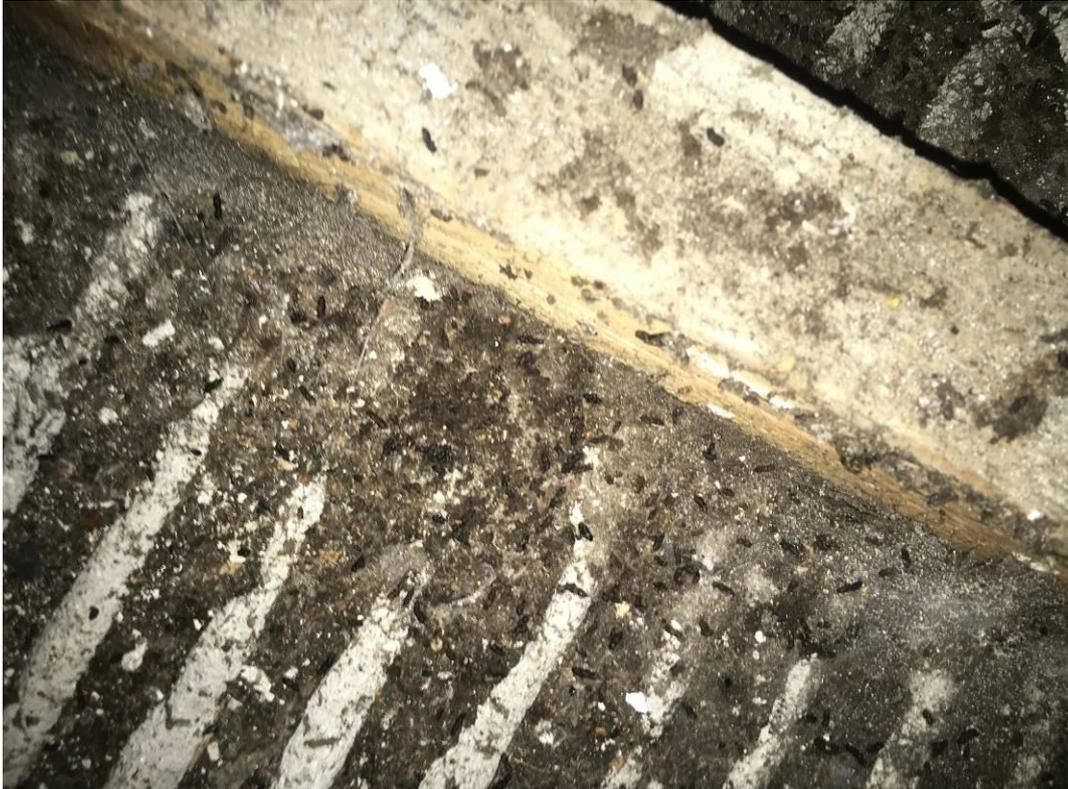
Large accumulations of droppings, showing the characteristics of brown long-eared or Natterer's bats were recorded within roof voids 1, 2 and 3 of the main building, strongly indicating the presence of a maternity roost of significance. A small accumulation of droppings showing the characteristics of pipistrelle or small *Myotis* bat species were also located in roof void 6.

Small quantity of bat droppings consistent with those produced by pipistrelle or small Myotis bats within roof void 6.

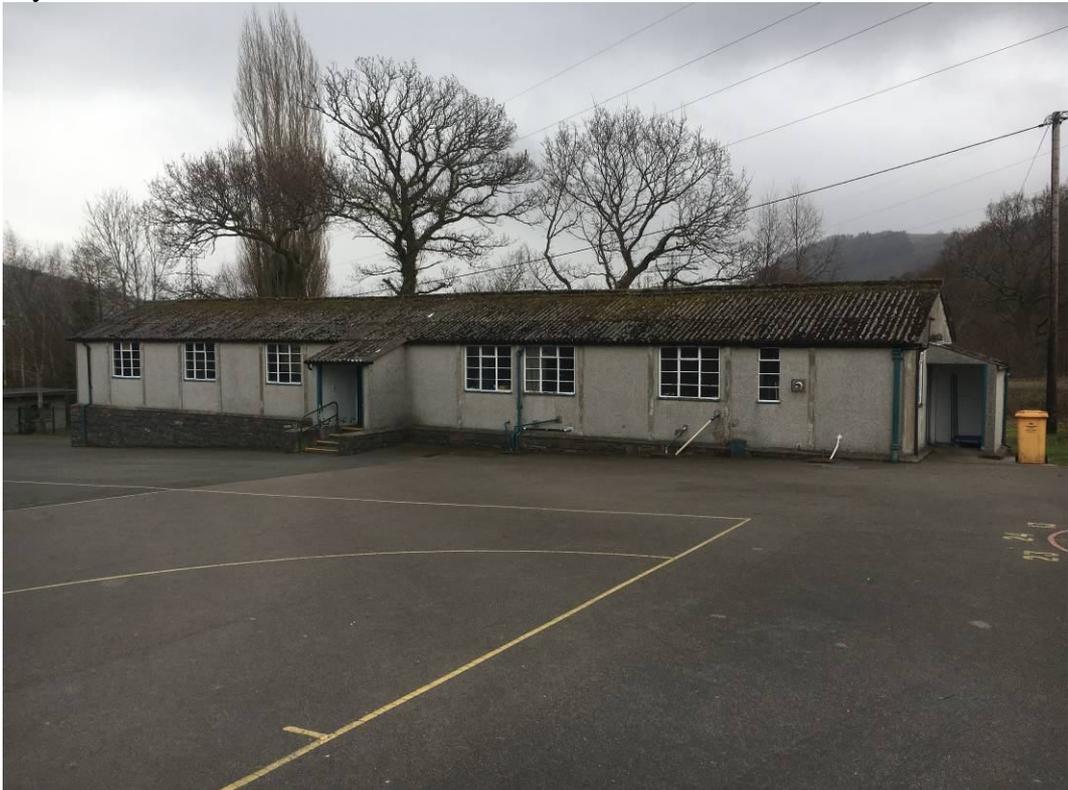
The canteen showed no evidence of bat usage, either past or current. Overall its potential to support roosting bats was assessed as low-medium for single male or non-breeding female, crevice dwelling bats.

Canteen, North elevation.

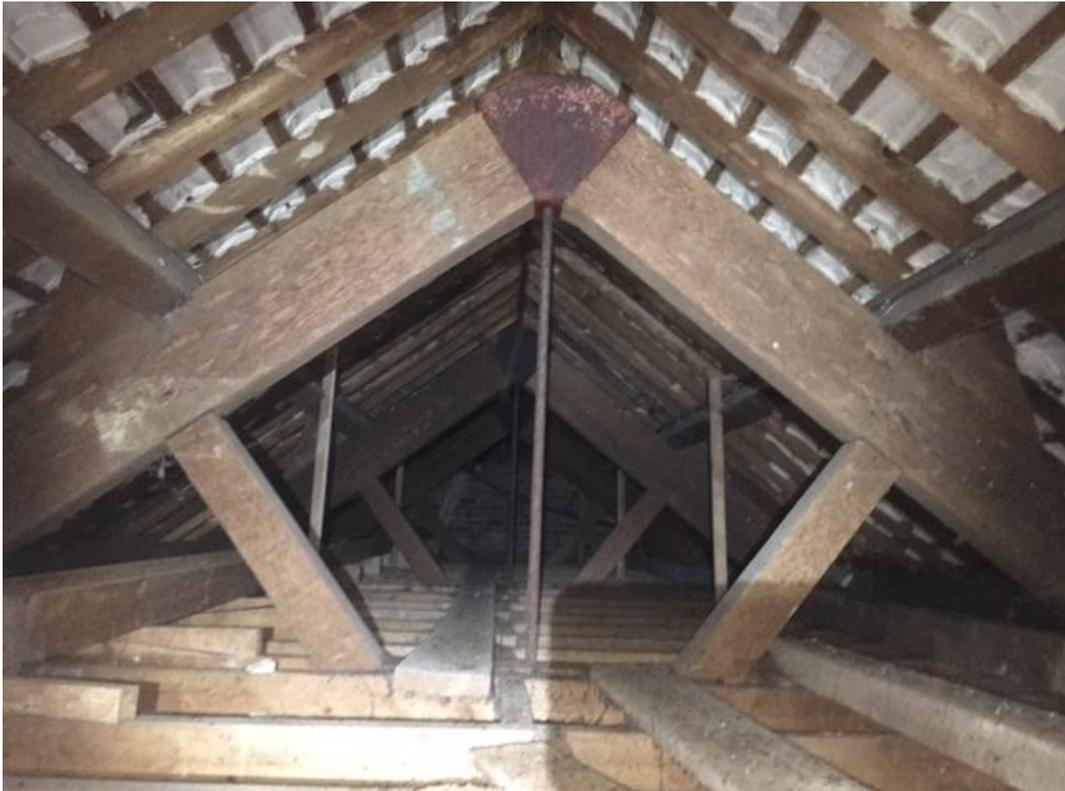
Internal view of roof void 5

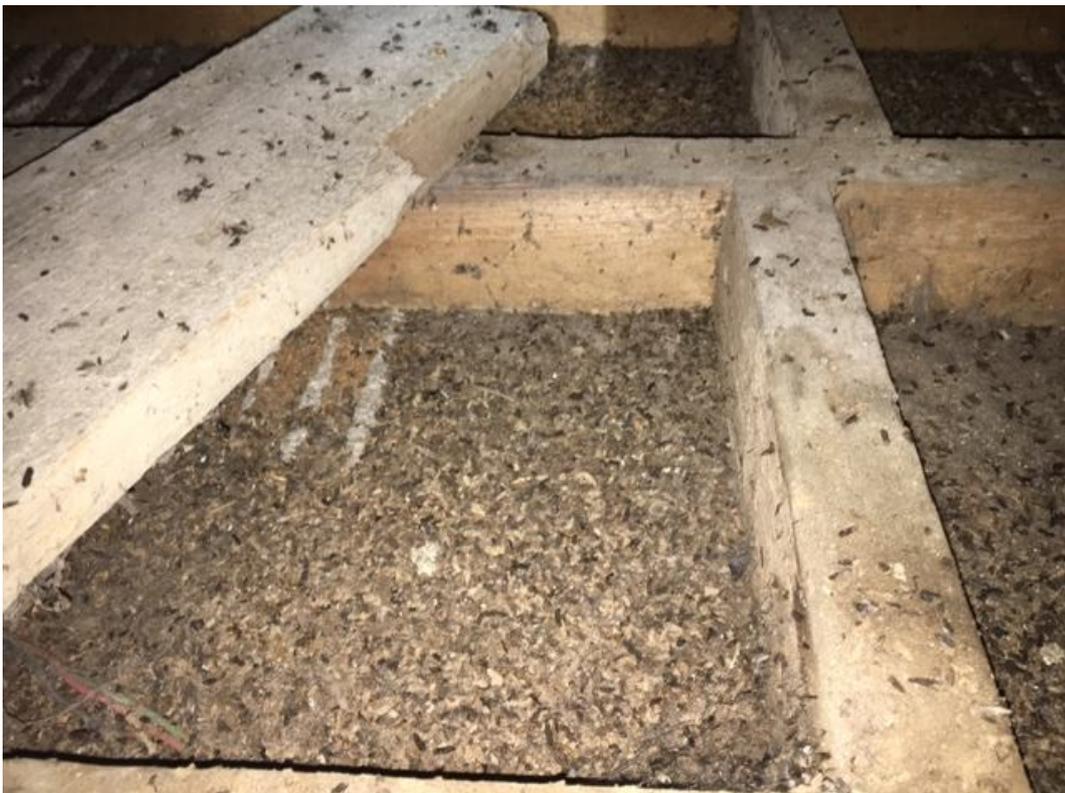
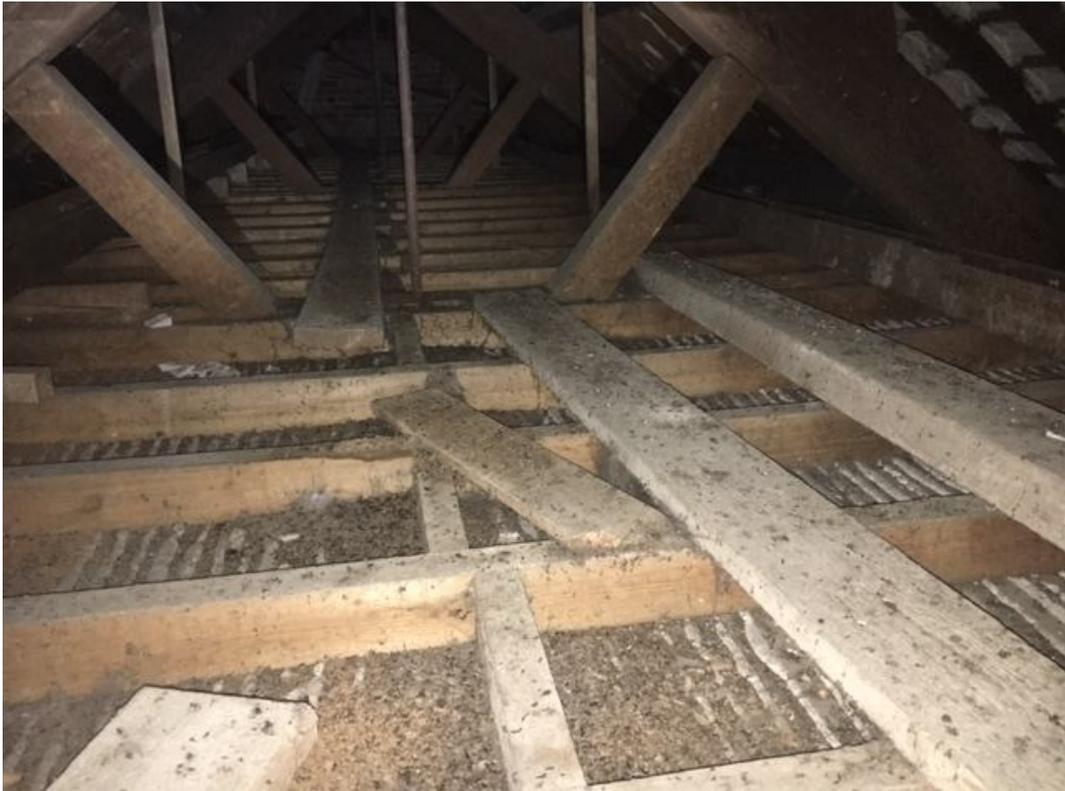
Significant quantities of bat droppings consistent with those produced by brown long-eared bats throughout roof void 5.

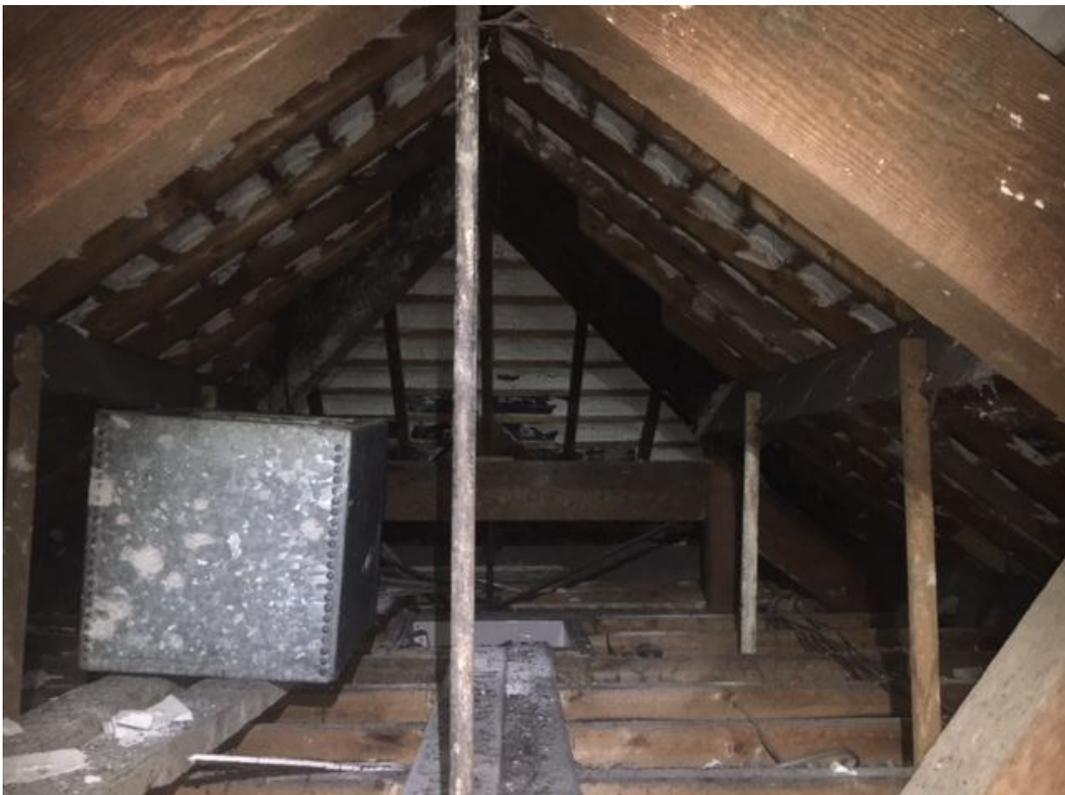
Internal view of roof void 4

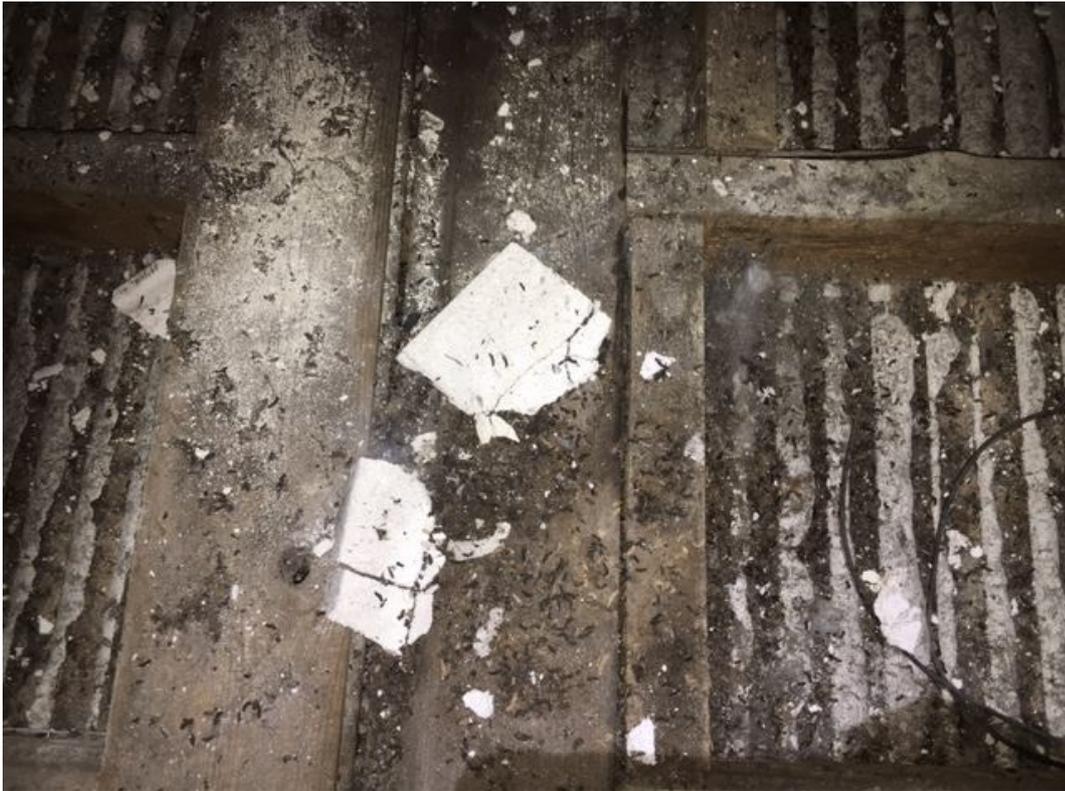
Quantities of bat droppings consistent with those produced by brown long-eared bats throughout roof void 4.
