# CMU 3/1 - QUARRY JETTY

# CMU 3/3 LLANDDULAS WASTE TIP

# CMU 3/2 B - LLANDDULAS BEACH

# CMU 3/2 A - LLANDDULAS REVETMENT

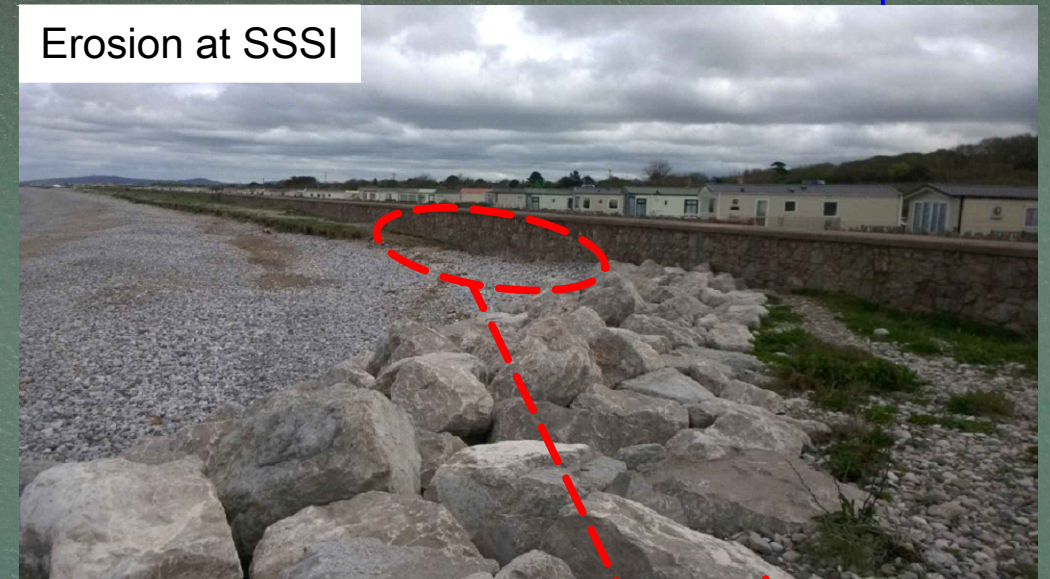
- Erosion of SSSI exacerbated by end effect of revetment.
- Need to maintain protection, as failure here could lead to extensive erosion and risk of contamination as well as exposure to the railway line and A55 behind.

Erosion at SSSI

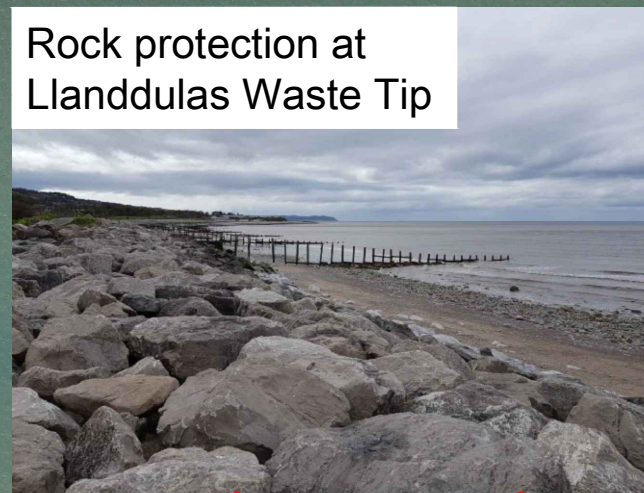
Rock protection at Llanddulas Waste Tip

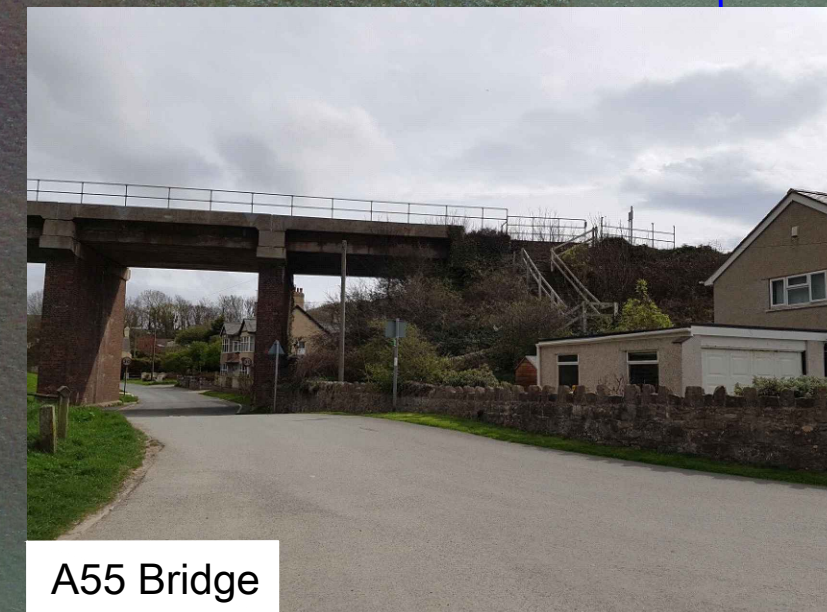
- This area floods significantly under extreme conditions.
- The low point and narrow valley cause water to be focused towards the carpark.
- Flood water flows under the A55 bridge.

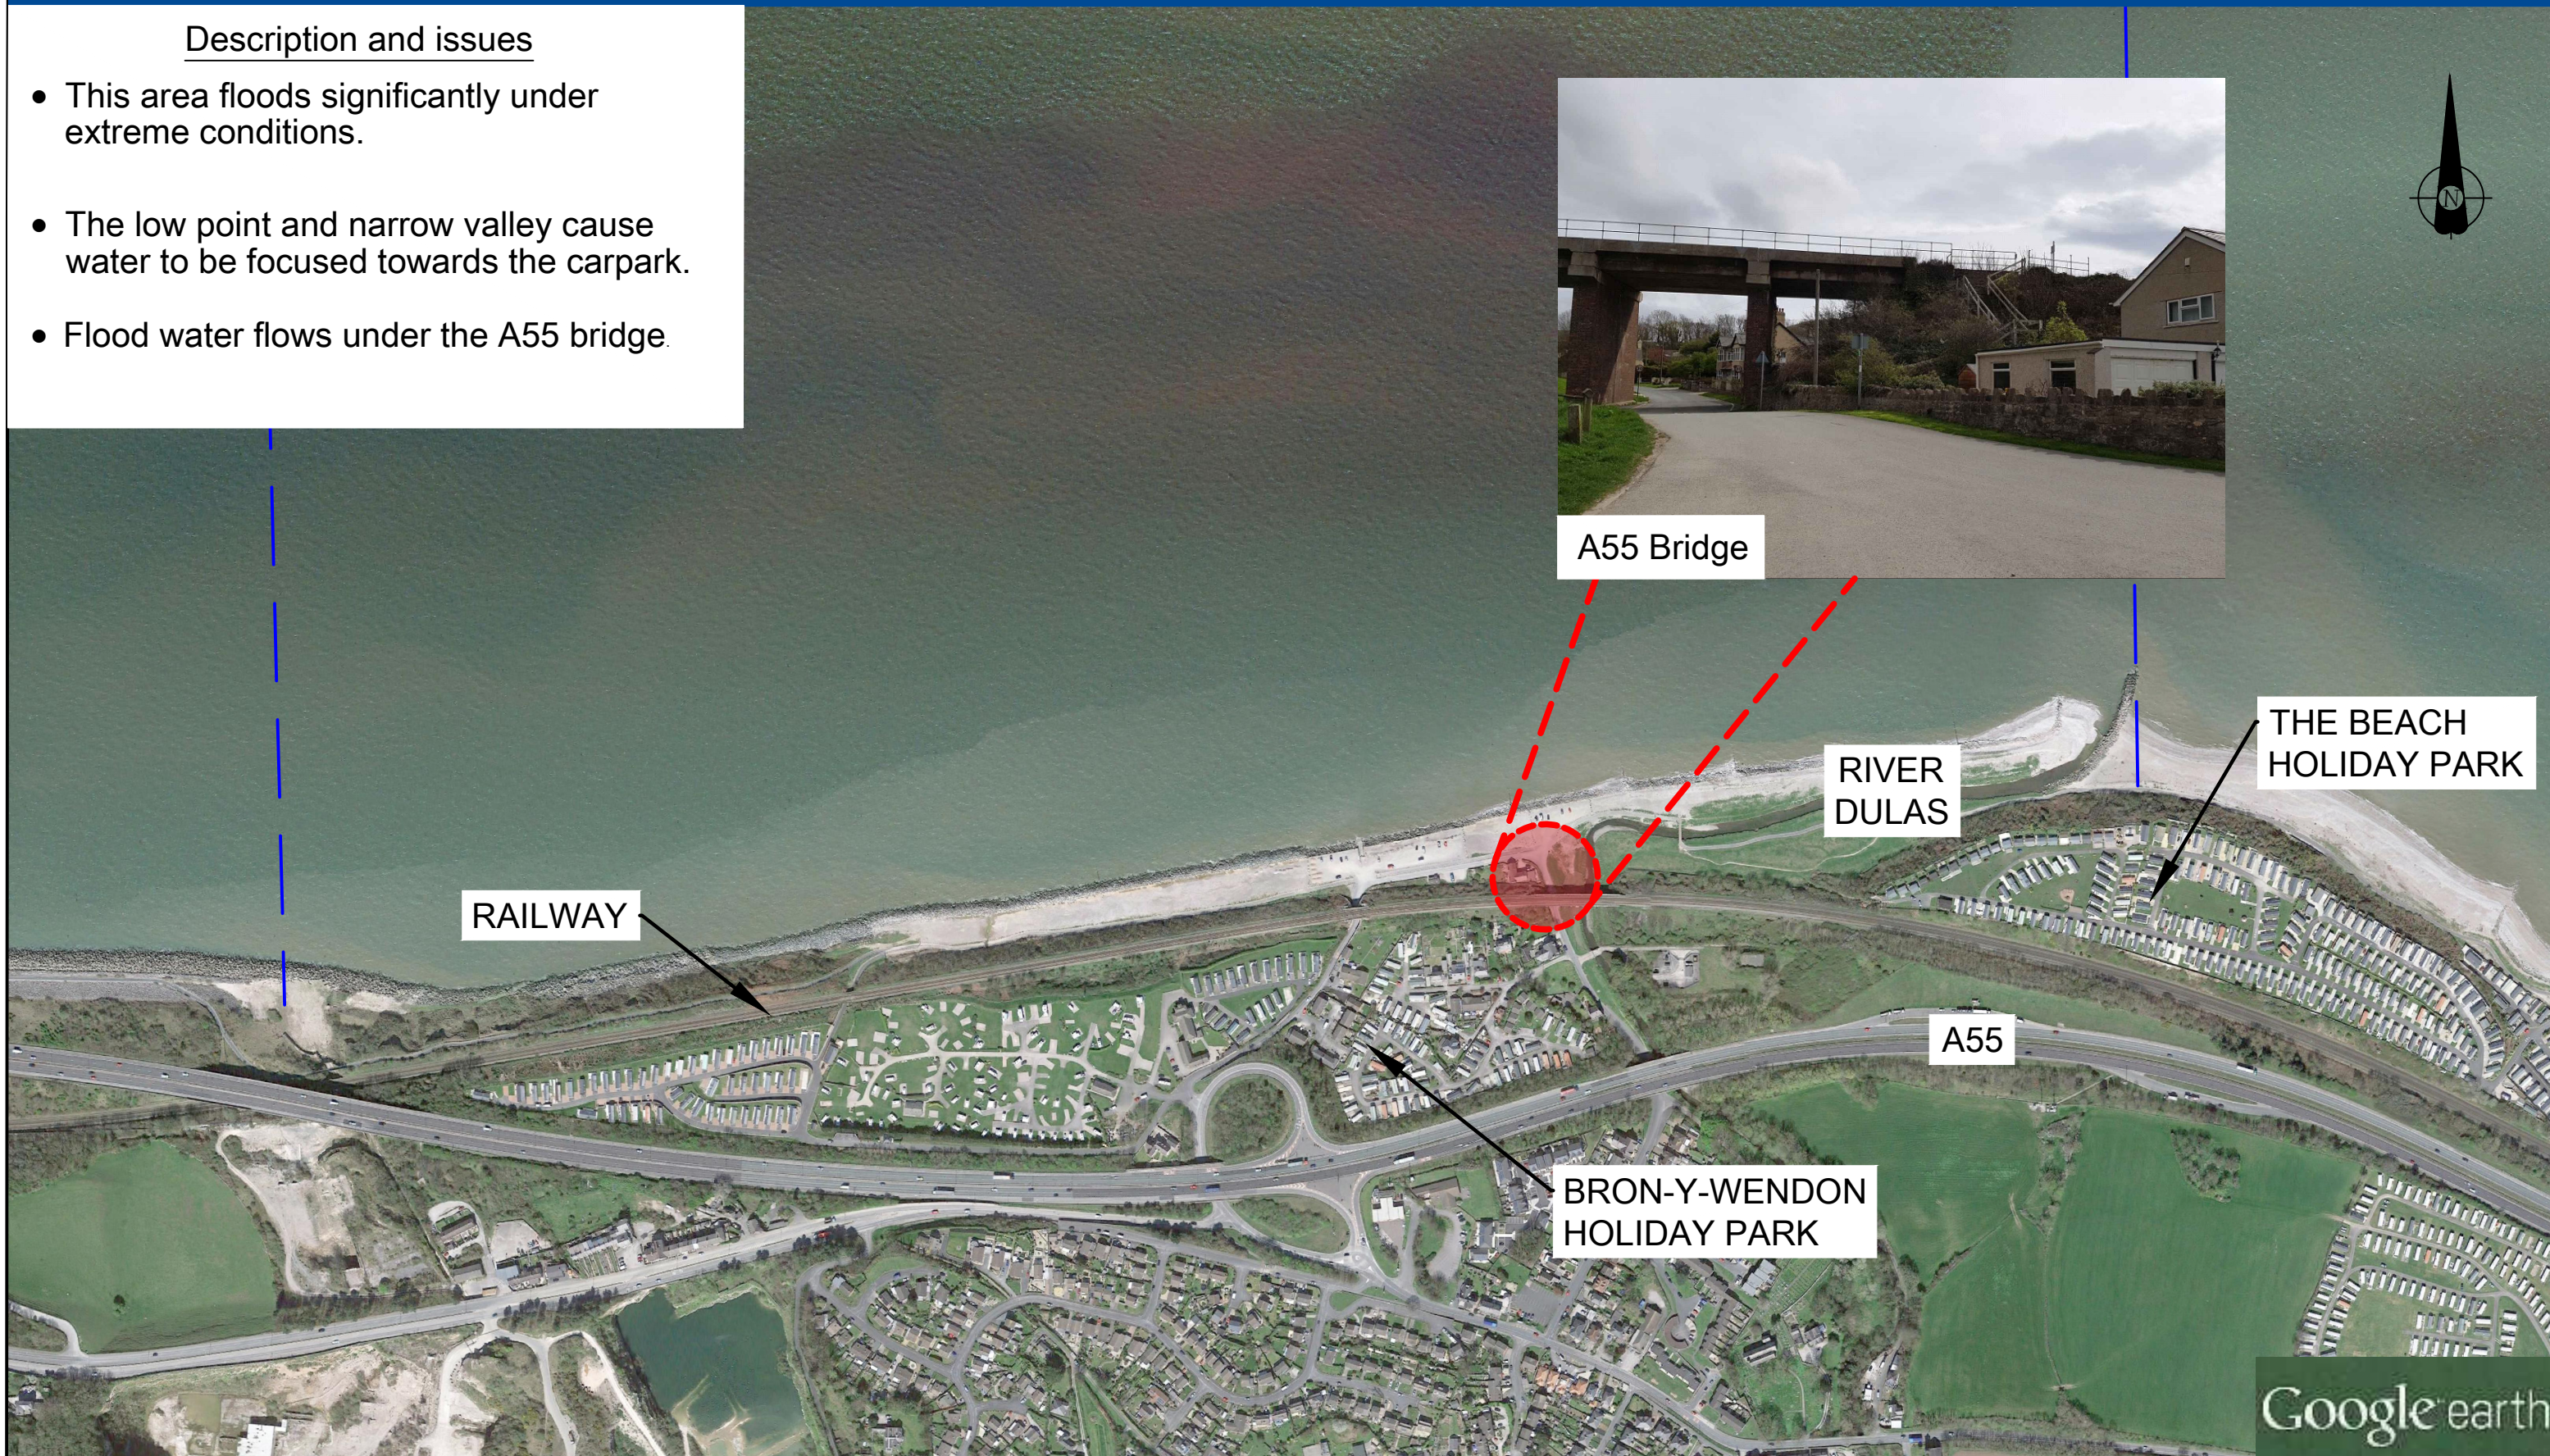
A55 Bridge

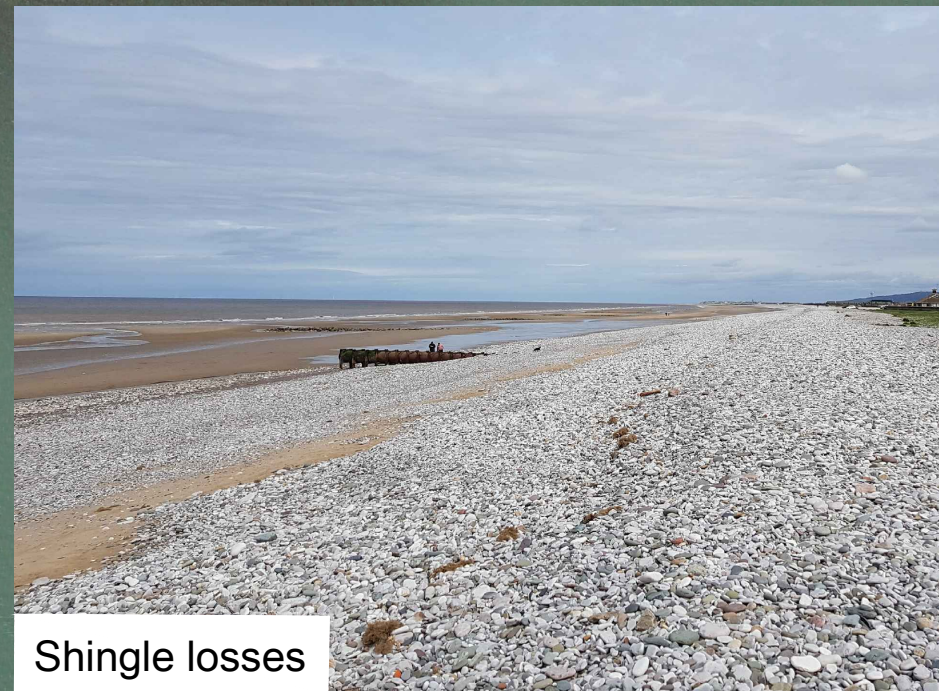
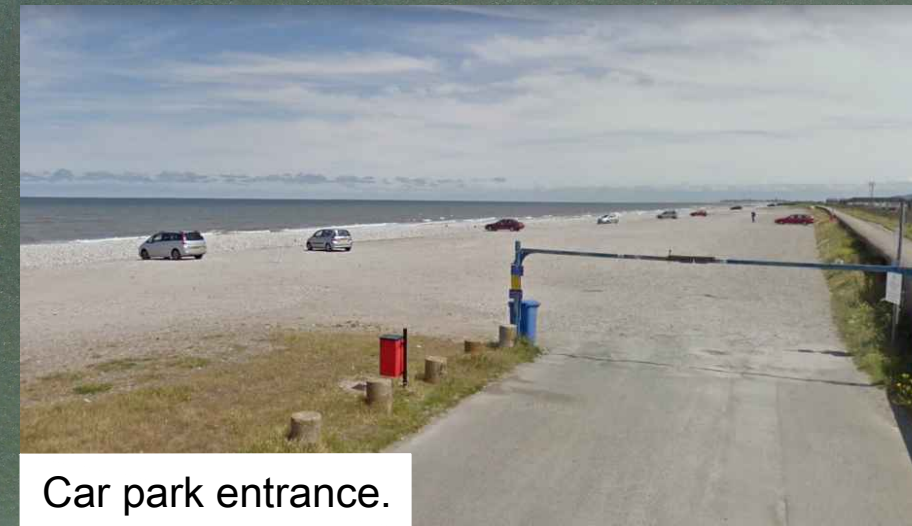
- Pensarn Beach presents similar challenges as Kinnel Bay in-relation to erosion and overtopping.
- This stretch is particularly suffering the effect of coastal squeeze.
- Presence of custom car parking on the beach.

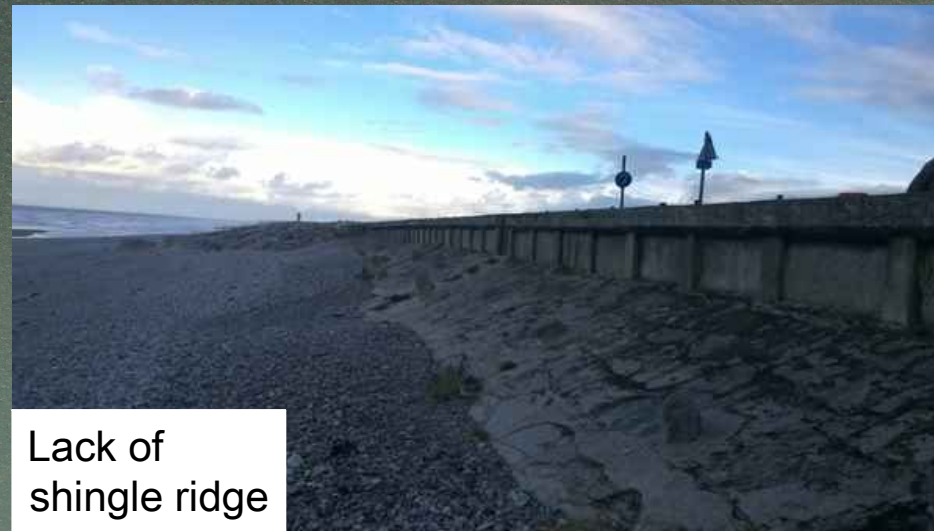
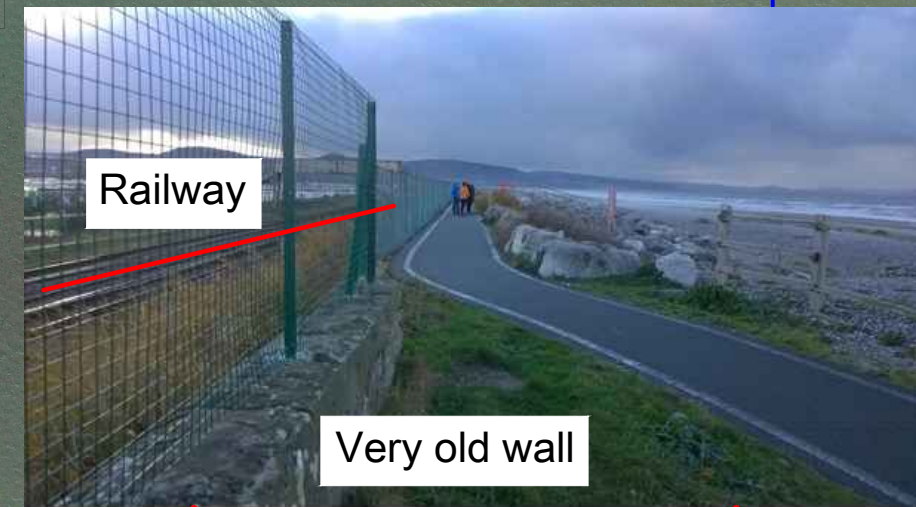
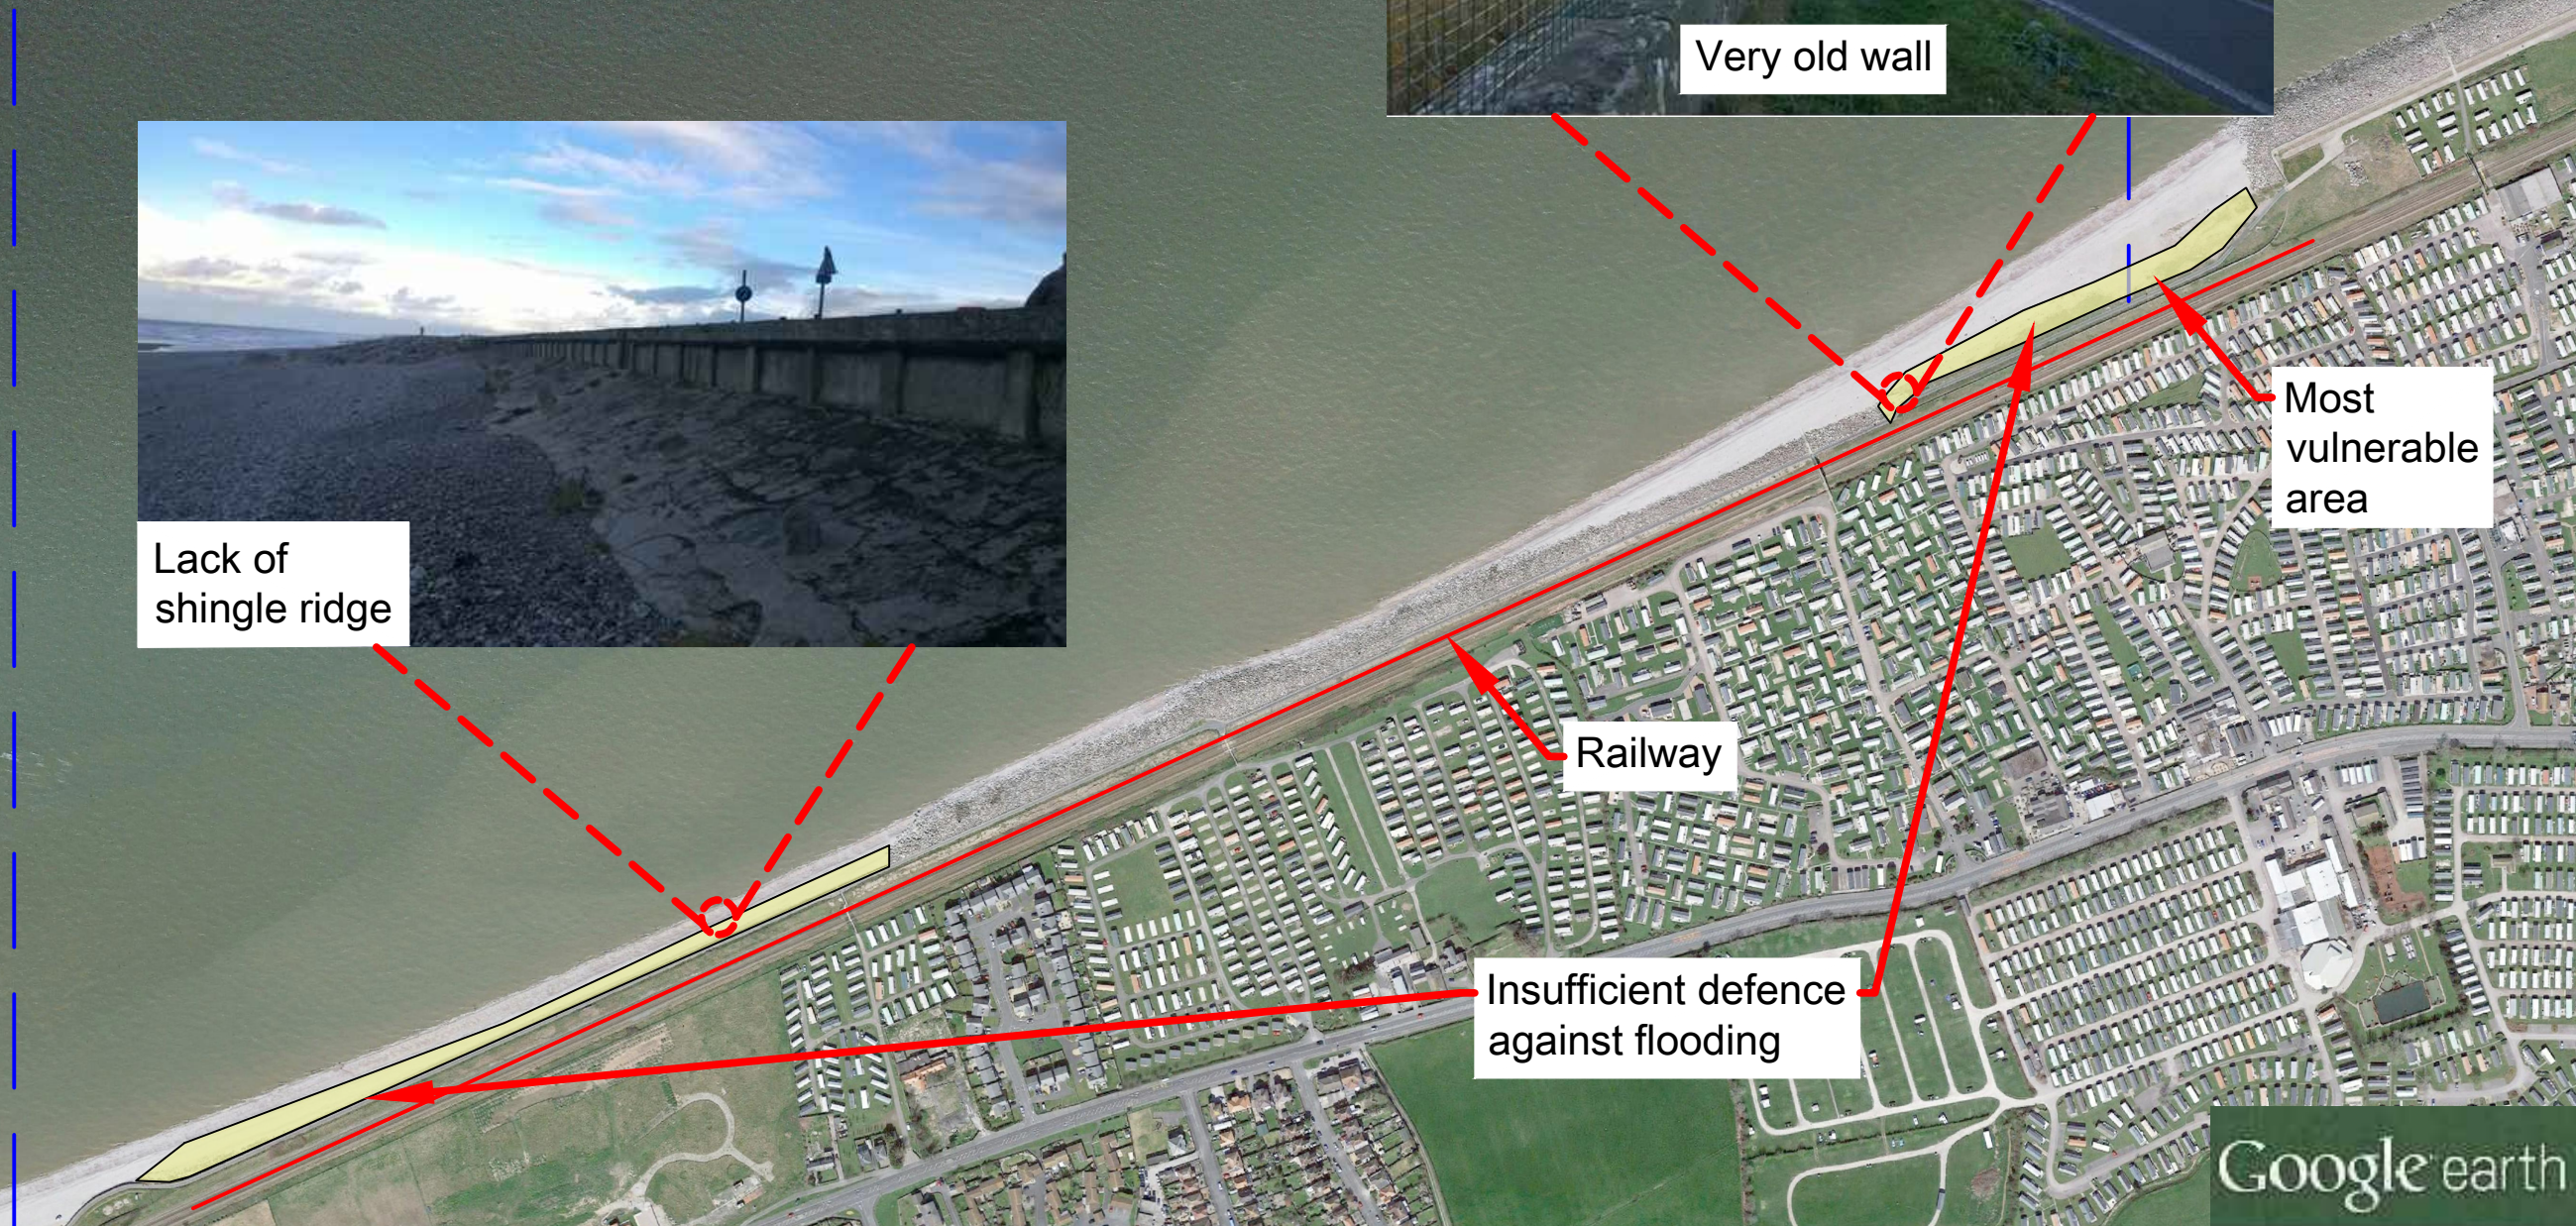
- Low-lying and strikingly sparse region, with a distinct lack of shingle ridge.
- To the west of the Towyn embankment, the railway line is perilously close to the beach, with little protection, provided by an old seawall, circa 100 years old. This is a key area for concern

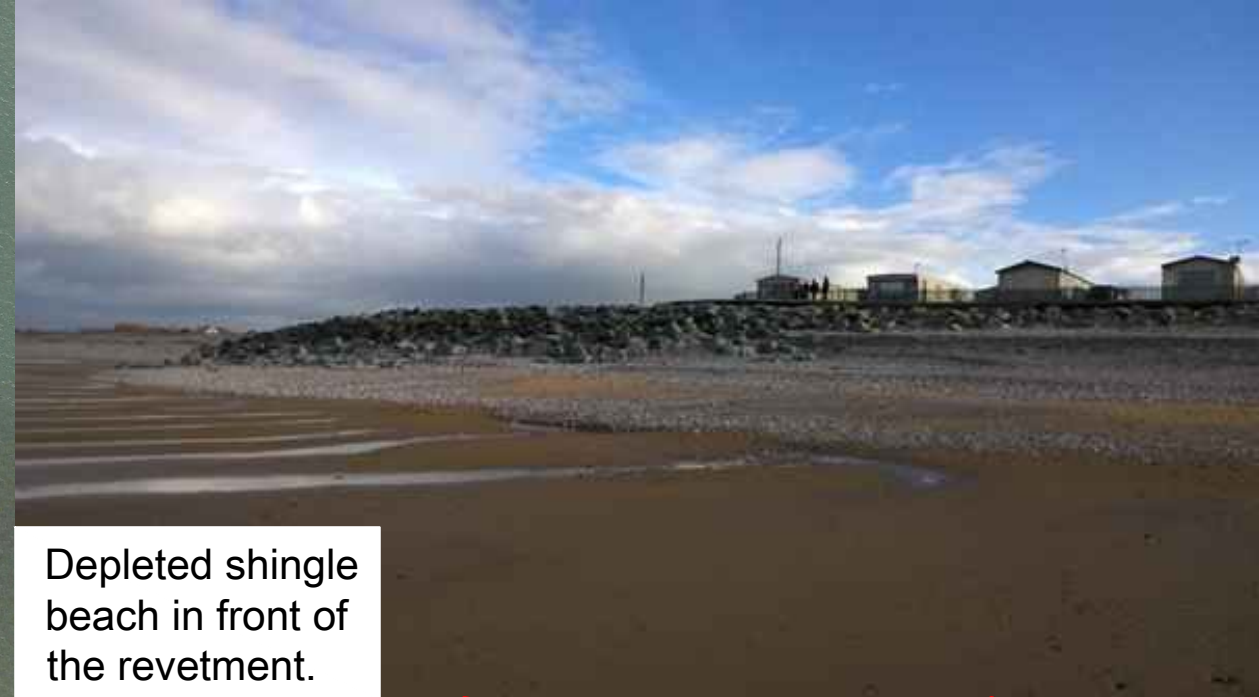
- The eastern end of the revetment experienced significant overtopping in December 2013.
- Even though the seawall seems quite high, as shown in the photographs, the beach/revetment is fairly steep and there is little space to dissipate wave energy due to the depleted shingle beach.
- The remaining stretch of the revetment provides enough protection against overtopping

Depleted shingle beach in front of the revetment.

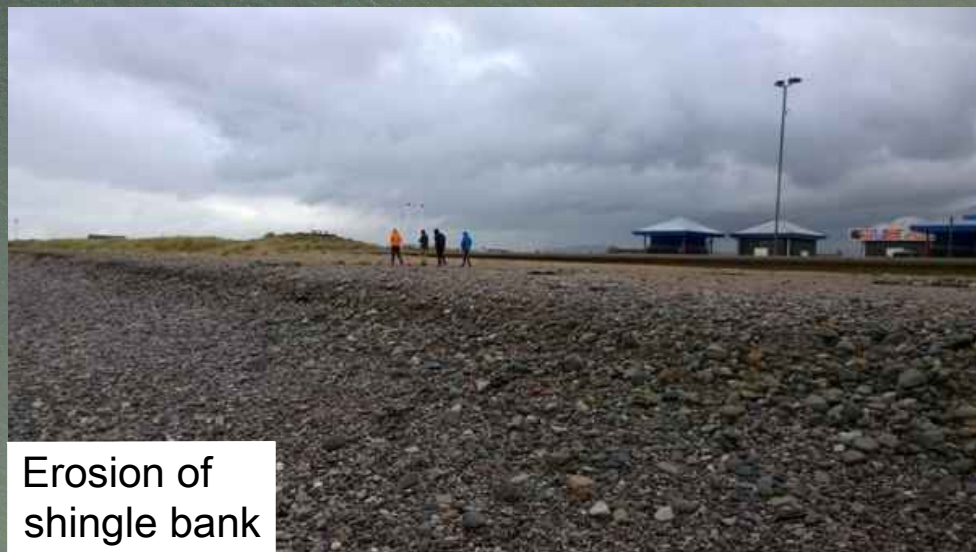
- High shingle beaches susceptible to significant levels of overtopping, particularly under climate change.
- The shingle bank in front of Kinmel Bay has significantly been eroded since November 2016.

Erosion of shingle bank

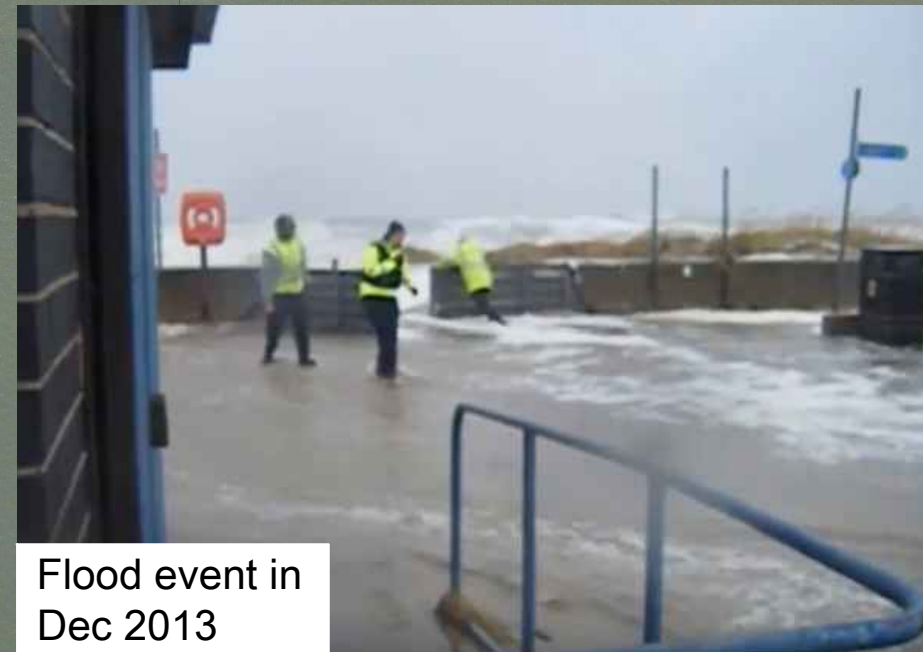
Flood event in Dec 2013

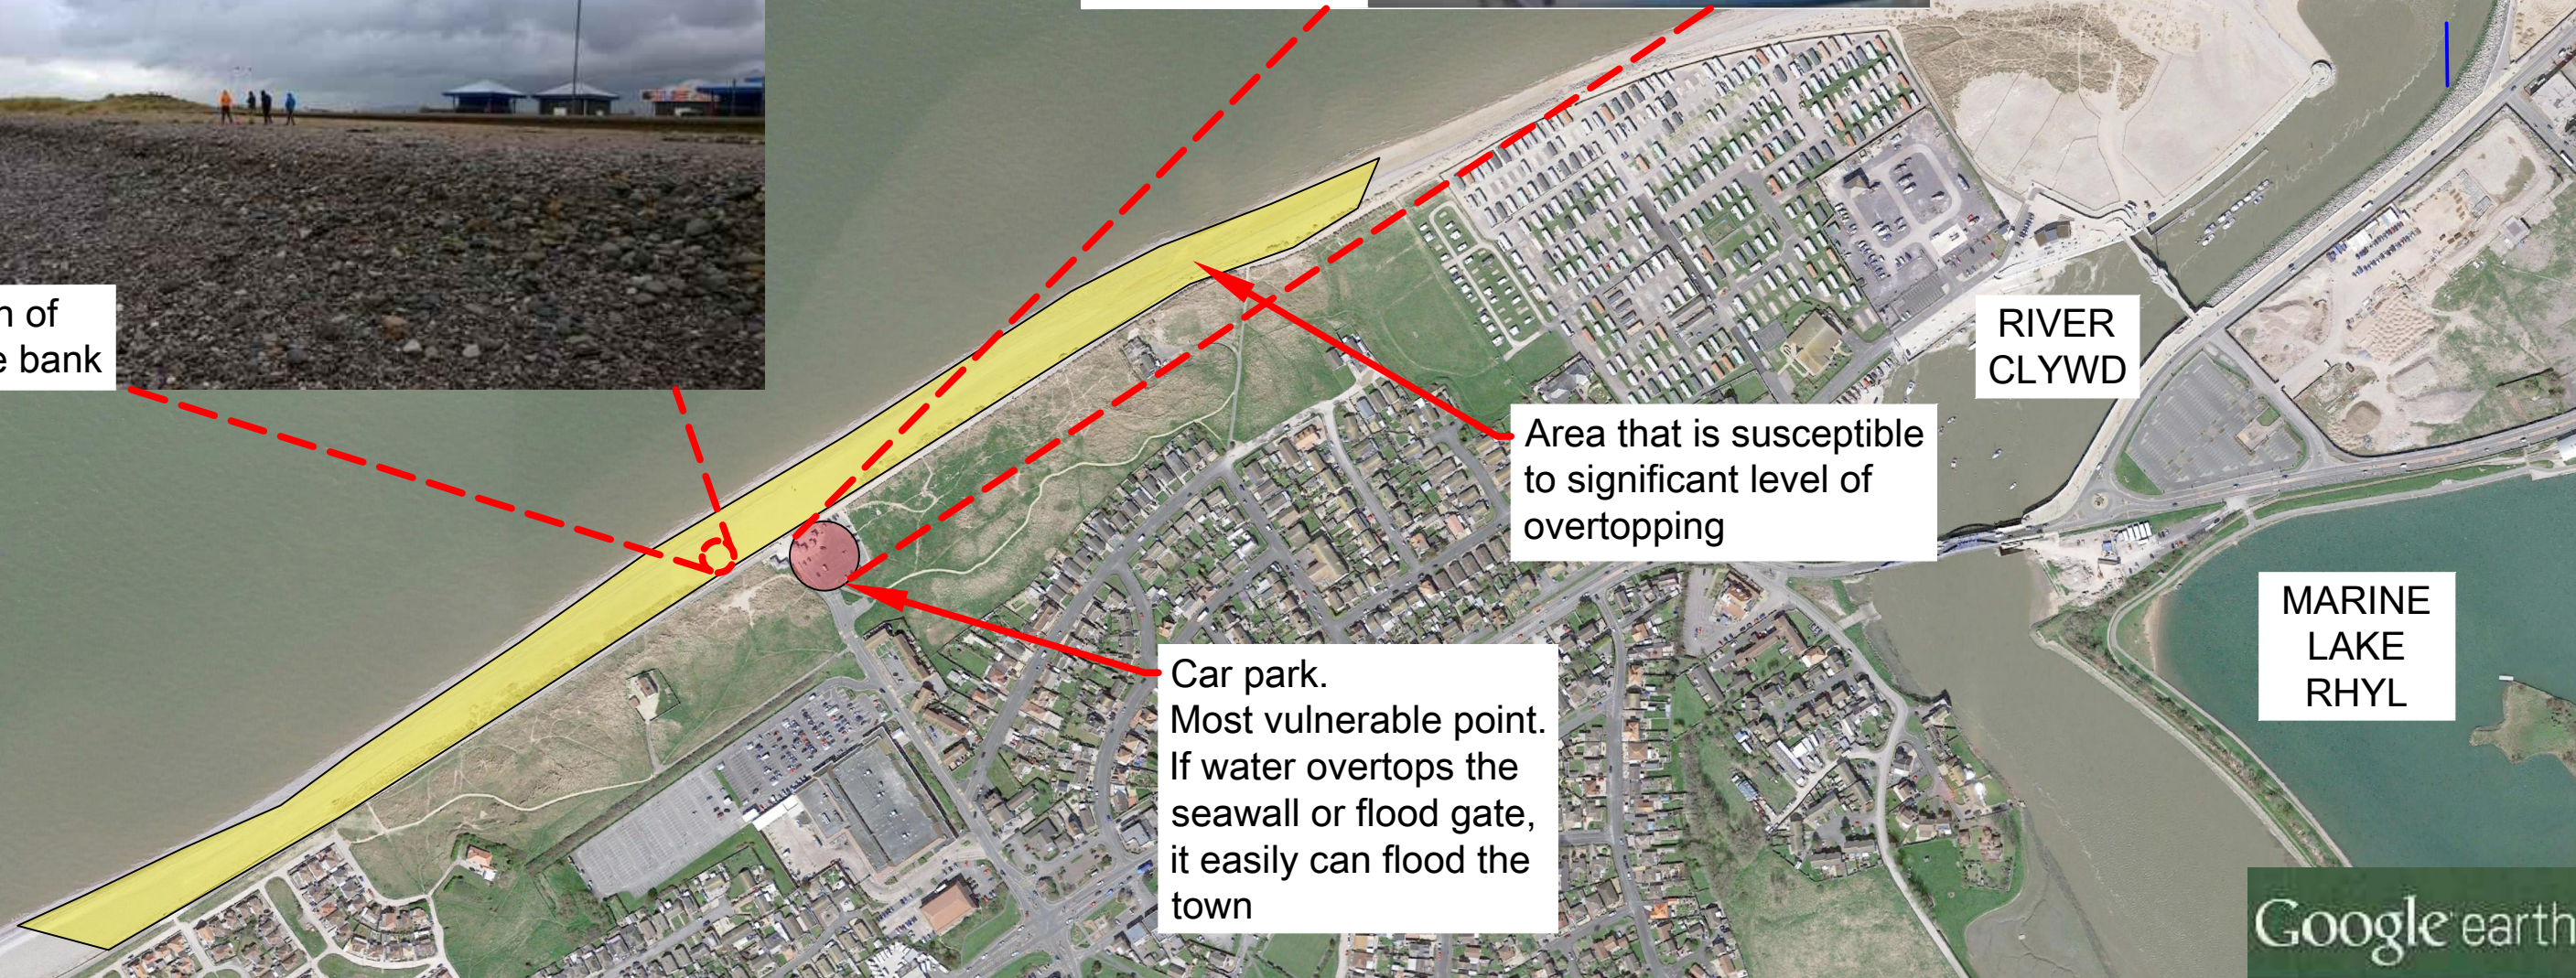
Area that is susceptible to significant level of overtopping

Car park.  
Most vulnerable point.  
If water overtops the seawall or flood gate, it easily can flood the town
