To provide forward looking planning and management of the beaches of Llandudno, Conwy County Borough Council (CCBC) working in partnership with the Llandudno Coastal Forum (LCF) has commissioned AECOM to prepare an Outline Business Case (OBC) to cover both the North Shore and West Shore beach areas in Llandudno. This Public Display is intended to provide an update on the progress being made by CCBC/LCF and to identify the next steps towards achieving the goal of sustainable management of safe beaches for all.

PROGRESS TO DATE

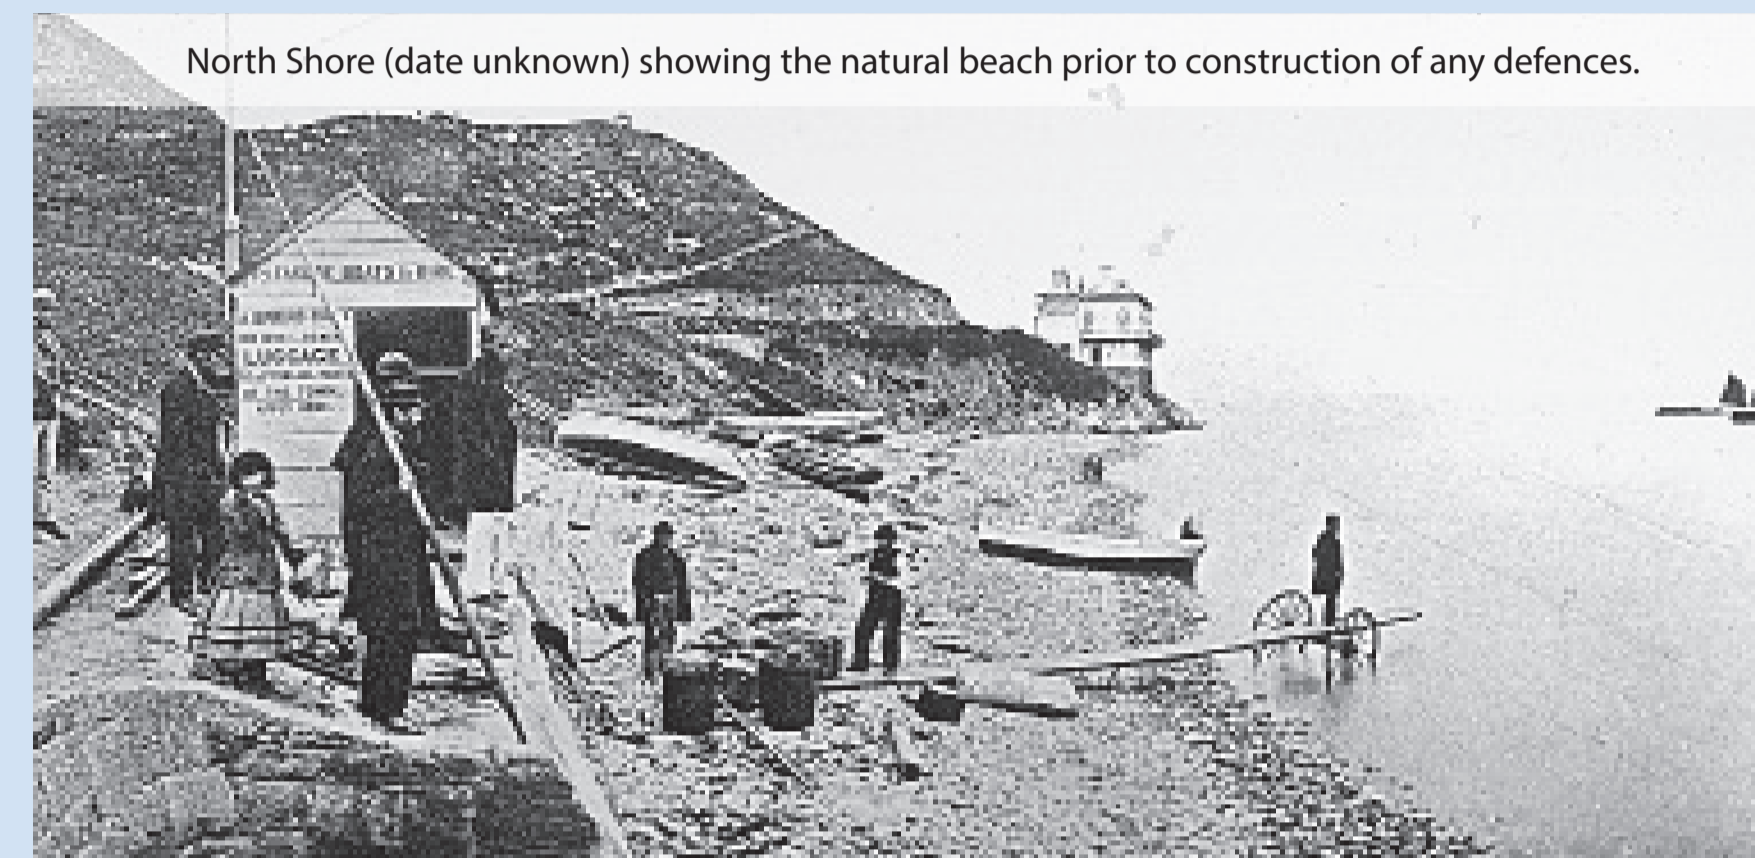
North Shore (date unknown) showing the natural beach prior to construction of any defences.

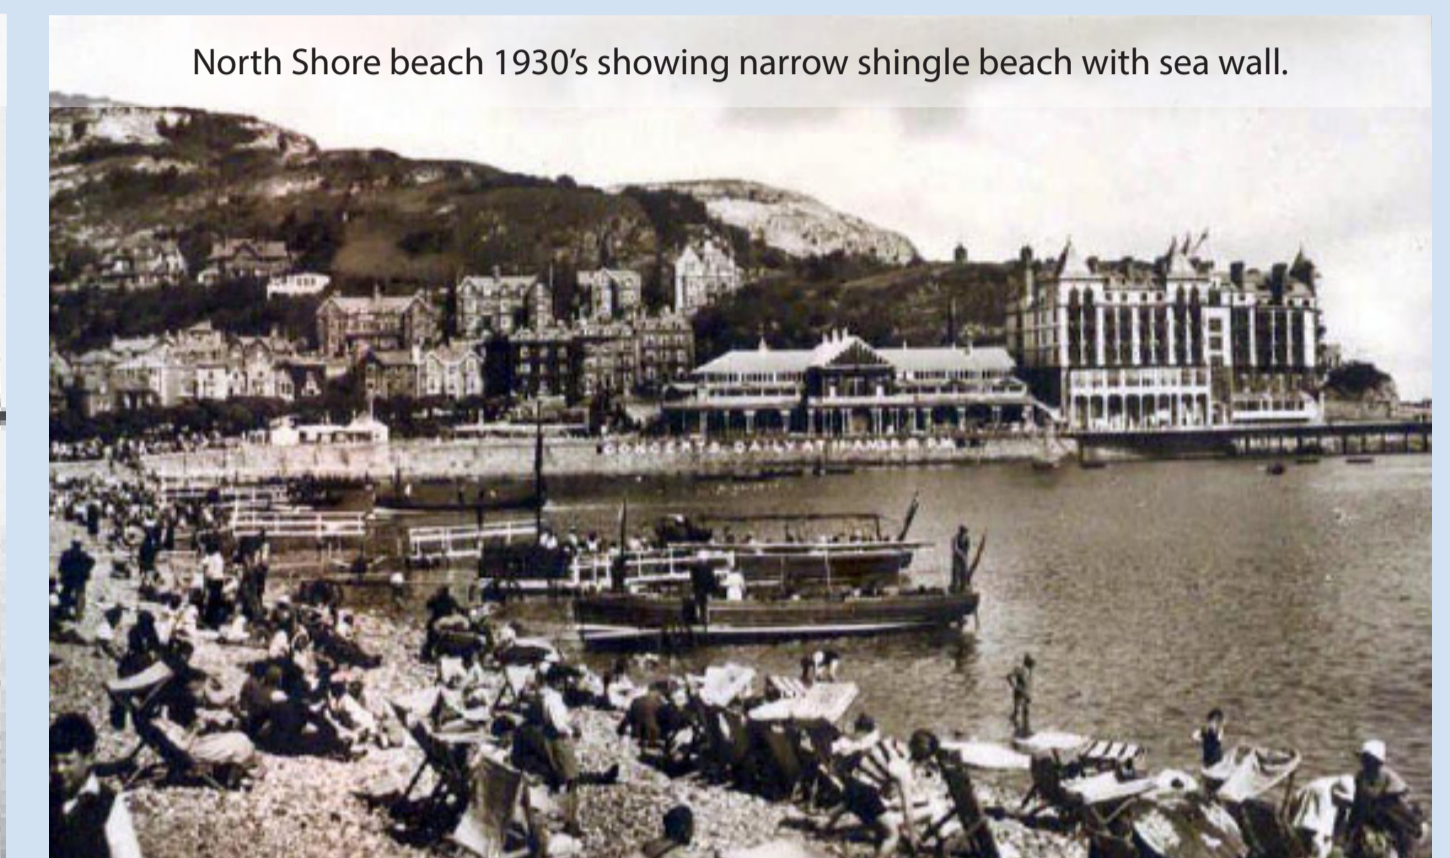
North Shore beach 1930's showing narrow shingle beach with sea wall.

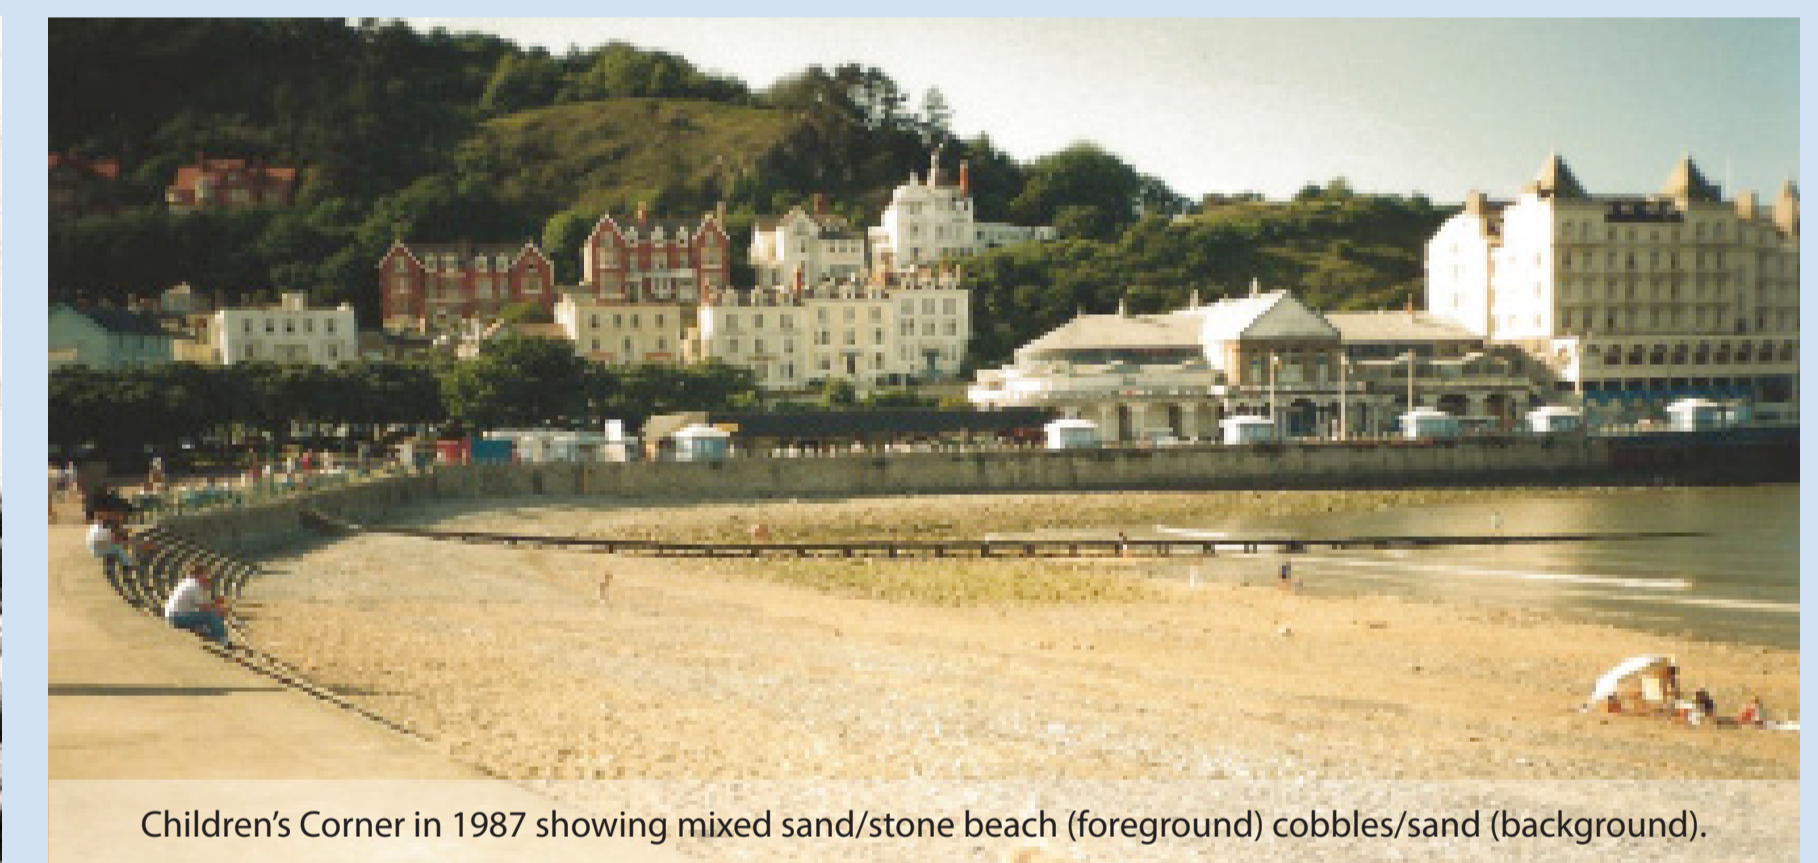
Children's Corner in 1987 showing mixed sand/stone beach (foreground) cobbles/sand (background).

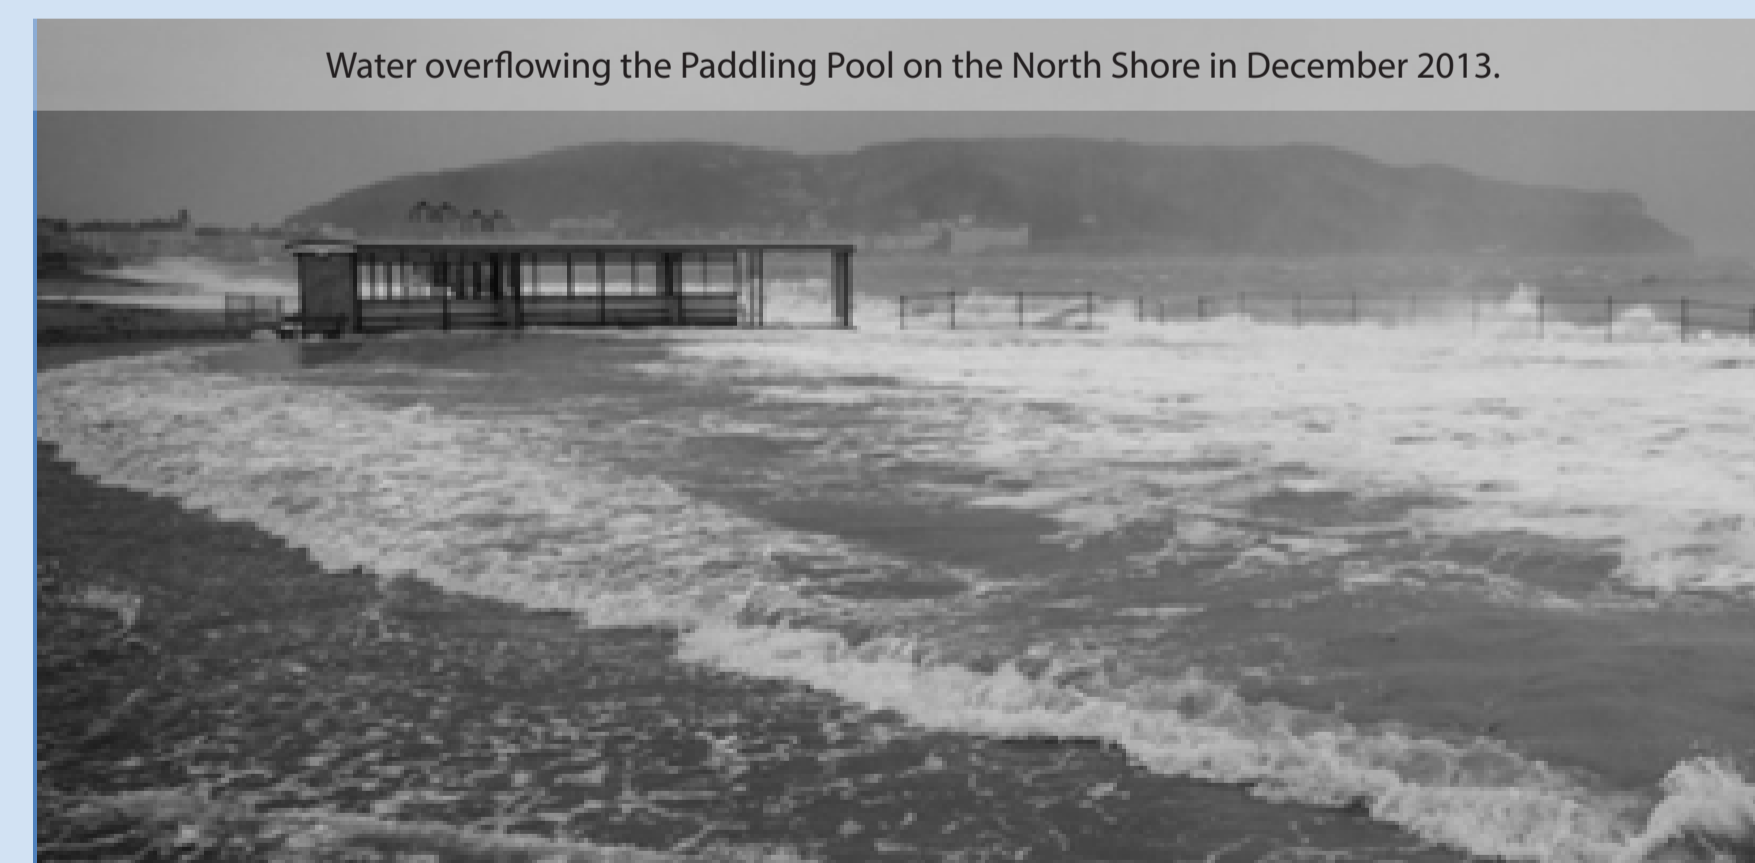
Water overflowing the Paddling Pool on the North Shore in December 2013.

Issues and Objectives
The sloping front wall allows waves to run up the face and overtop into the paddling pool. This results in significant overtopping by waves and large amounts of shingle being thrown onto the pool and surroundings. Damage from the stones is possible and the mix of water and stones overtopping in a storm event could present a risk to life. The objective for this MU is to maintain the paddling pool as an amenity and provide adequate flood protection.

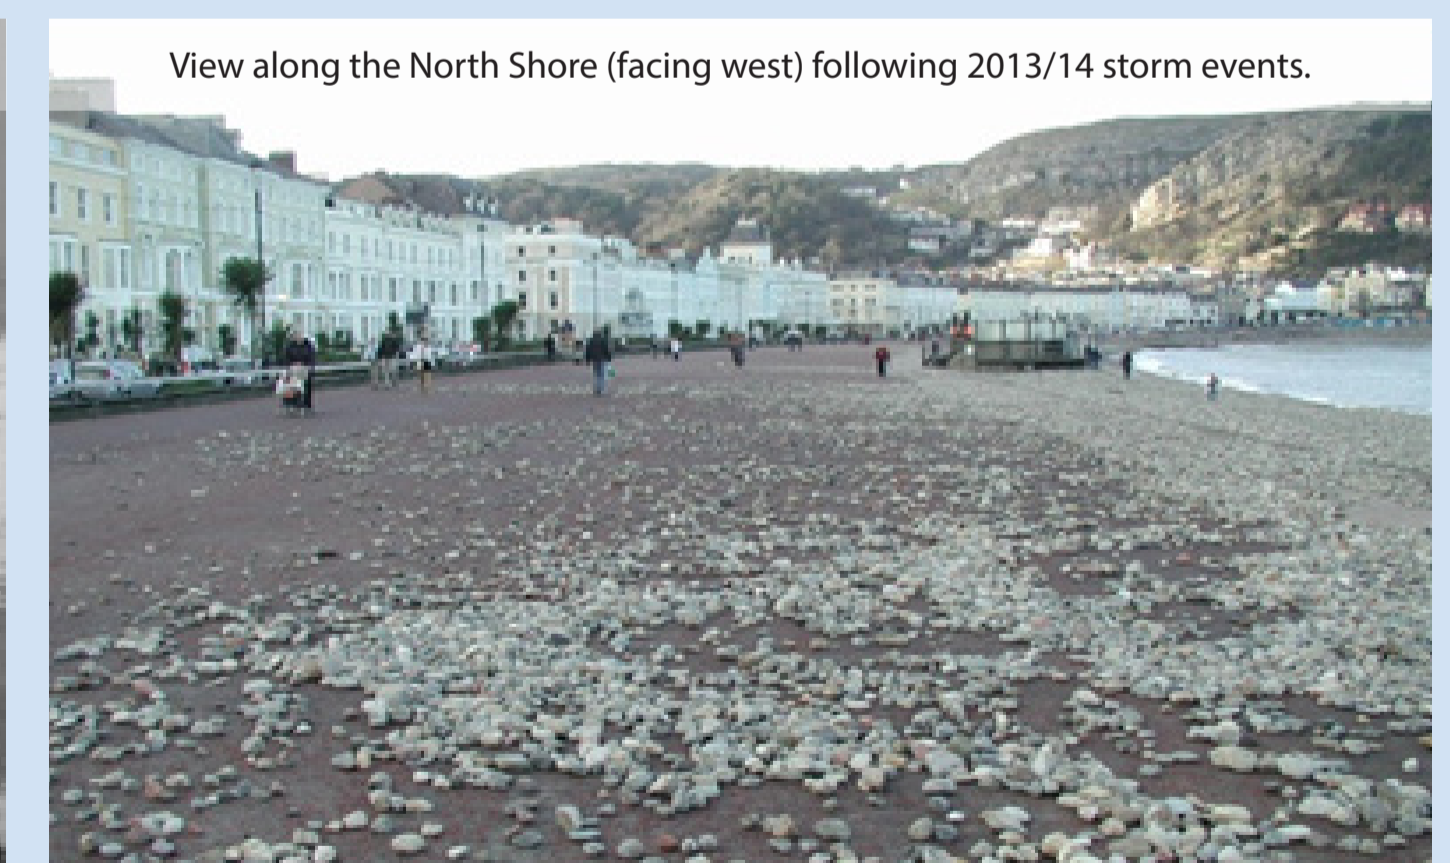
View along the North Shore (facing west) following 2013/14 storm events.

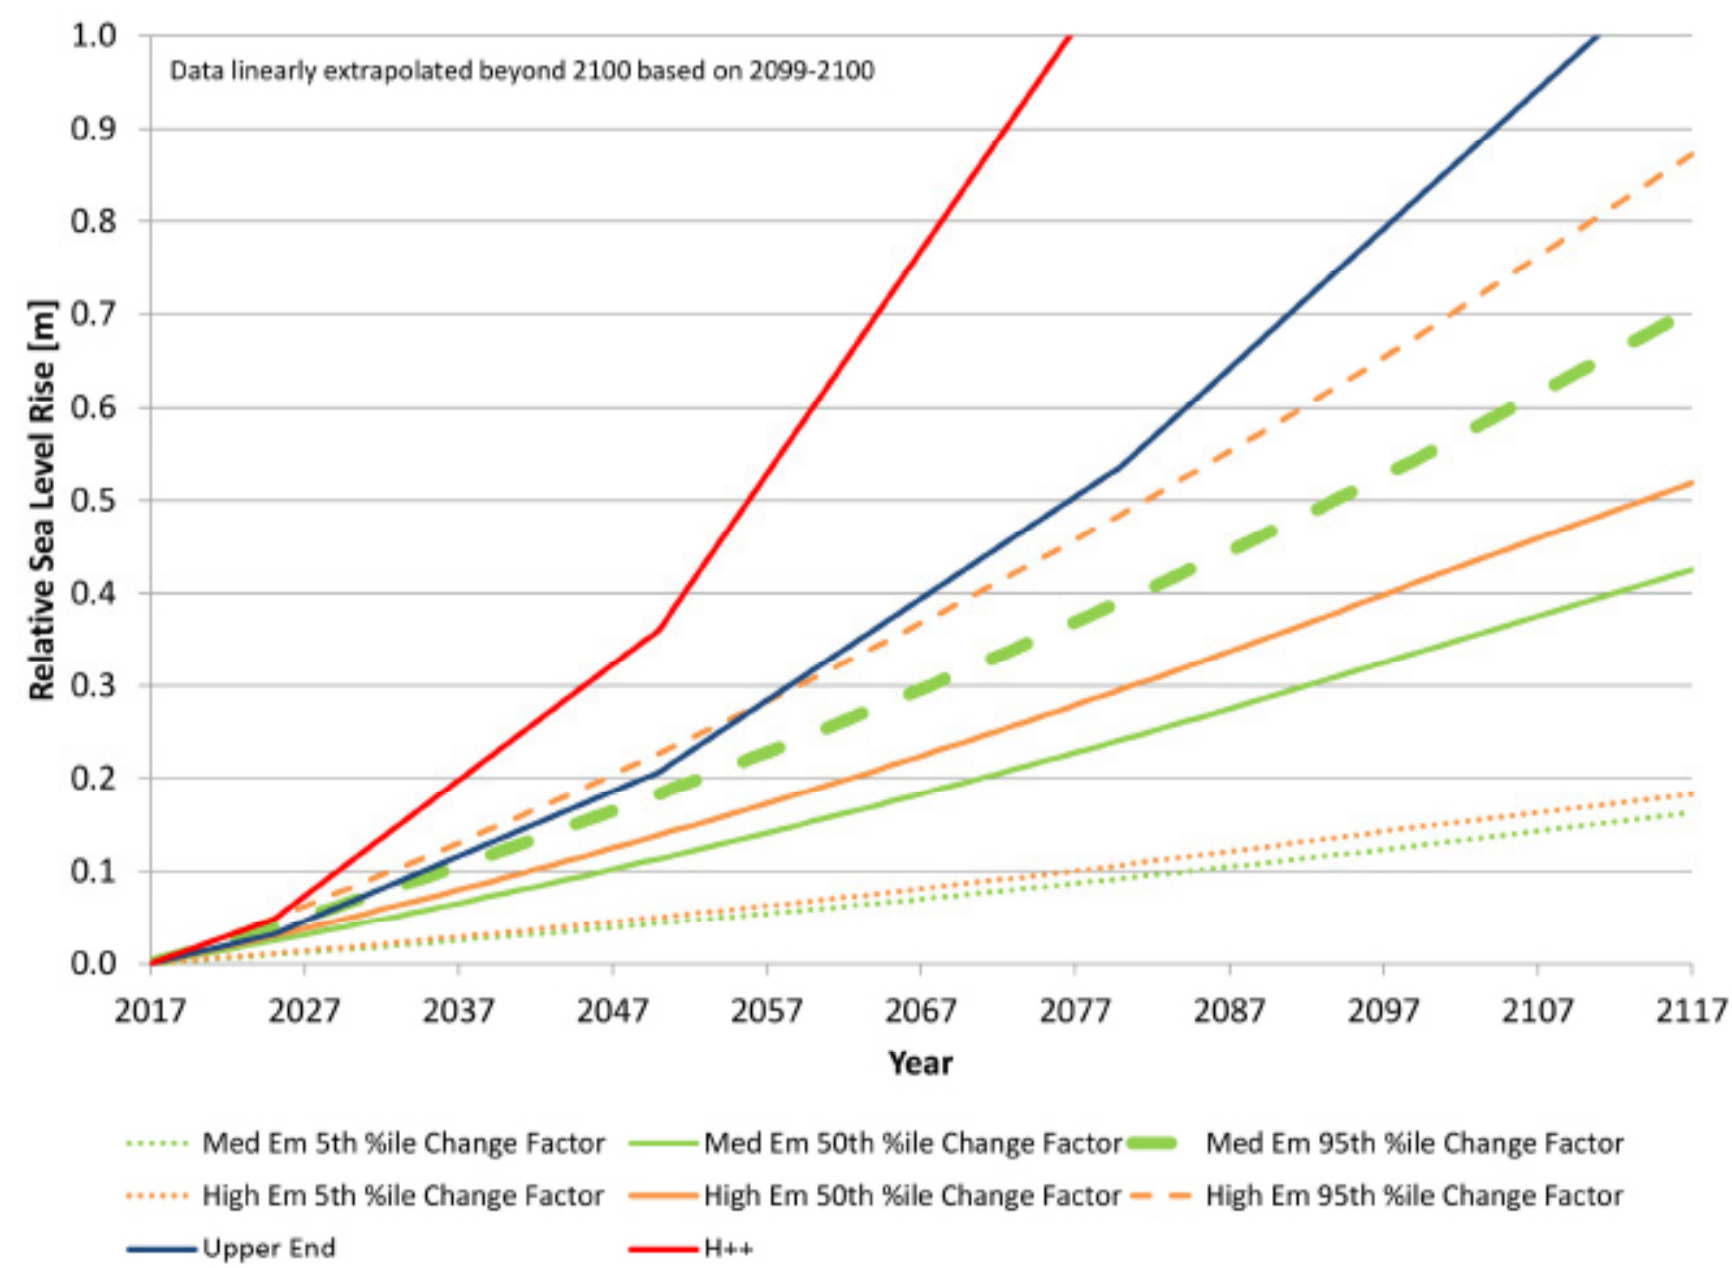
Sea levels are predicted to rise over the next 100 years due to climate change and this will increase the likelihood of flooding.

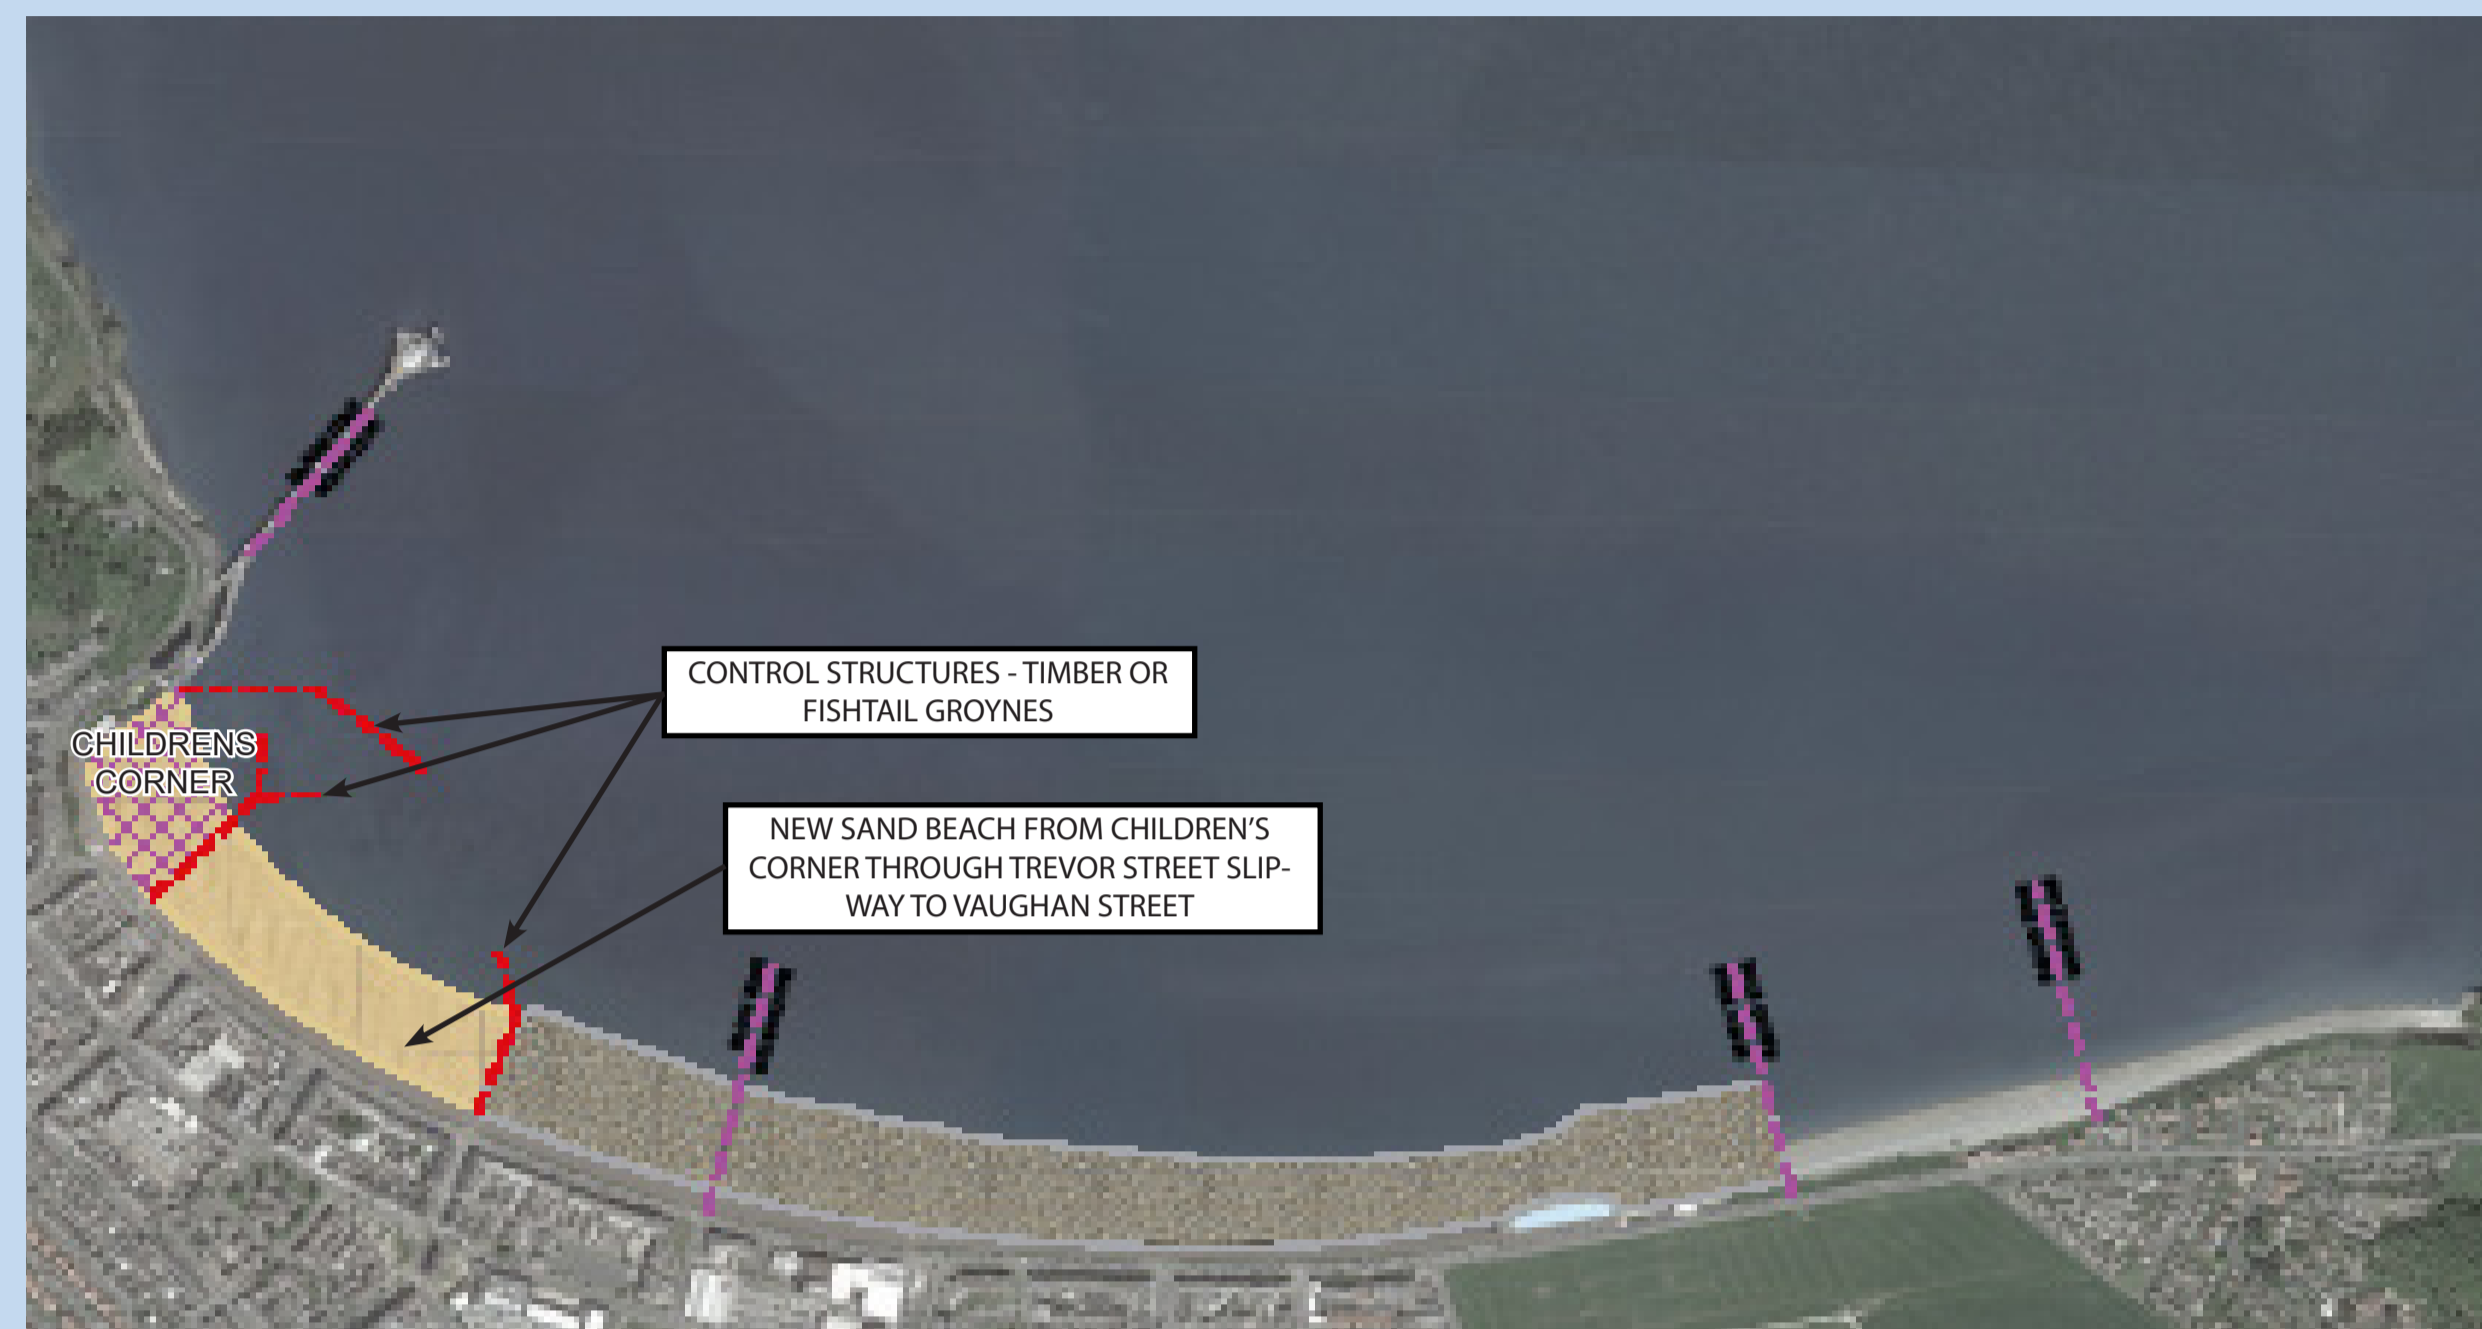
Option A: Beach Nourishment & Control Structures

Beach nourishment with shore connected control structures. Rock or timber groynes to be used as the control structures. This would replace the cobbles from Trevor St slipway/Children's Corner to approximately Vaughan Street with sand. The exact location of the change in material and the structures would need to be determined. Raising of the rear promenade wall would take place before year 50 to account for rising sea levels and the associated increase in flood risk.

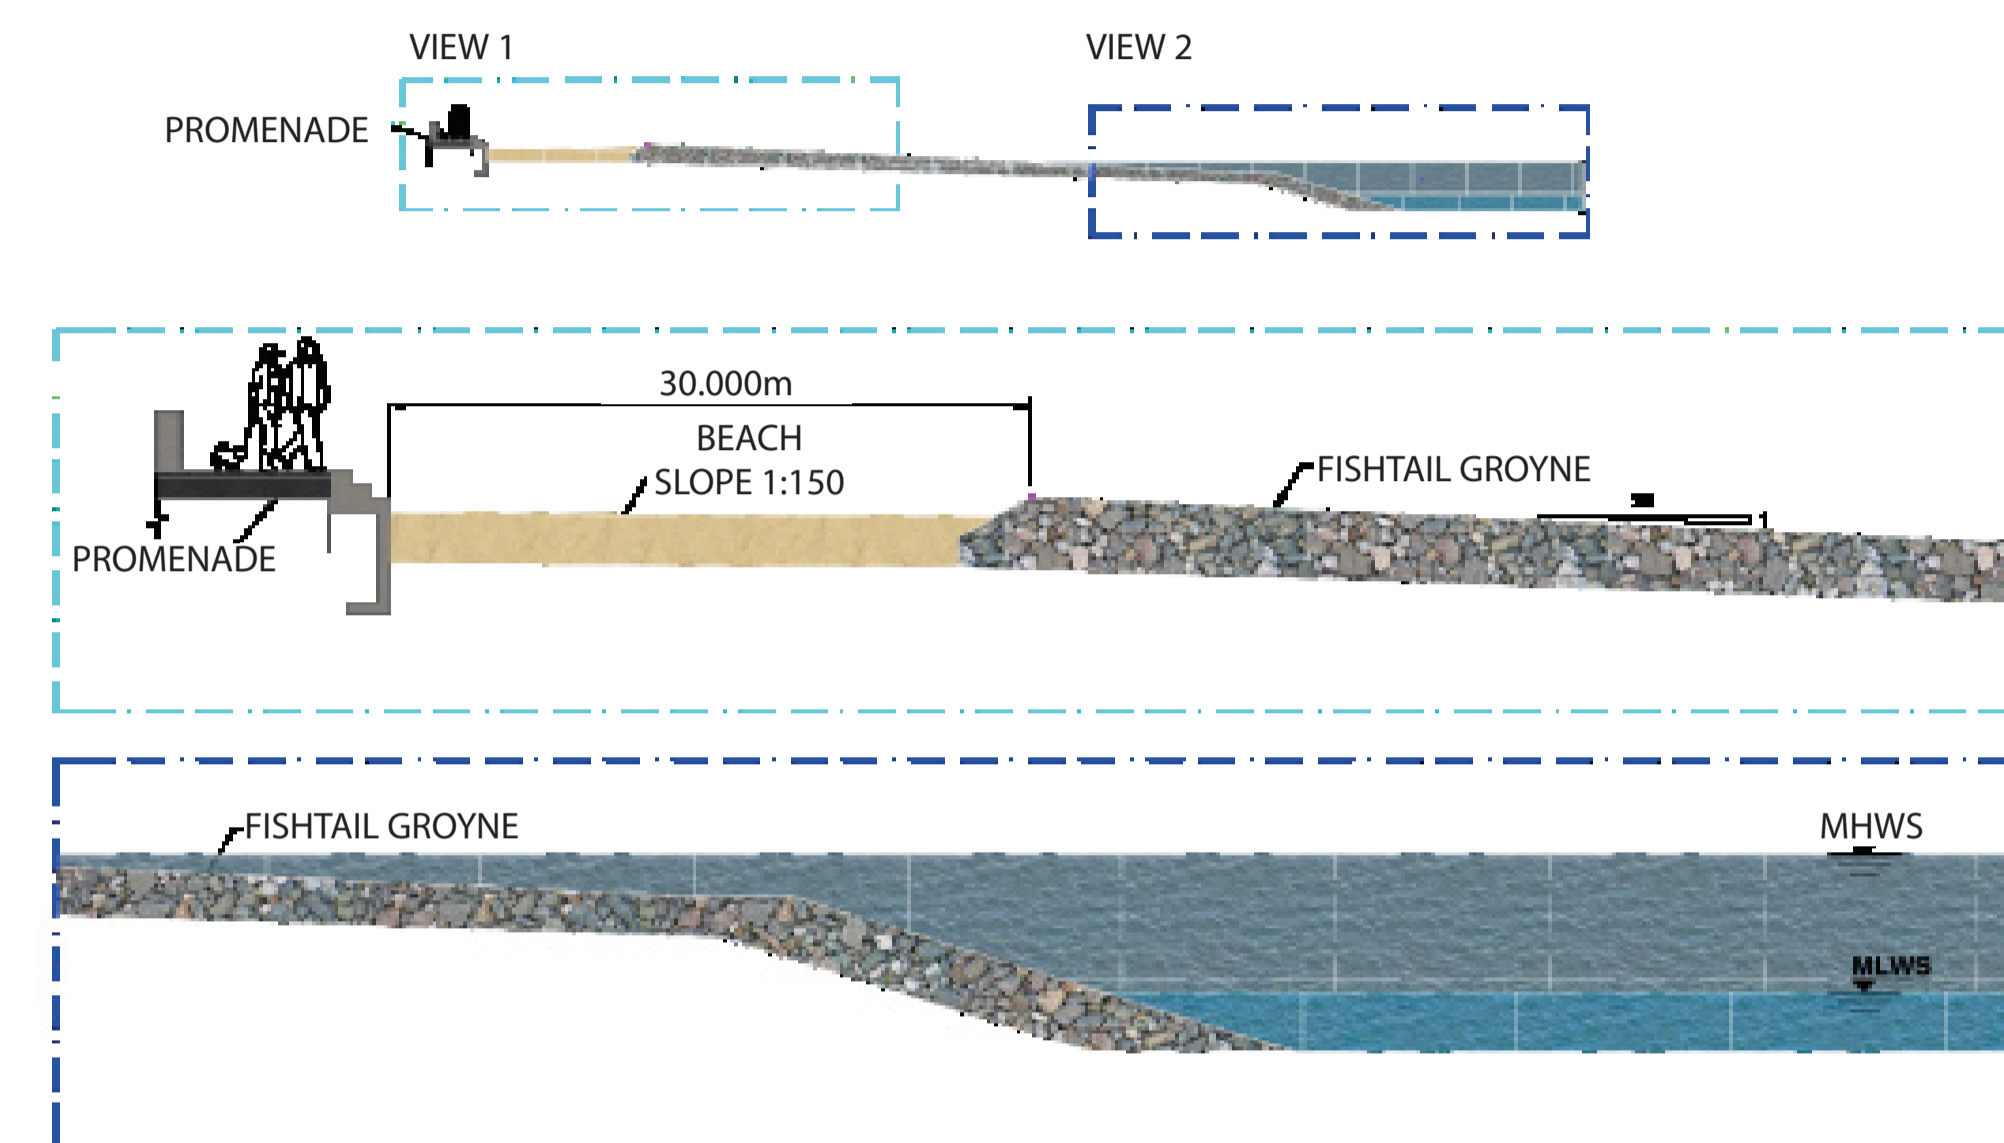
Rock Groynes

- Control structures will assist with accretion of sediment and assist with controlling longshore sediment transport.
- Control structures provide shelter, attenuating wave conditions at the shoreline and reducing energy acting on the beach.
- Stable pocket beaches will be created on the lee side -of rock groynes.
- Rock structures have potential for incorporating amenity.

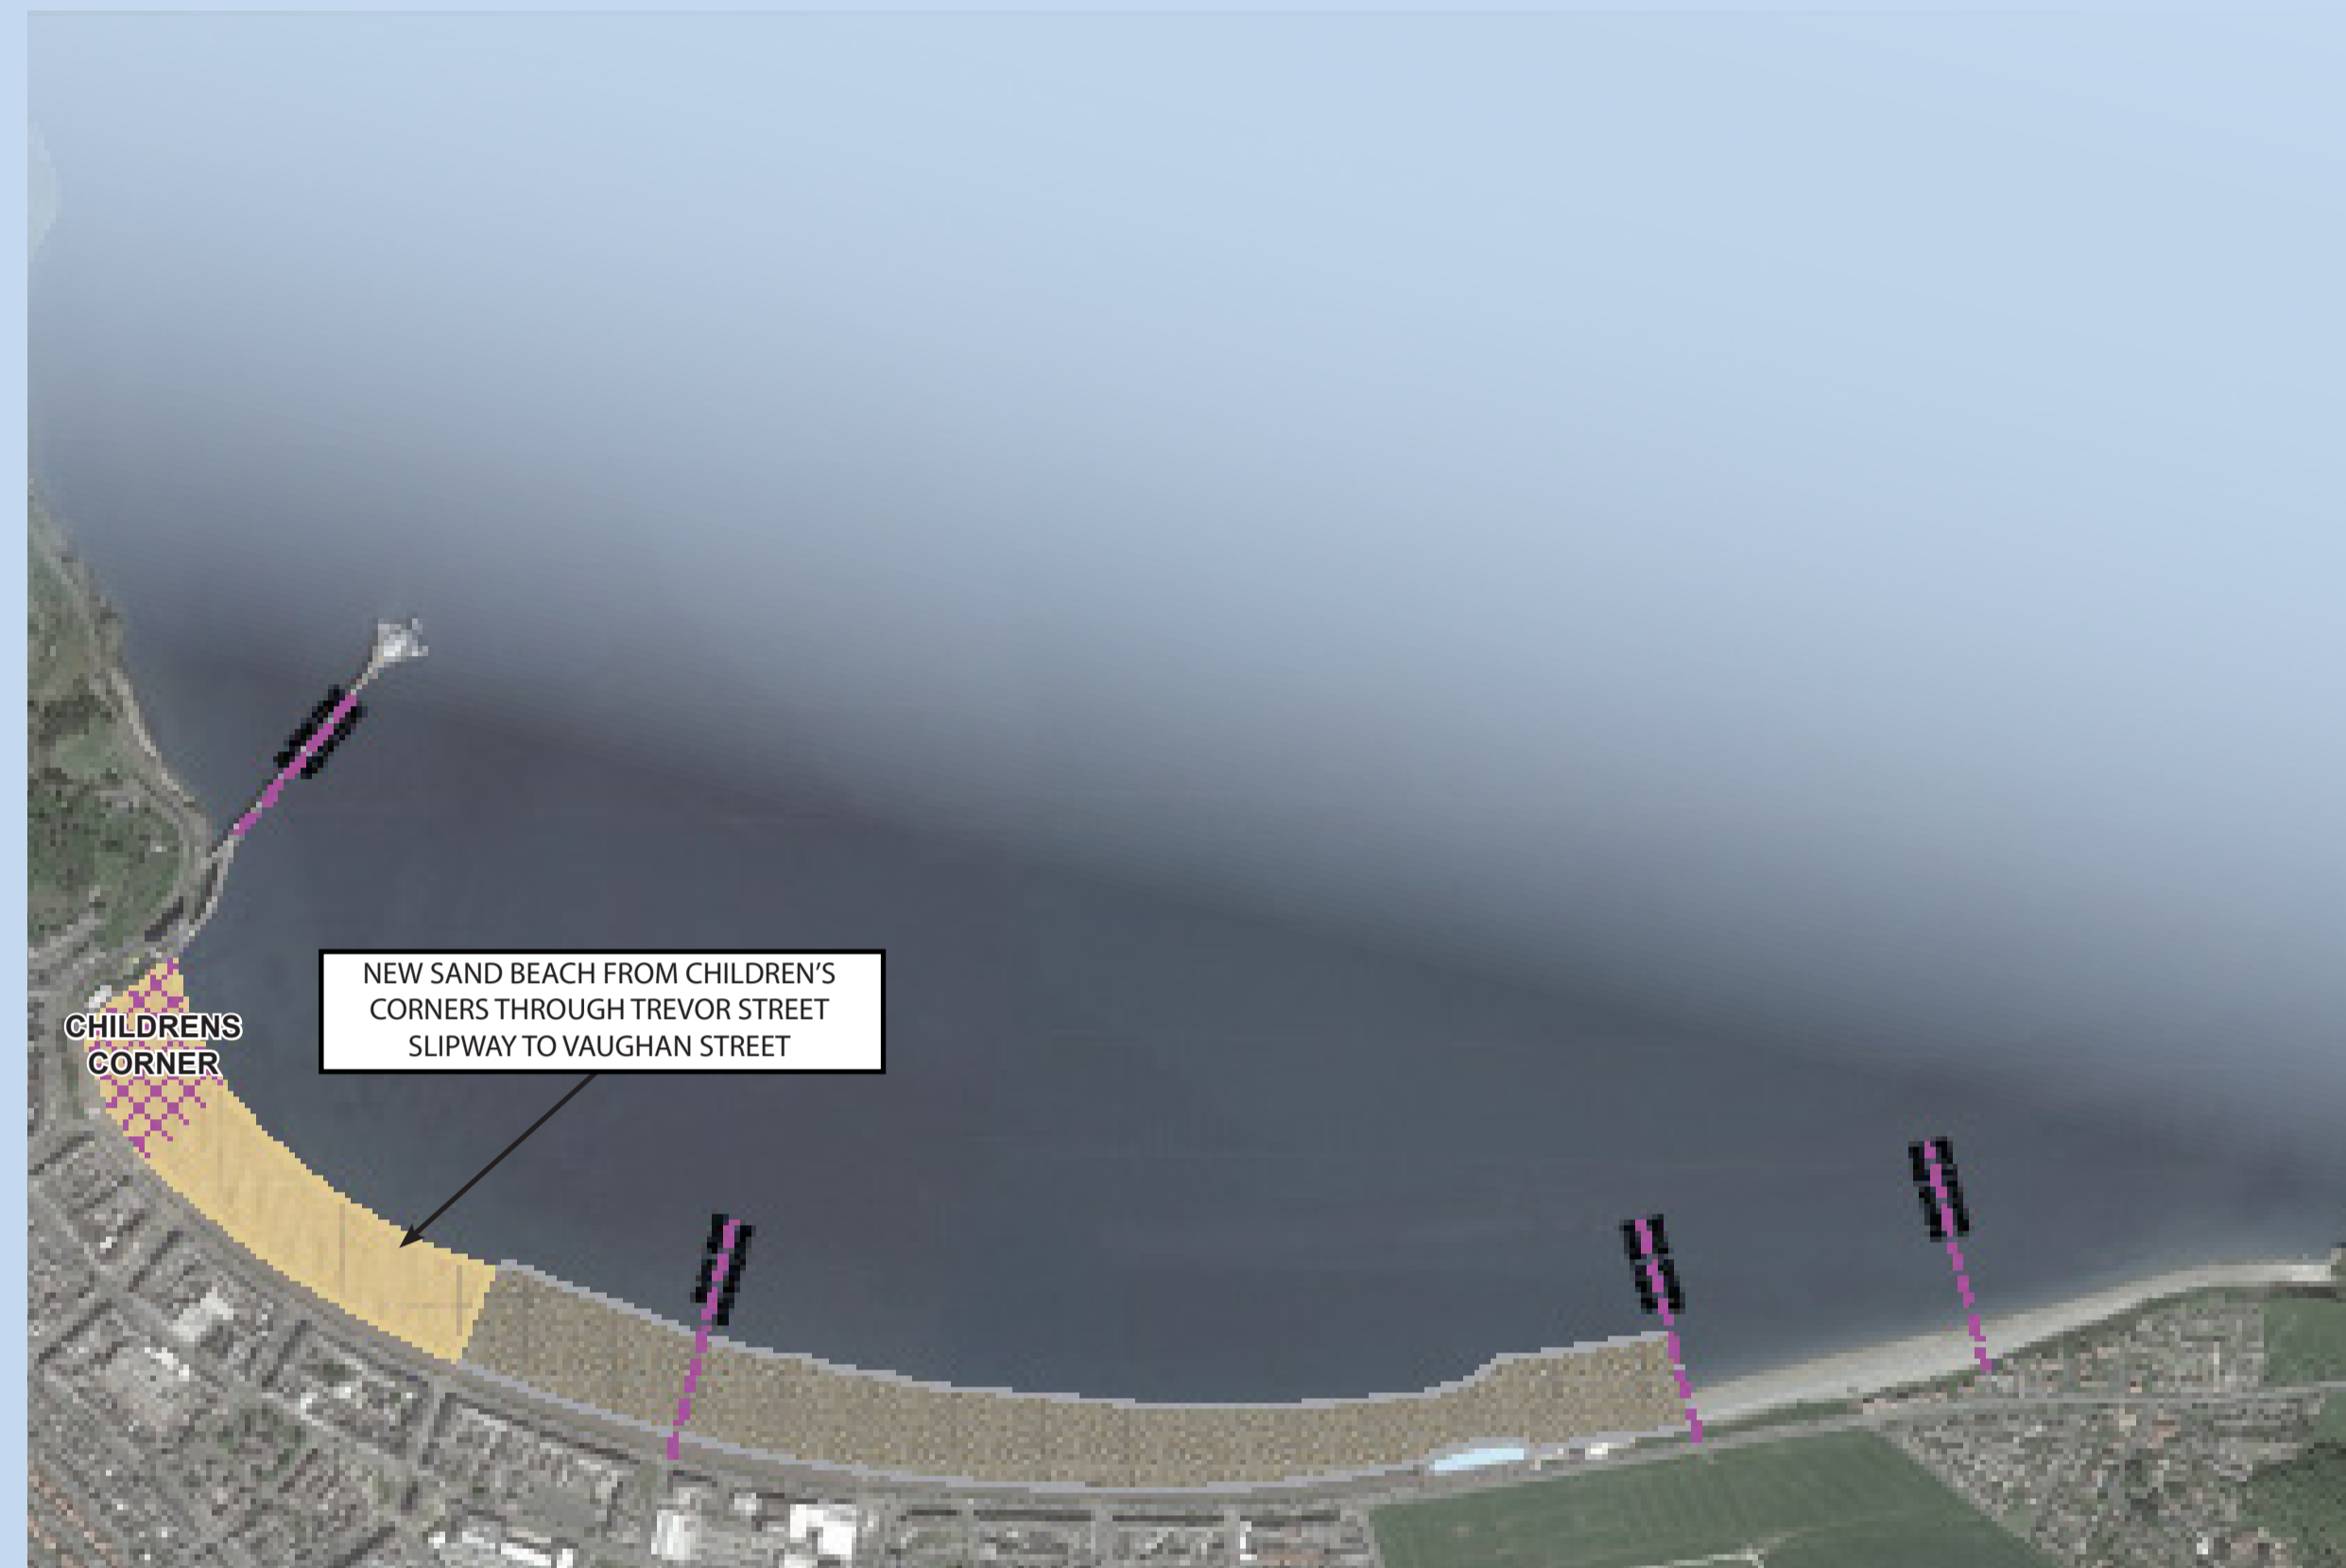
Option B: Beach Nourishment

Beach nourishment only. This would replace the cobble from Trevor St slipway/Children's Corner to approximately Vaughan Street with sand however no control structures would be put in place. Raising of the rear promenade wall would take place before year 50 to account for rising sea levels and the associated increase in flood risk.

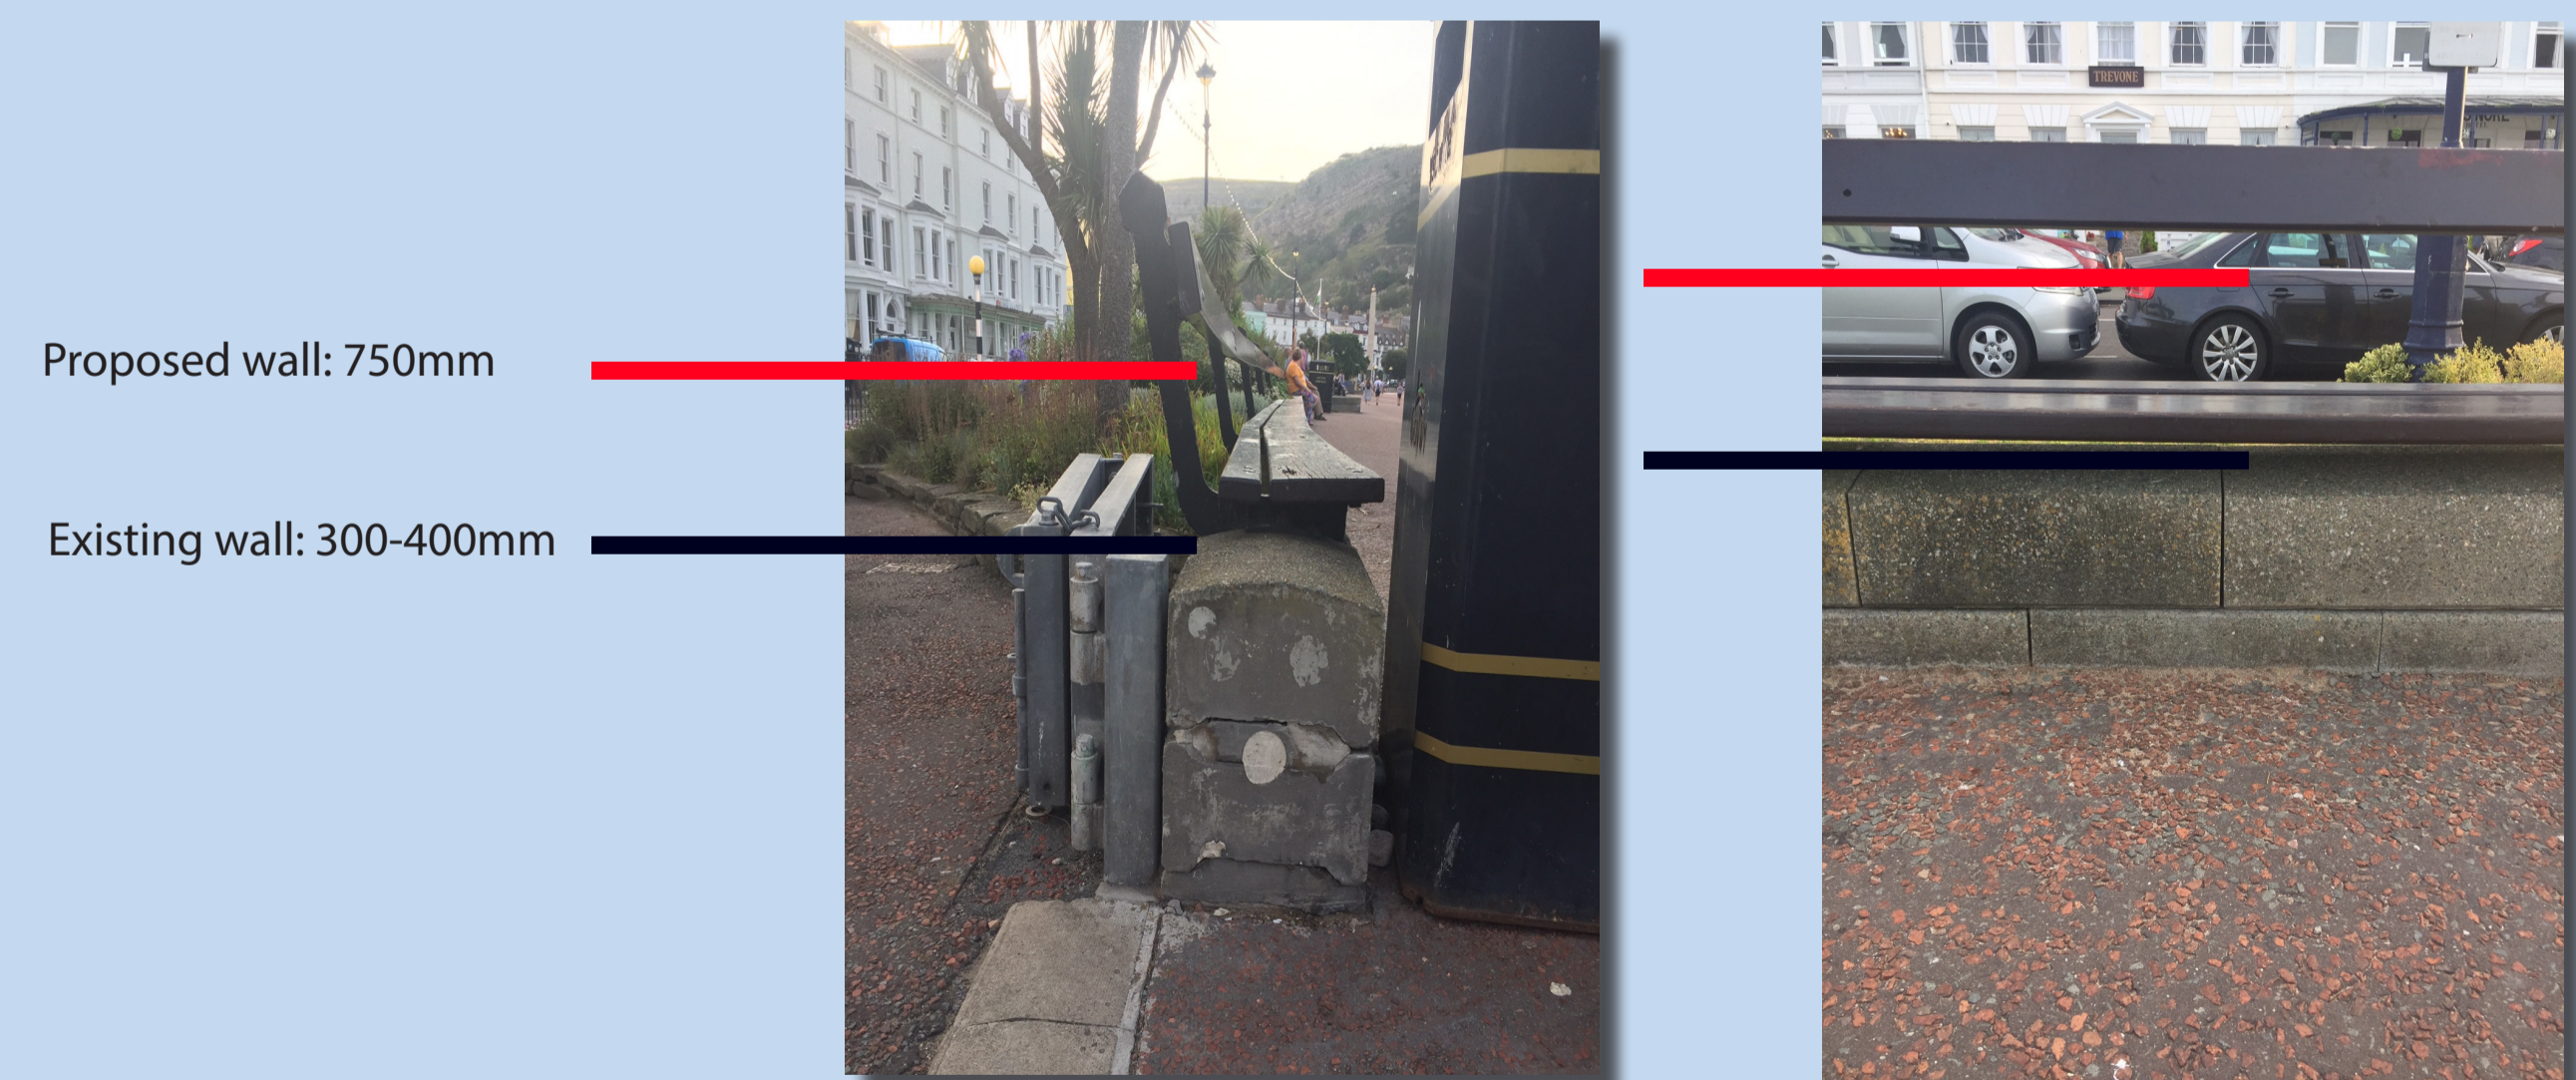
Proposed height for rear promenade wall:
