To provide forward looking planning and management of the beaches of Llandudno, Conwy County Borough Council (CCBC) working in partnership with the Llandudno Coastal Forum (LCF) has commissioned AECOM to prepare an Outline Business Case (OBC) to cover both the North Shore and West Shore beach areas in Llandudno. This Public Display is intended to provide an update on the progress being made by CCBC/LCF and to identify the next steps towards achieving the goal of sustainable management of safe beaches for all.

PROGRESS TO DATE

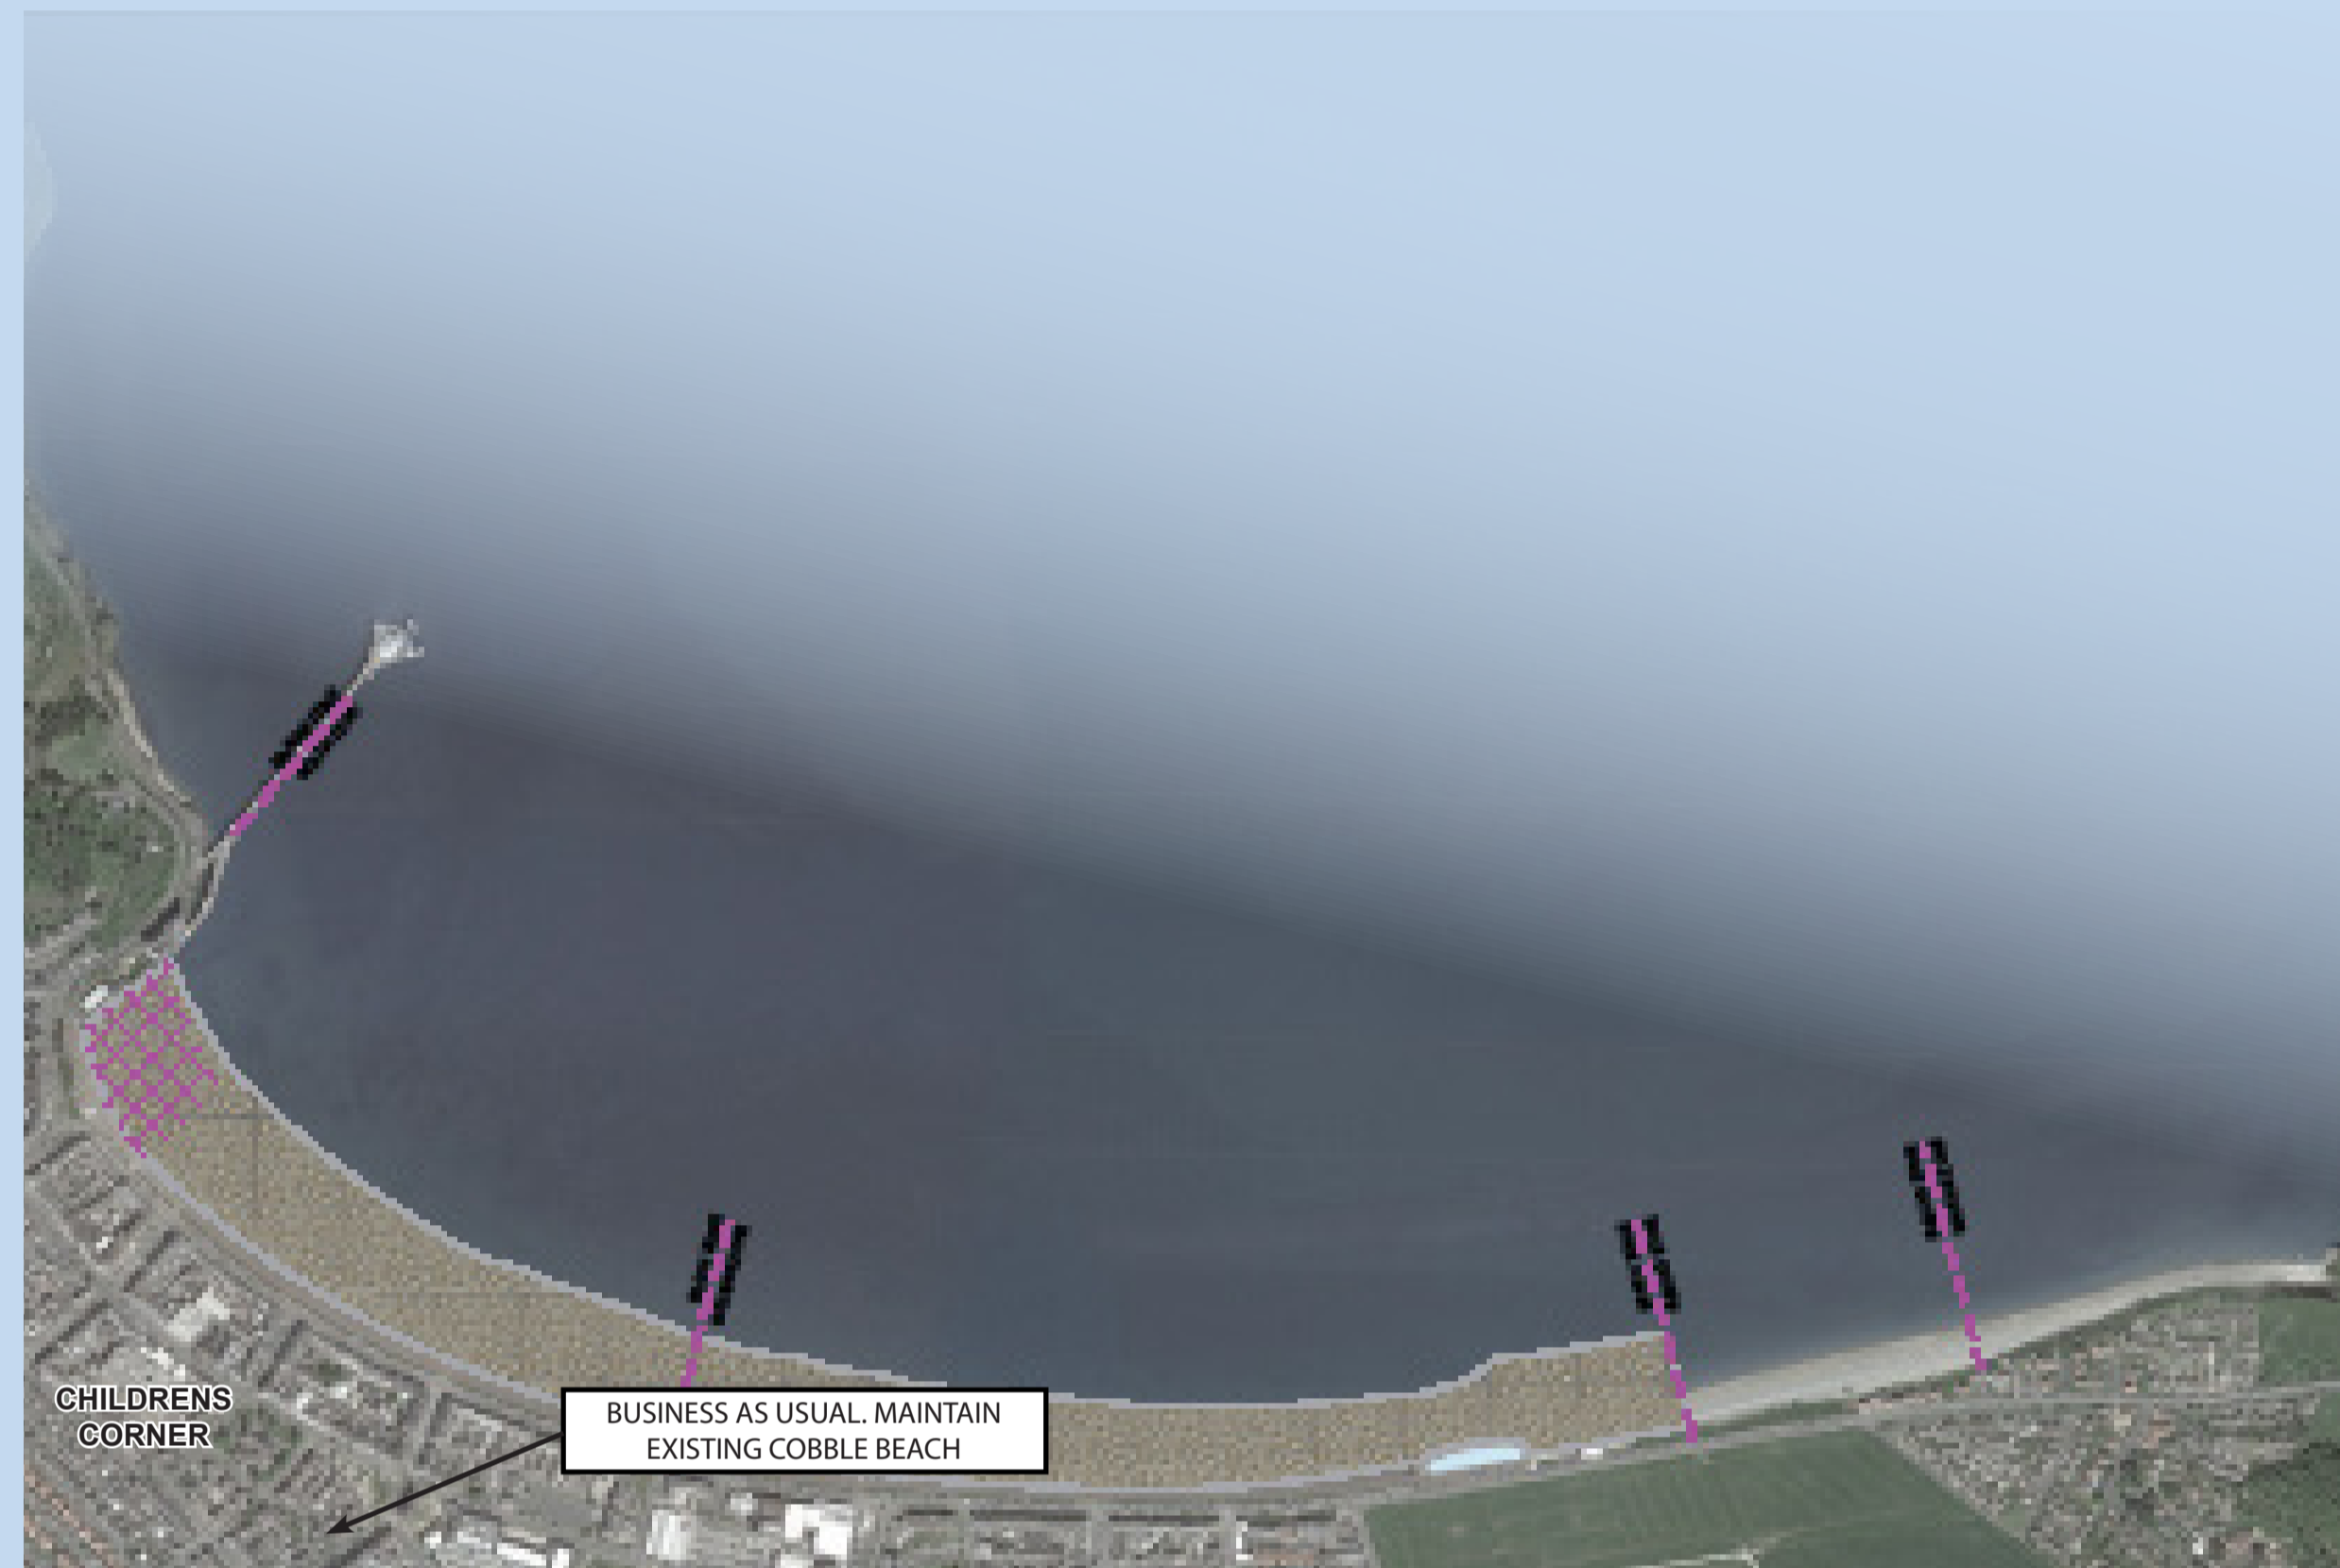
Option C: Business as Usual

Maintenance of the existing cobble beach from Trevor St slipway to Craig-Y-Don. Raising of the rear promenade wall would take place before year 50 to account for rising sea levels and the associated increase in flood risk.

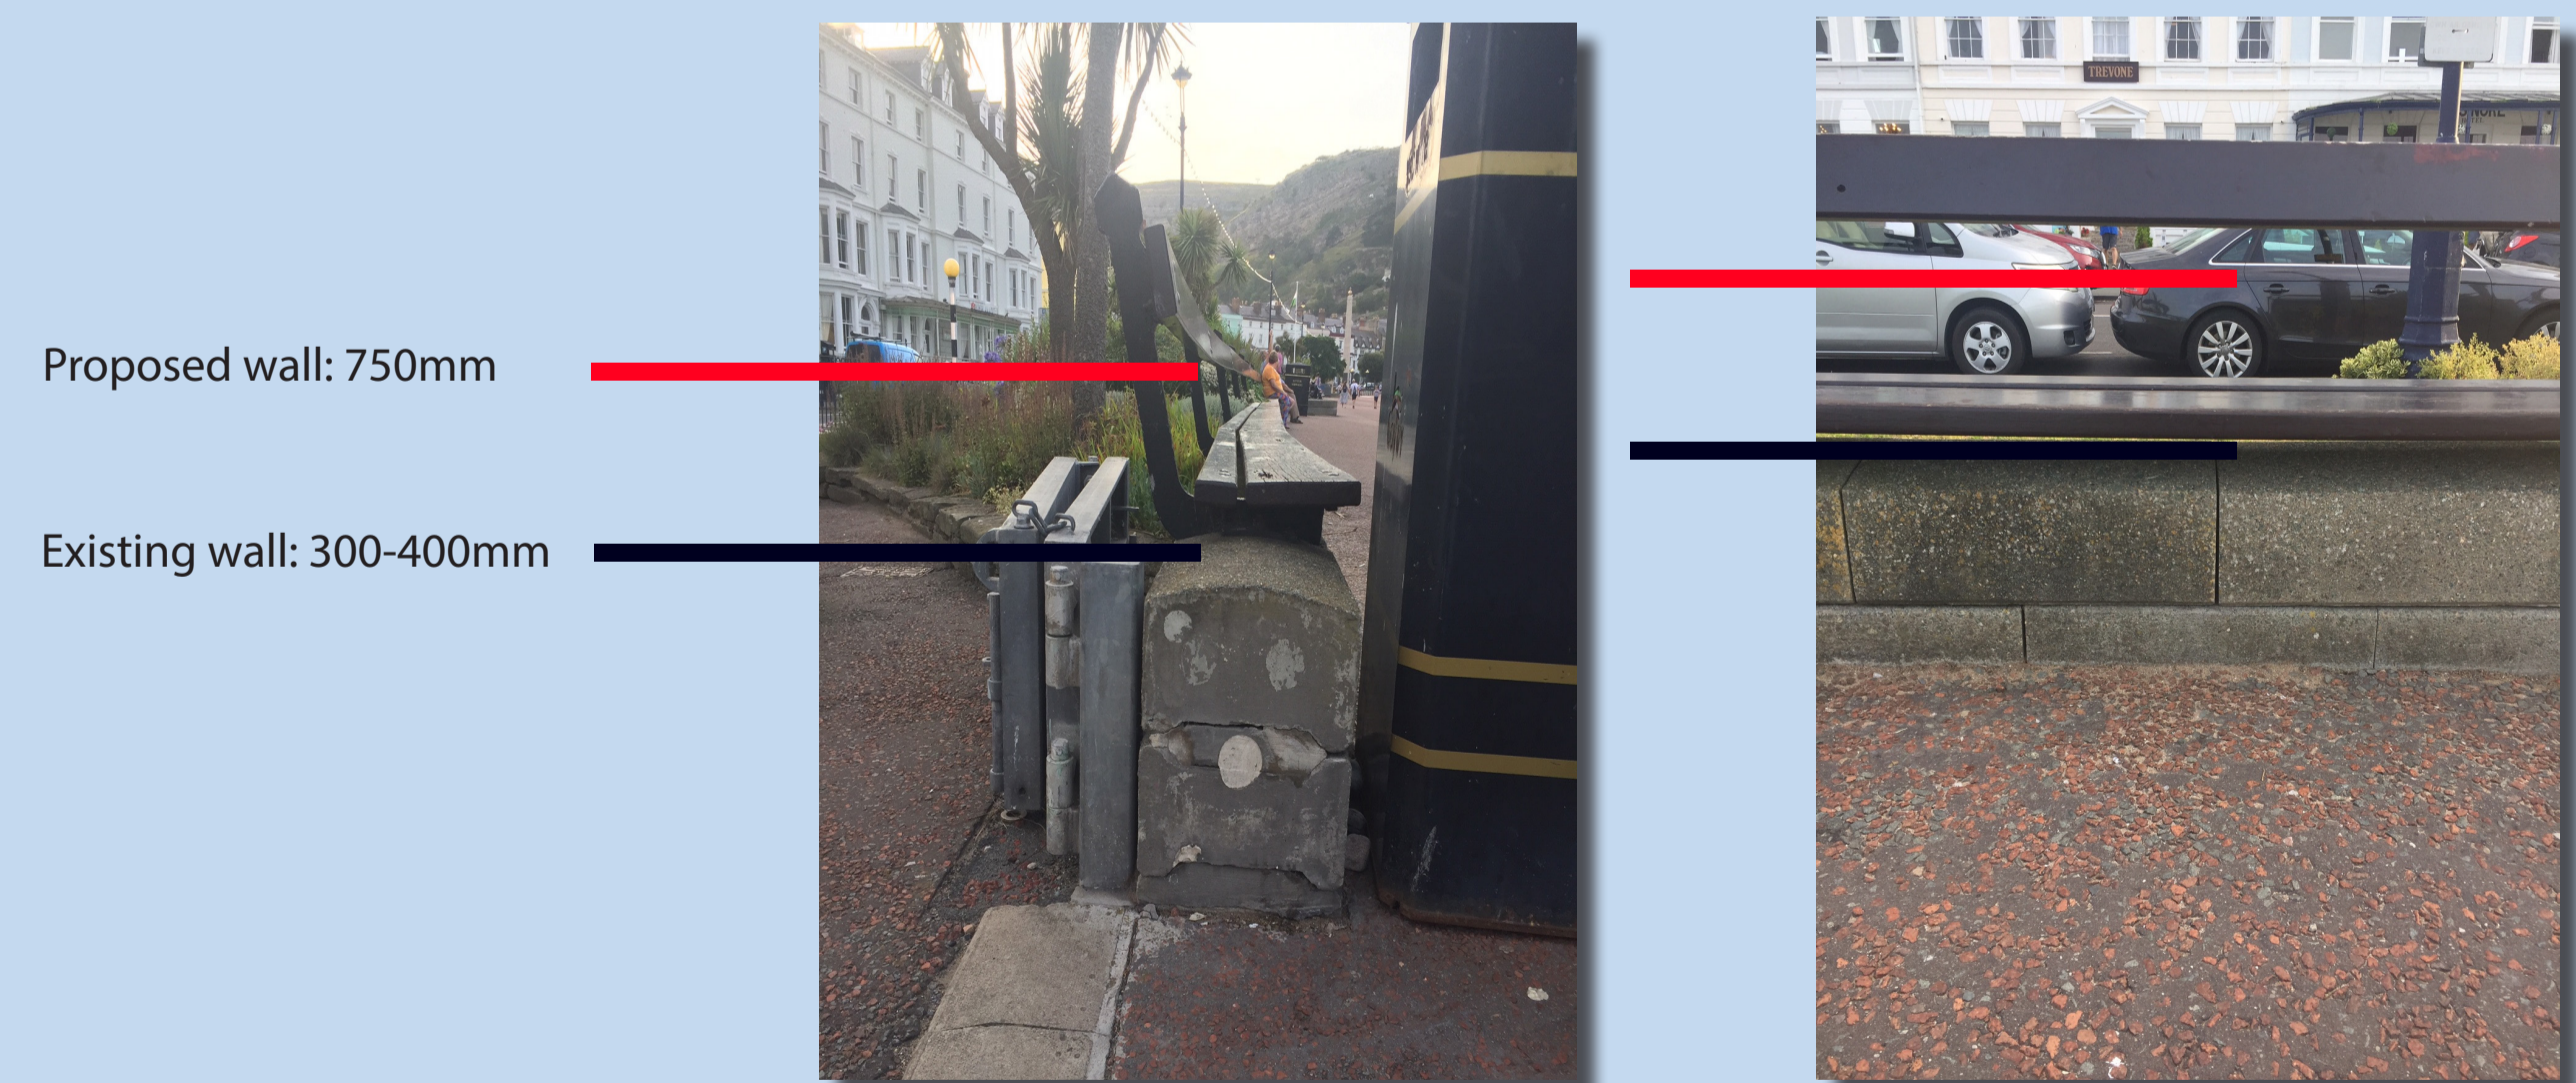
Proposed height for rear promenade wall:

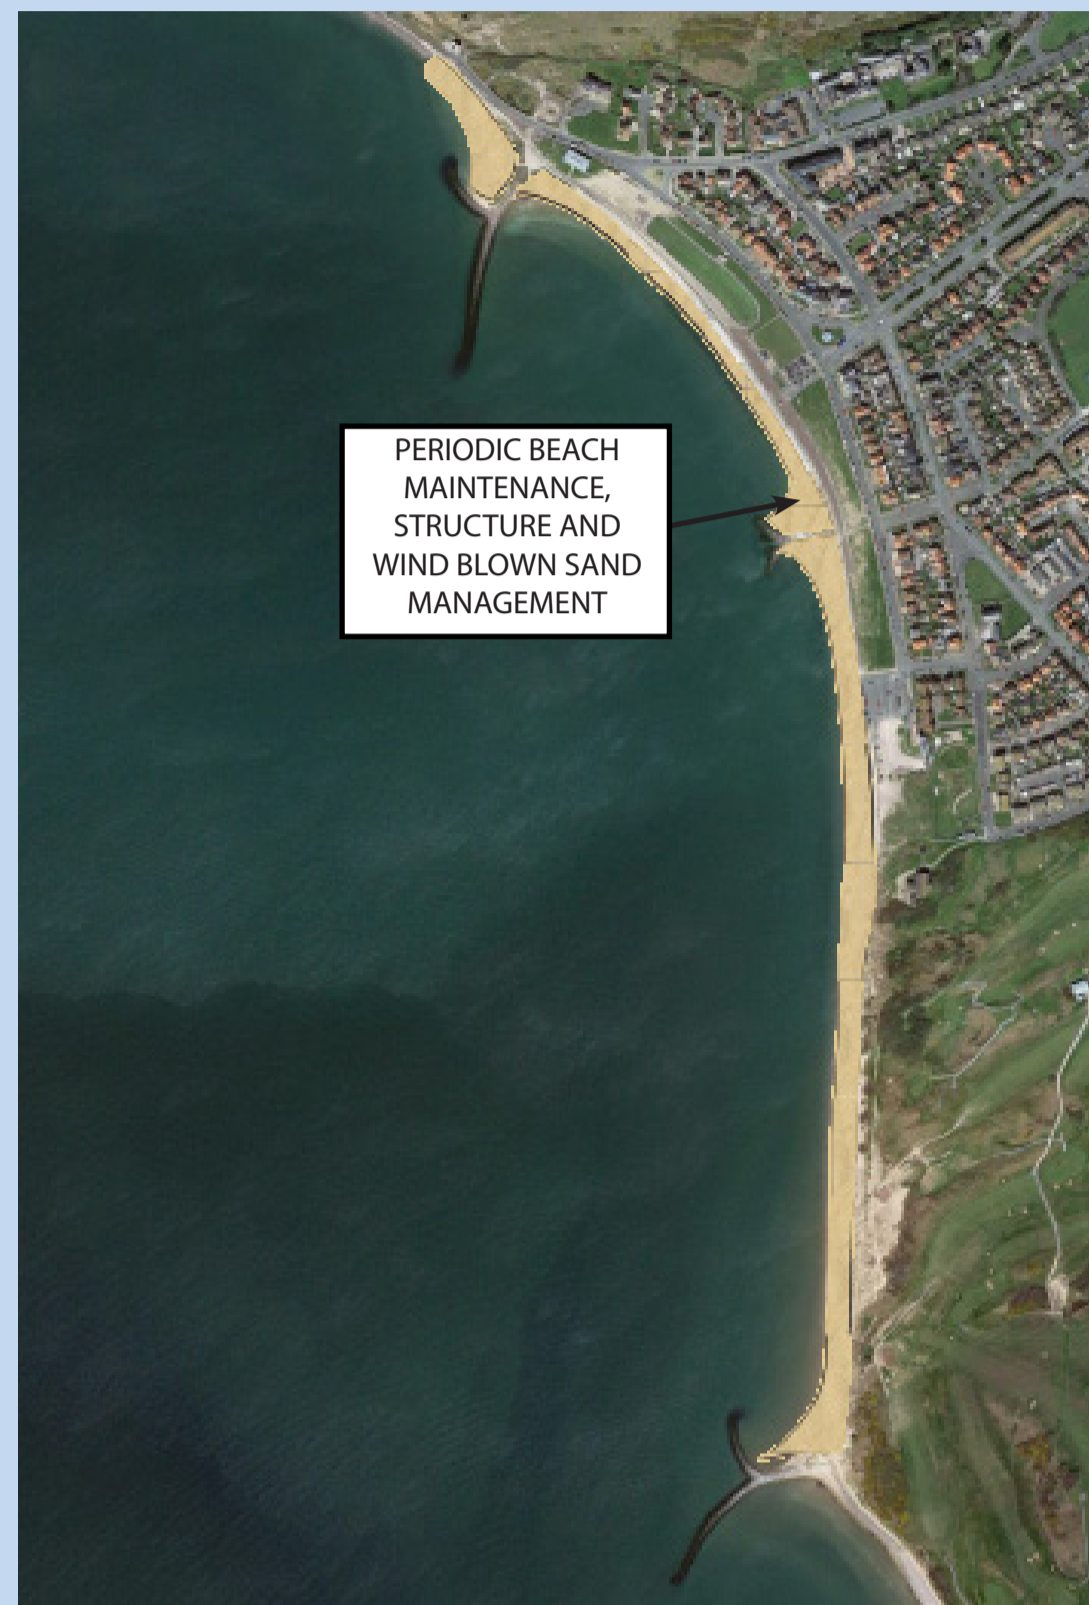
Option A: Maintenance & Beach Management

Periodic beach maintenance – will include for the topping up of additional shingle as well as the business as usual maintenance works – windblown sand clearance, concrete repairs etc.

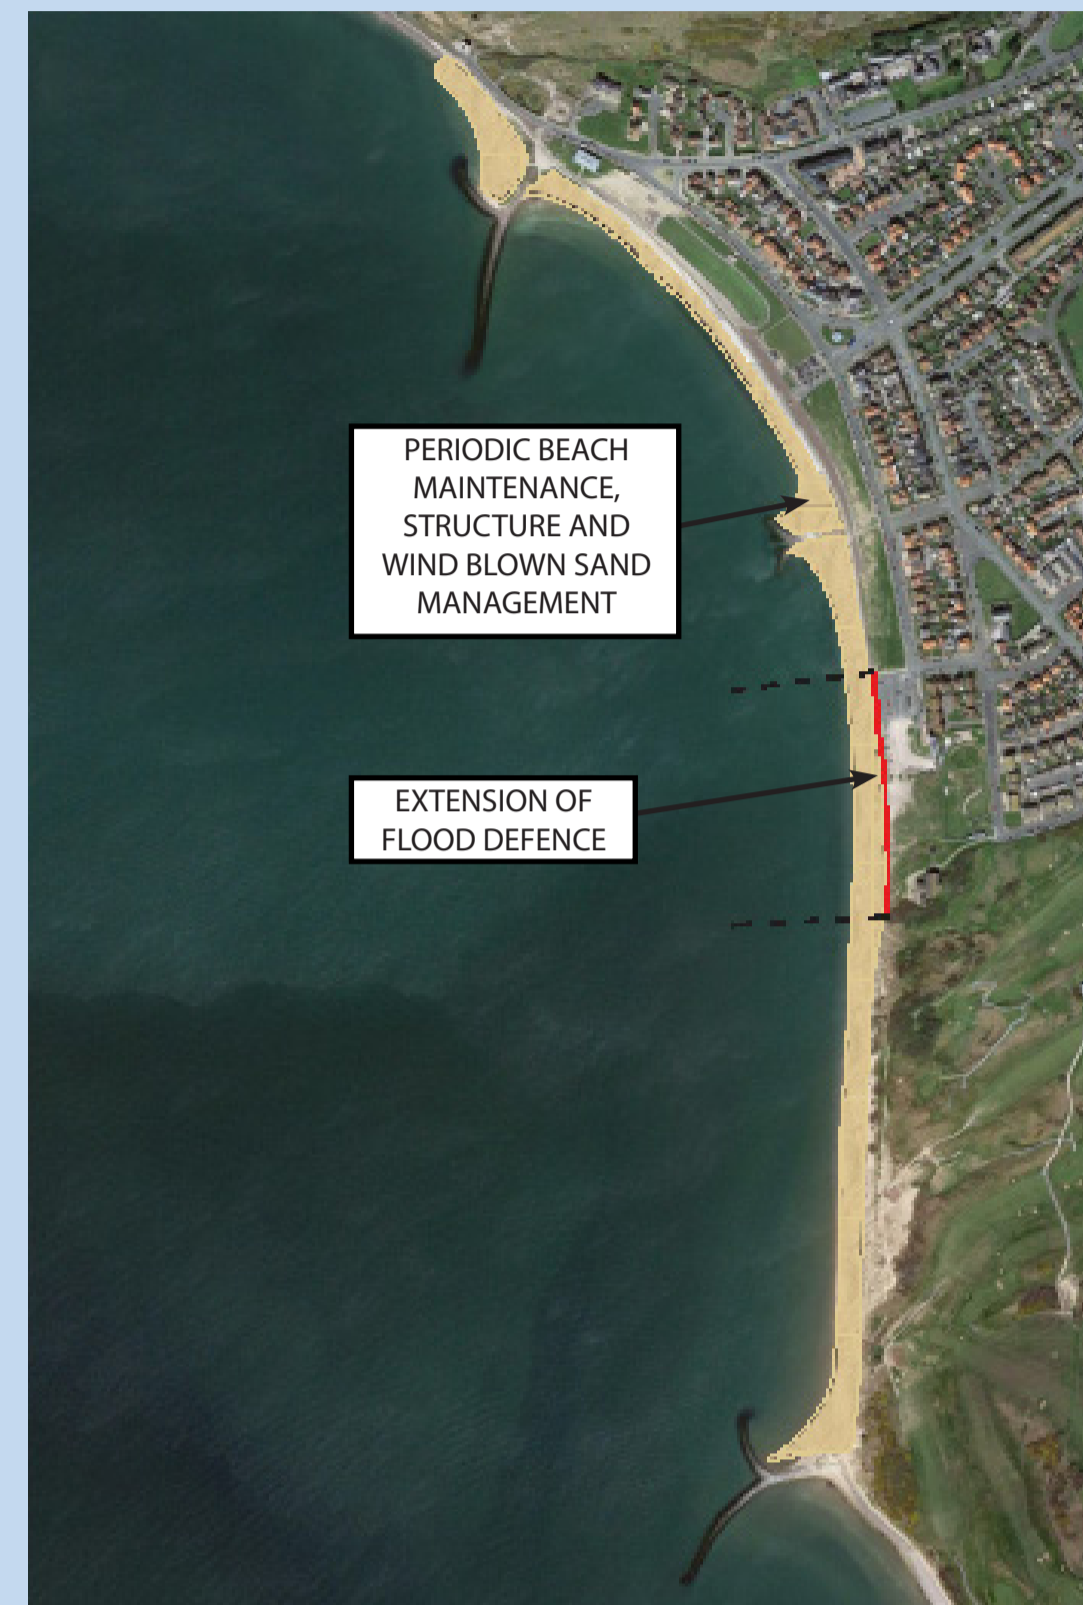
Option B: Extension of Flood Defences

Extension to the existing defences from end of existing concrete defences to the sand dunes.

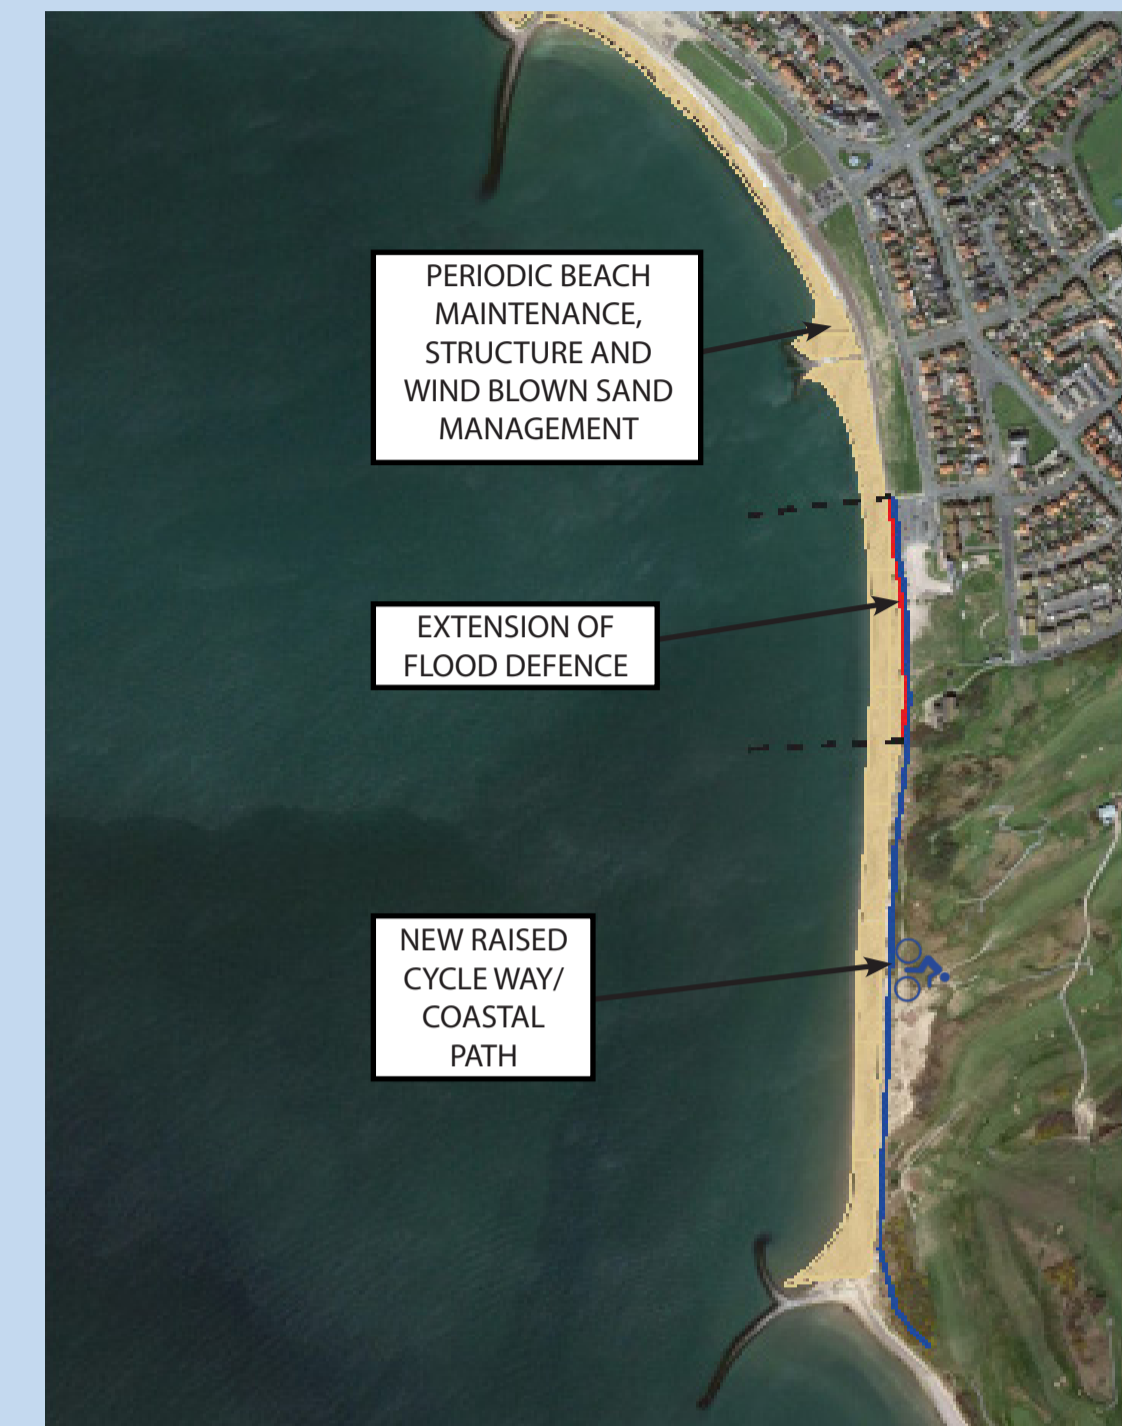
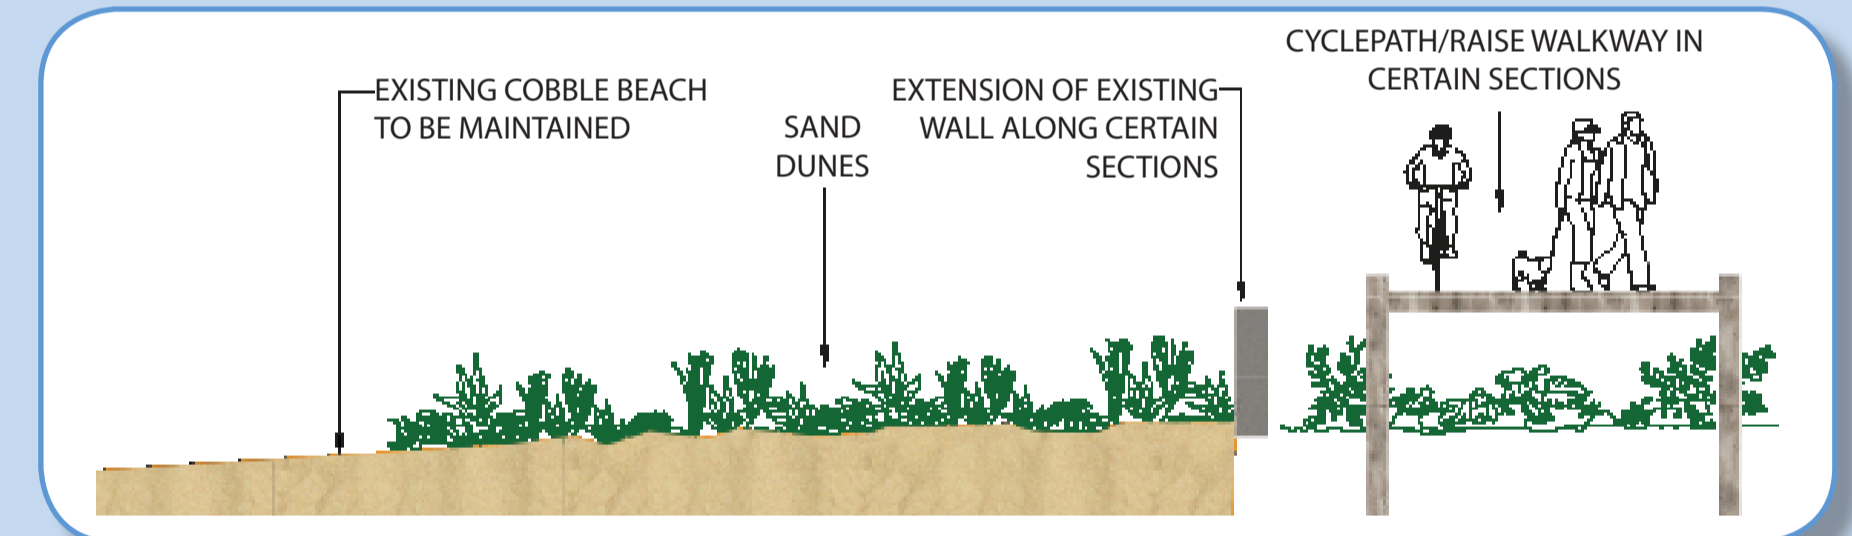
Option C: Combined Scheme

Combined scheme – maintaining and topping up beach conditions as necessary, extension of secondary defences between the existing wall and sand dunes, provision of windblown sand control measures, and provision of a raised walkway across the southern half of the frontage.

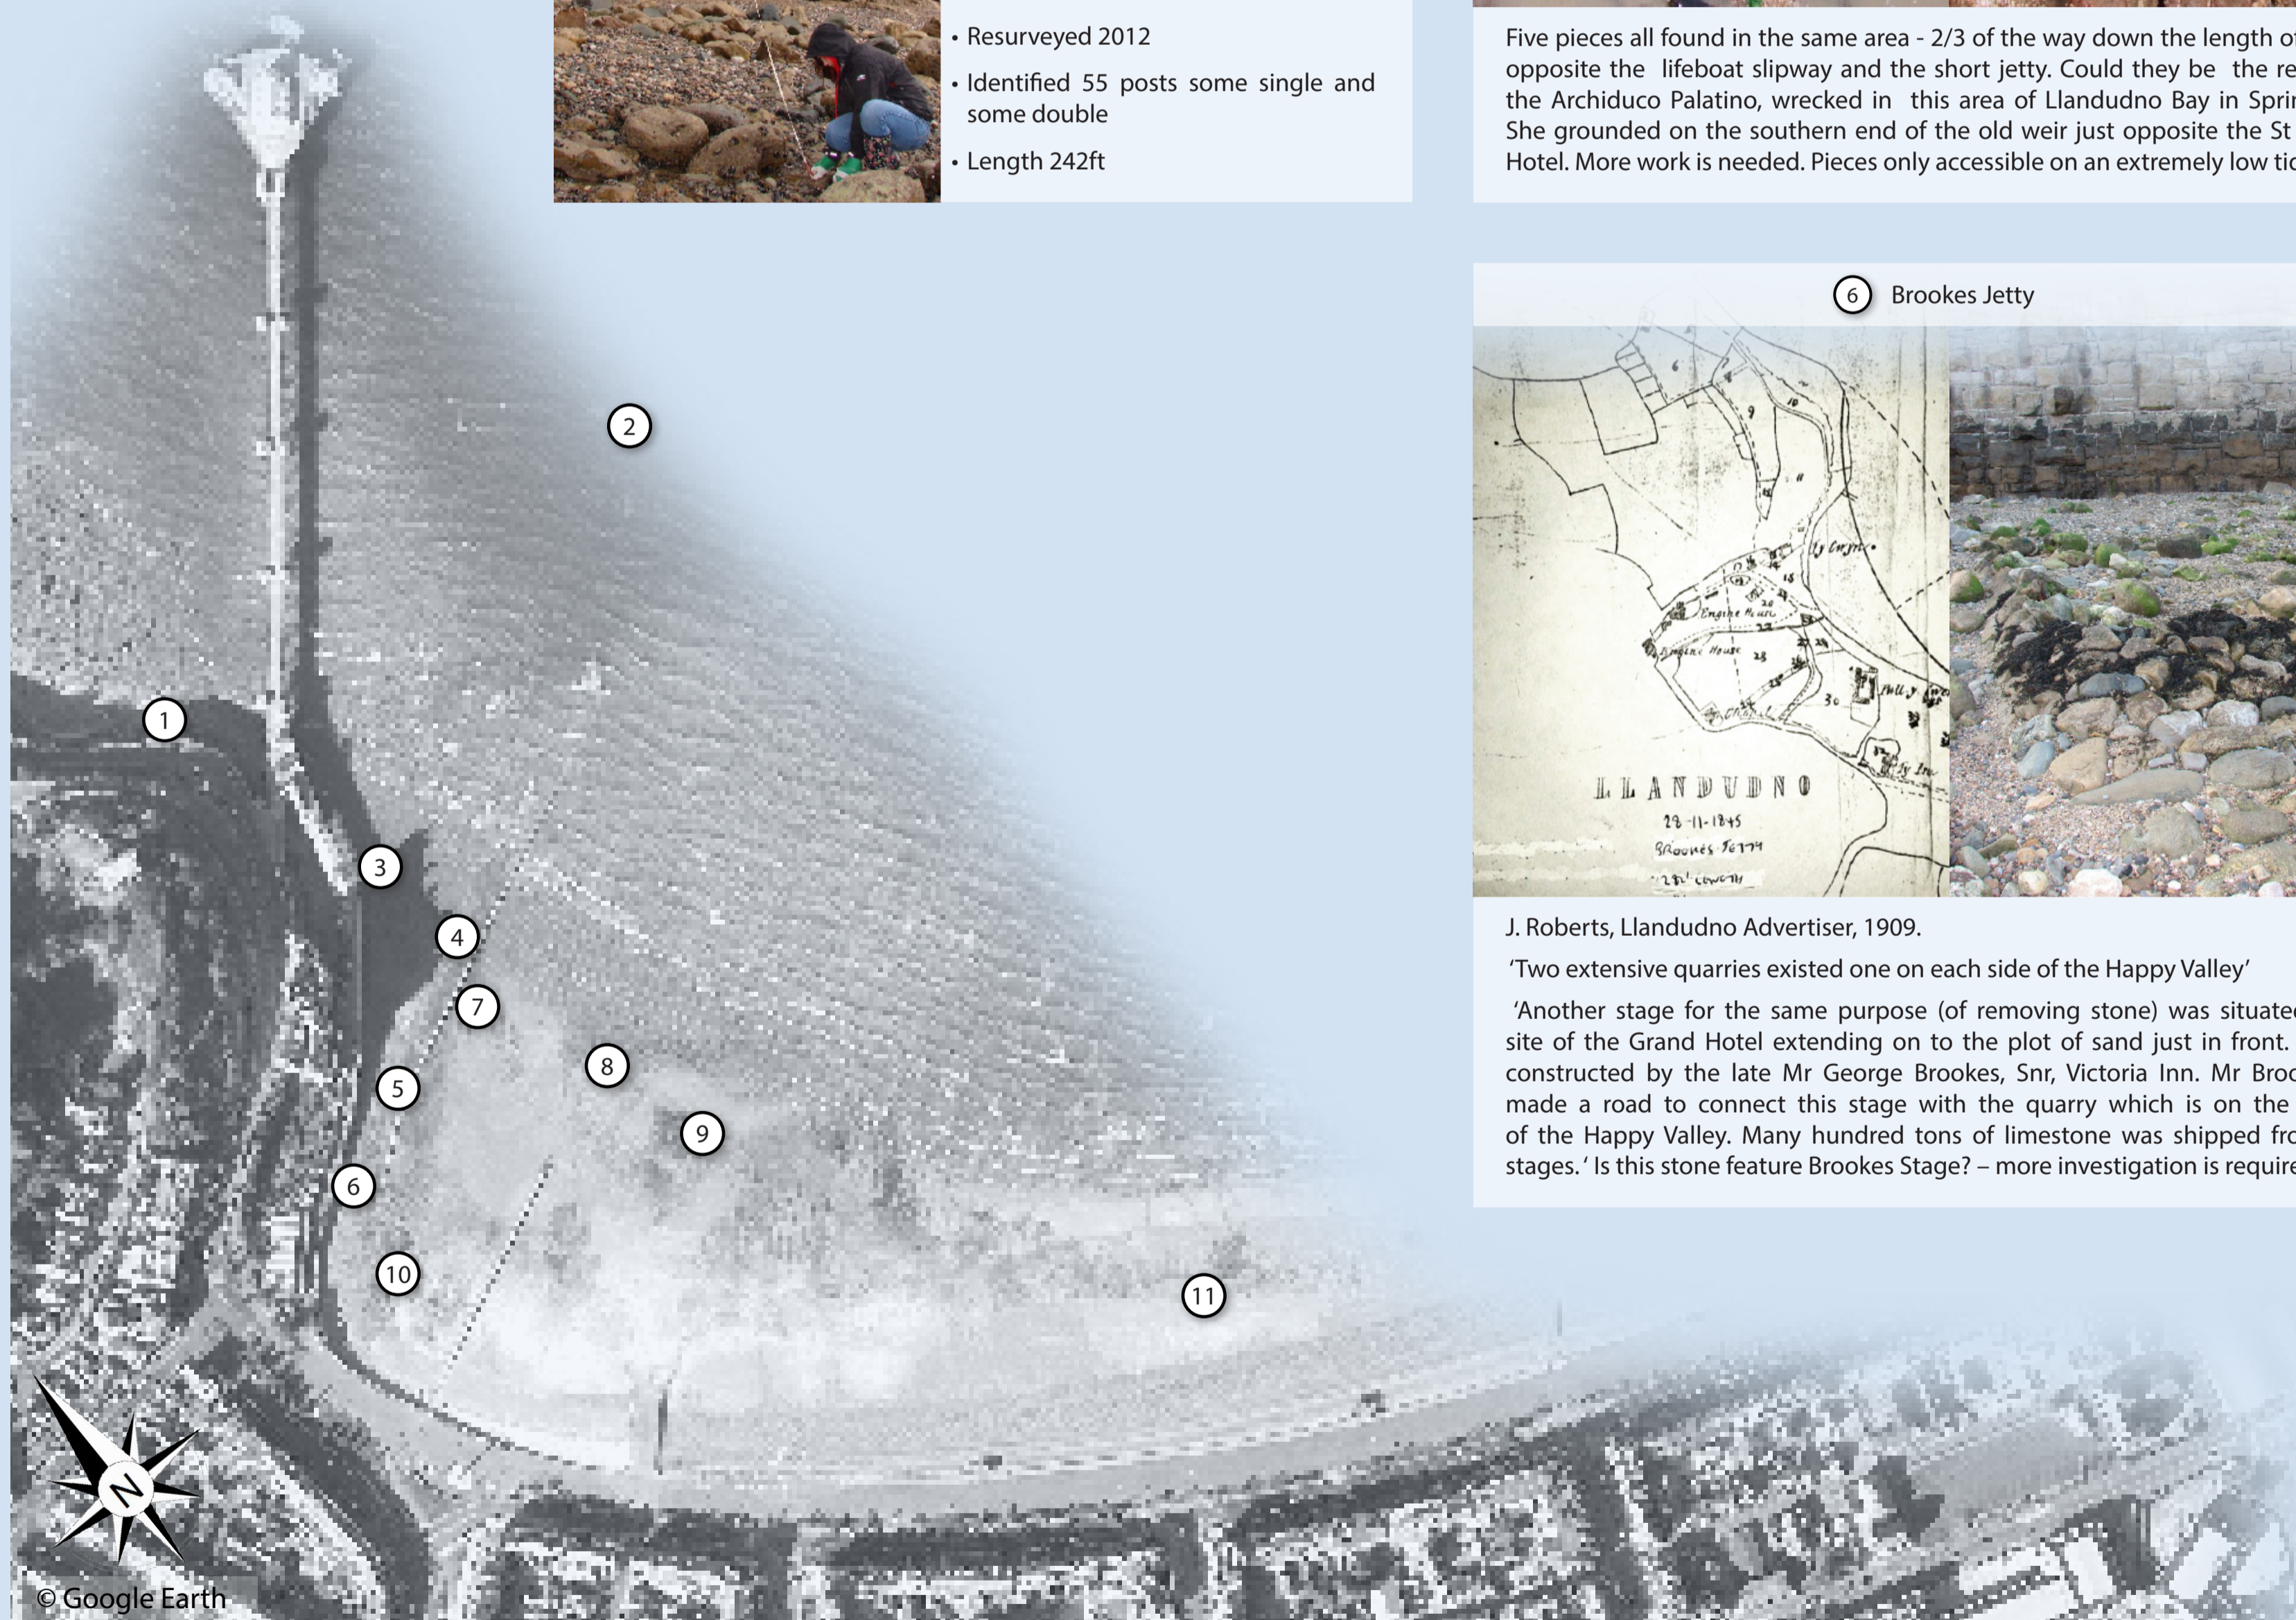
1 Llandudno's First Pier

- Construction began 1858
- Badly damaged in the storm of 26th October 1859.
- Repaired and reused to bring timbers to build Llandudno
- Eventually sold at auction and dismantled.
- Resurveyed 2012
- Identified 55 posts some single and some double
- Length 242ft
