**Mostyn Estates Limited**

**Agricultural Land Classification and Soil Resources**

**Land off Conway Road, Llandudno**

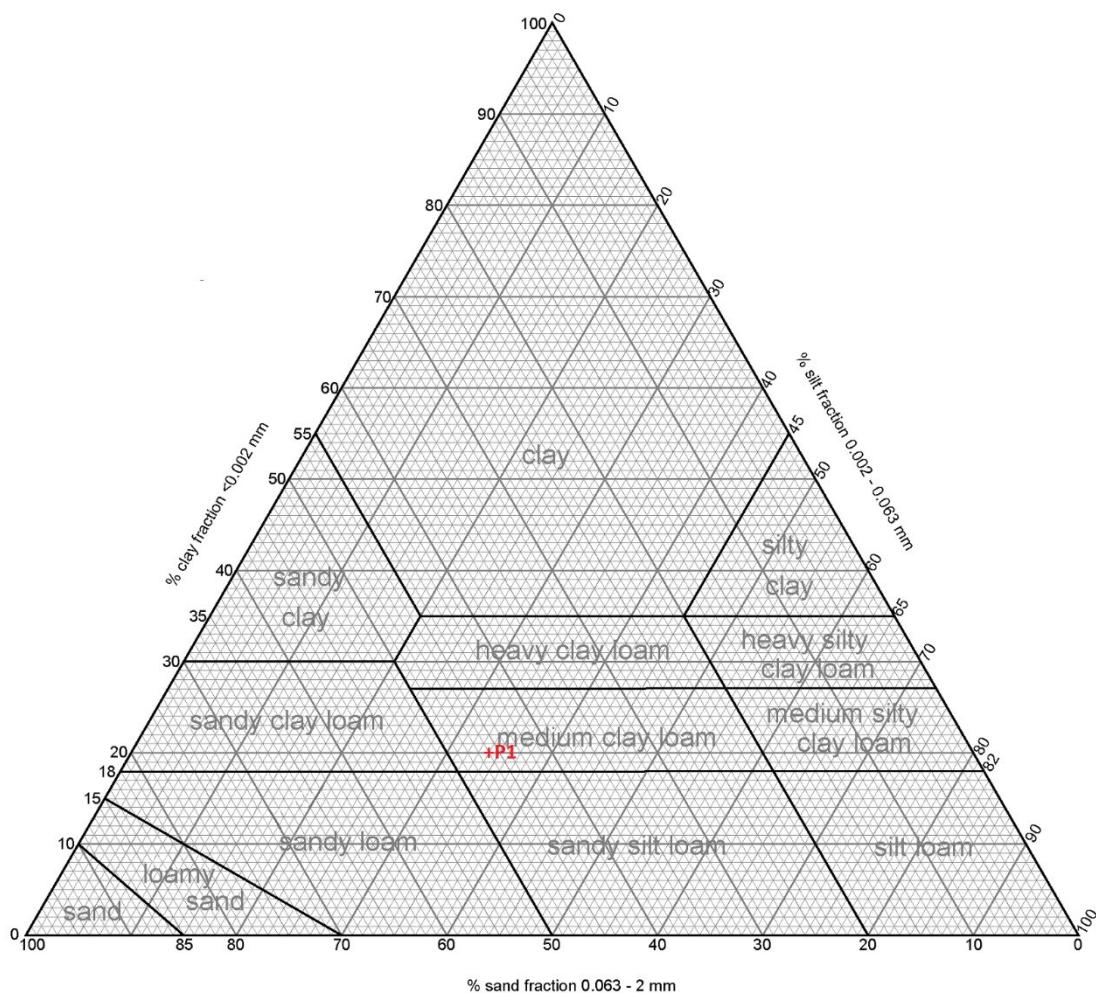
### Soil Texture by Particle Size Analysis

Determinand	Pit 1	Units
Sand 2.00-0.063 mm	46	% w/w
Silt 0.063-0.002 mm	34	% w/w
Clay <0.002 mm	20	% w/w
Organic Matter	5.4	% w/w
Texture	Medium Clay Loam

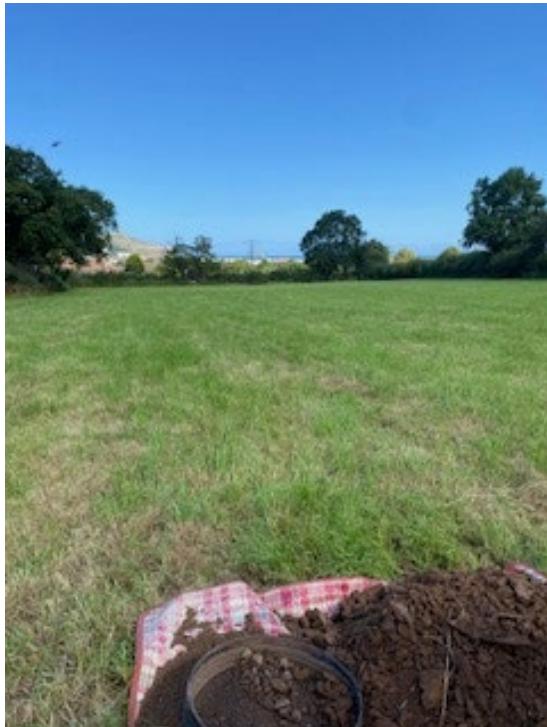
Site

- 2.1 The site extends to approximately 3.5ha of agricultural grassland with established hedgerows and tree belts at the northern and eastern boundaries. The site is fully constrained by existing infrastructure: Conway Road (B5115) is to the west and Wormhout Way (A470) to the east, with the convergence of the two at a roundabout to the north. Llanrhos Lawn Cemetery is to the south.
- 2.2 The topography is characterised by a north-facing slope between altitudes of around 20m and 30m above Ordnance Datum (AOD). Drainage is facilitated by the slope and is also through the soil profile.
- 2.3 DataMapWales<sup>3</sup> shows no significant risk of flooding at the site.

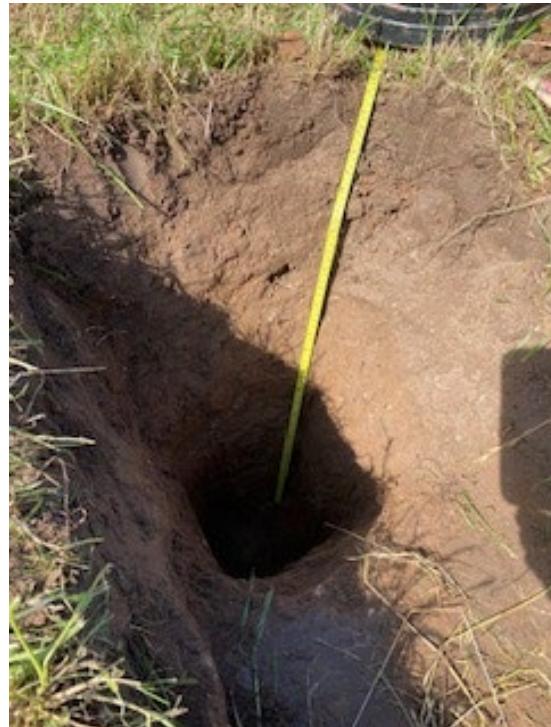
Pit 1

**Pit 1** – Grid ref SH79389 80600, grass, pit dug to 80cm

0-38 cm	Medium clay loam, 7.5YR3/3, weakly developed, fine subangular blocky structure, many fibrous roots, common earthworms, stone content 8% >2cm 5%, >6cm 3% hard rounded stones
38-40 cm	Heavy clay loam, 7.5YR4/4, weakly developed, medium subangular blocky, porosity >0.5% greater than 0.5mm diameter, friable
40-55 cm	Heavy clay loam, 7.5YR4/4, weakly developed, medium subangular blocky, common ochreous mottles, porosity >0.5% greater than 0.5mm diameter, friable
55-70 cm	Heavy clay loam, 7.5YR4/4 (ped face 5YR5/2), weakly developed, coarse angular blocky, porosity >0.5% greater than 0.5mm diameter, common ochreous mottles, firm
70-80 cm	Heavy clay loam, 5YR4/4, weakly developed, medium prismatic, porosity >0.5% greater than 0.5mm diameter, common ochreous mottles, firm

Slowly permeable layer > 80cm, WC I, Grade 2

3.7 The topsoil is dark brown (7.5YR3/3 or 10YR3/3 in the Munsell soil colour charts<sup>9</sup>) medium clay loam which is 38-40cm deep. The topsoil is slightly stony, non-calcareous and has a weakly developed, fine subangular blocky structure. Many fibrous roots and common earthworms were observed throughout the topsoil.

3.8 The upper subsoil horizons are brown (7.5YR4/3, 7.5YR4/4 or 10YR5/3) heavy clay loam or occasionally medium clay loam and are also slightly stony and non-calcareous. Beneath the topsoil, the upper subsoil has a weak medium subangular blocky structure and is friable. The auger observations were obstructed by stone at an average depth of 55cm, however from the pit it is noted that the subsoil continues to depth, transitioning to reddish brown (5YR4/4) heavy clay loam lower subsoil. The lower subsoil structure is weakly developed with coarse angular blocky peds, becoming prismatic with depth, although it maintains >0.5% biopores greater than 0.5mm diameter. There is no slowly permeable layer within 80cm and the profiles are classed as WC I. The limitation is due to the topsoil texture under a FCD regime of 183 days which results in a workability limitation to Grade 2.

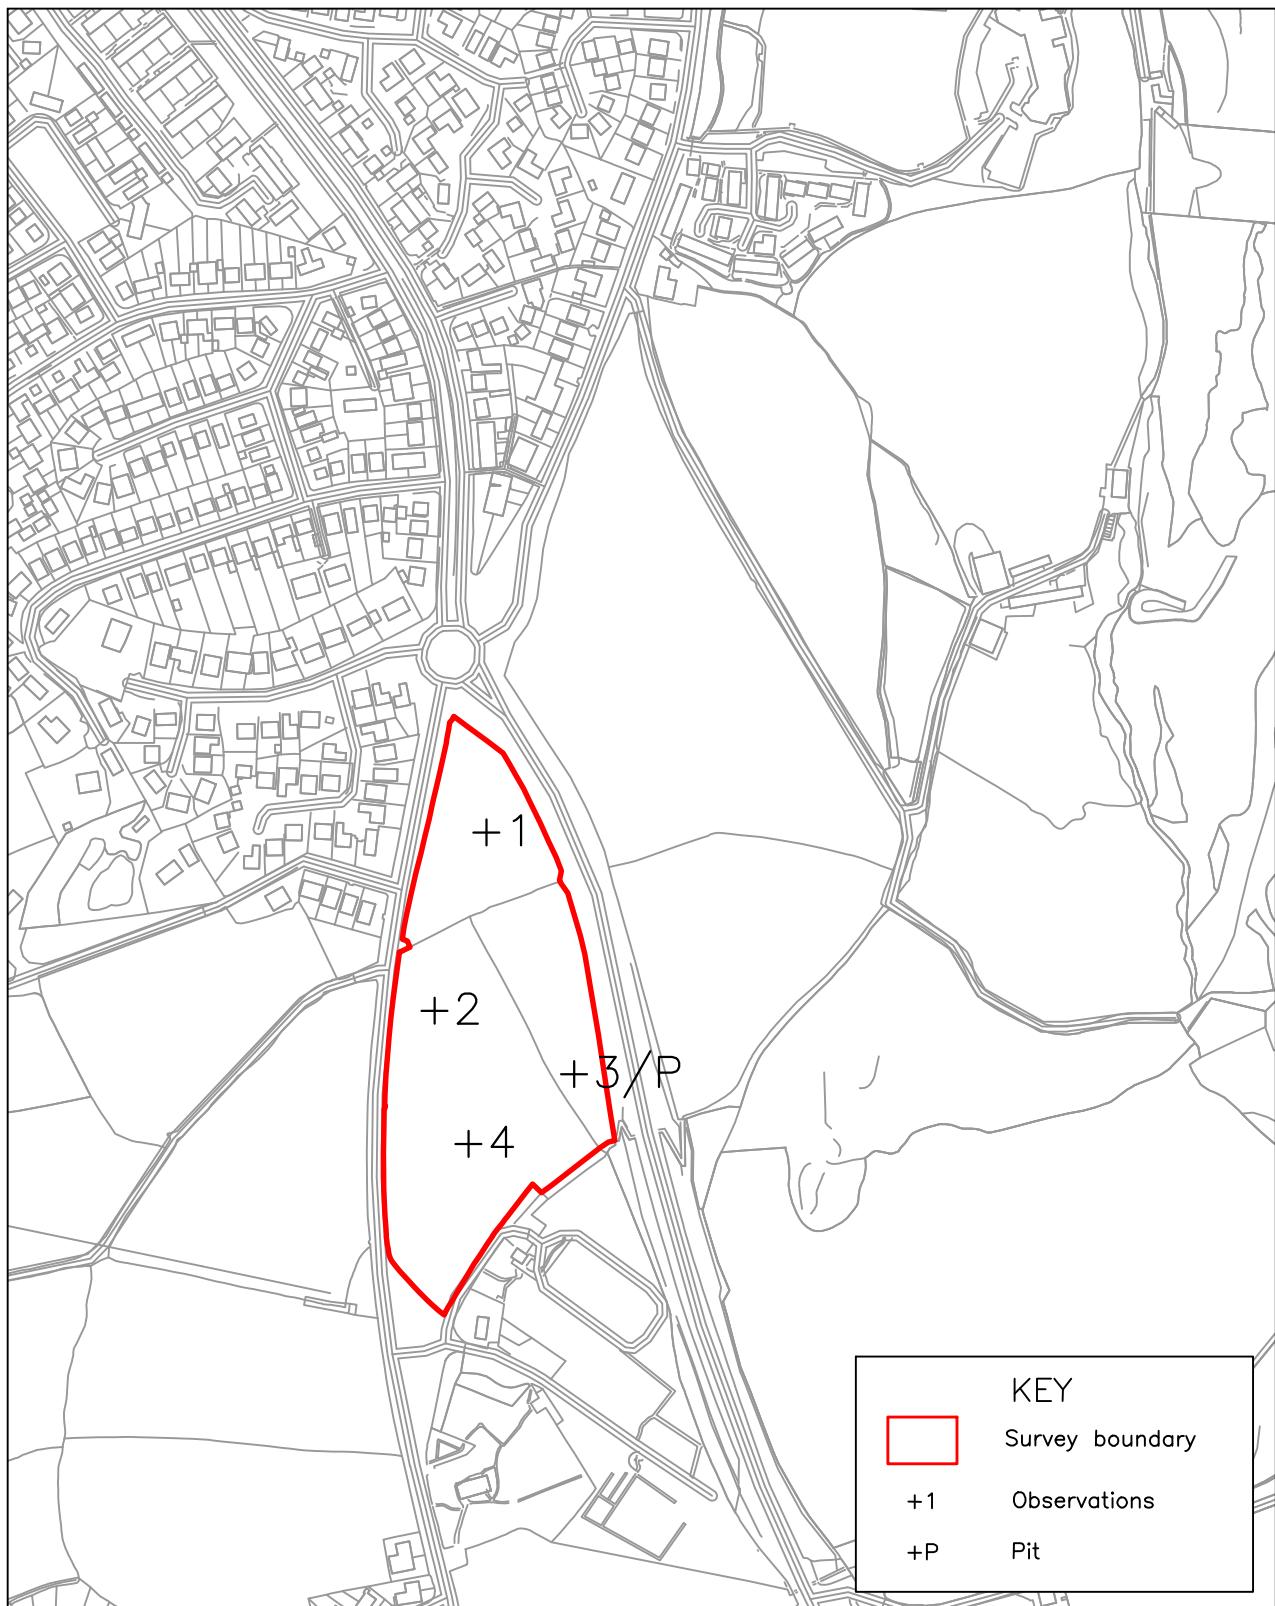
3.1 Four soil profiles were examined using an Edelman (Dutch) auger at an observation density of one per hectare in accordance with the established recommendations for ALC surveys<sup>4</sup>. One observation pit was also excavated to examine subsoil structures. The locations of observations are shown on Figure RAC/10492a/1. At each observation point the following characteristics were assessed for each soil horizon up to a maximum of 120cm or any impenetrable layer:

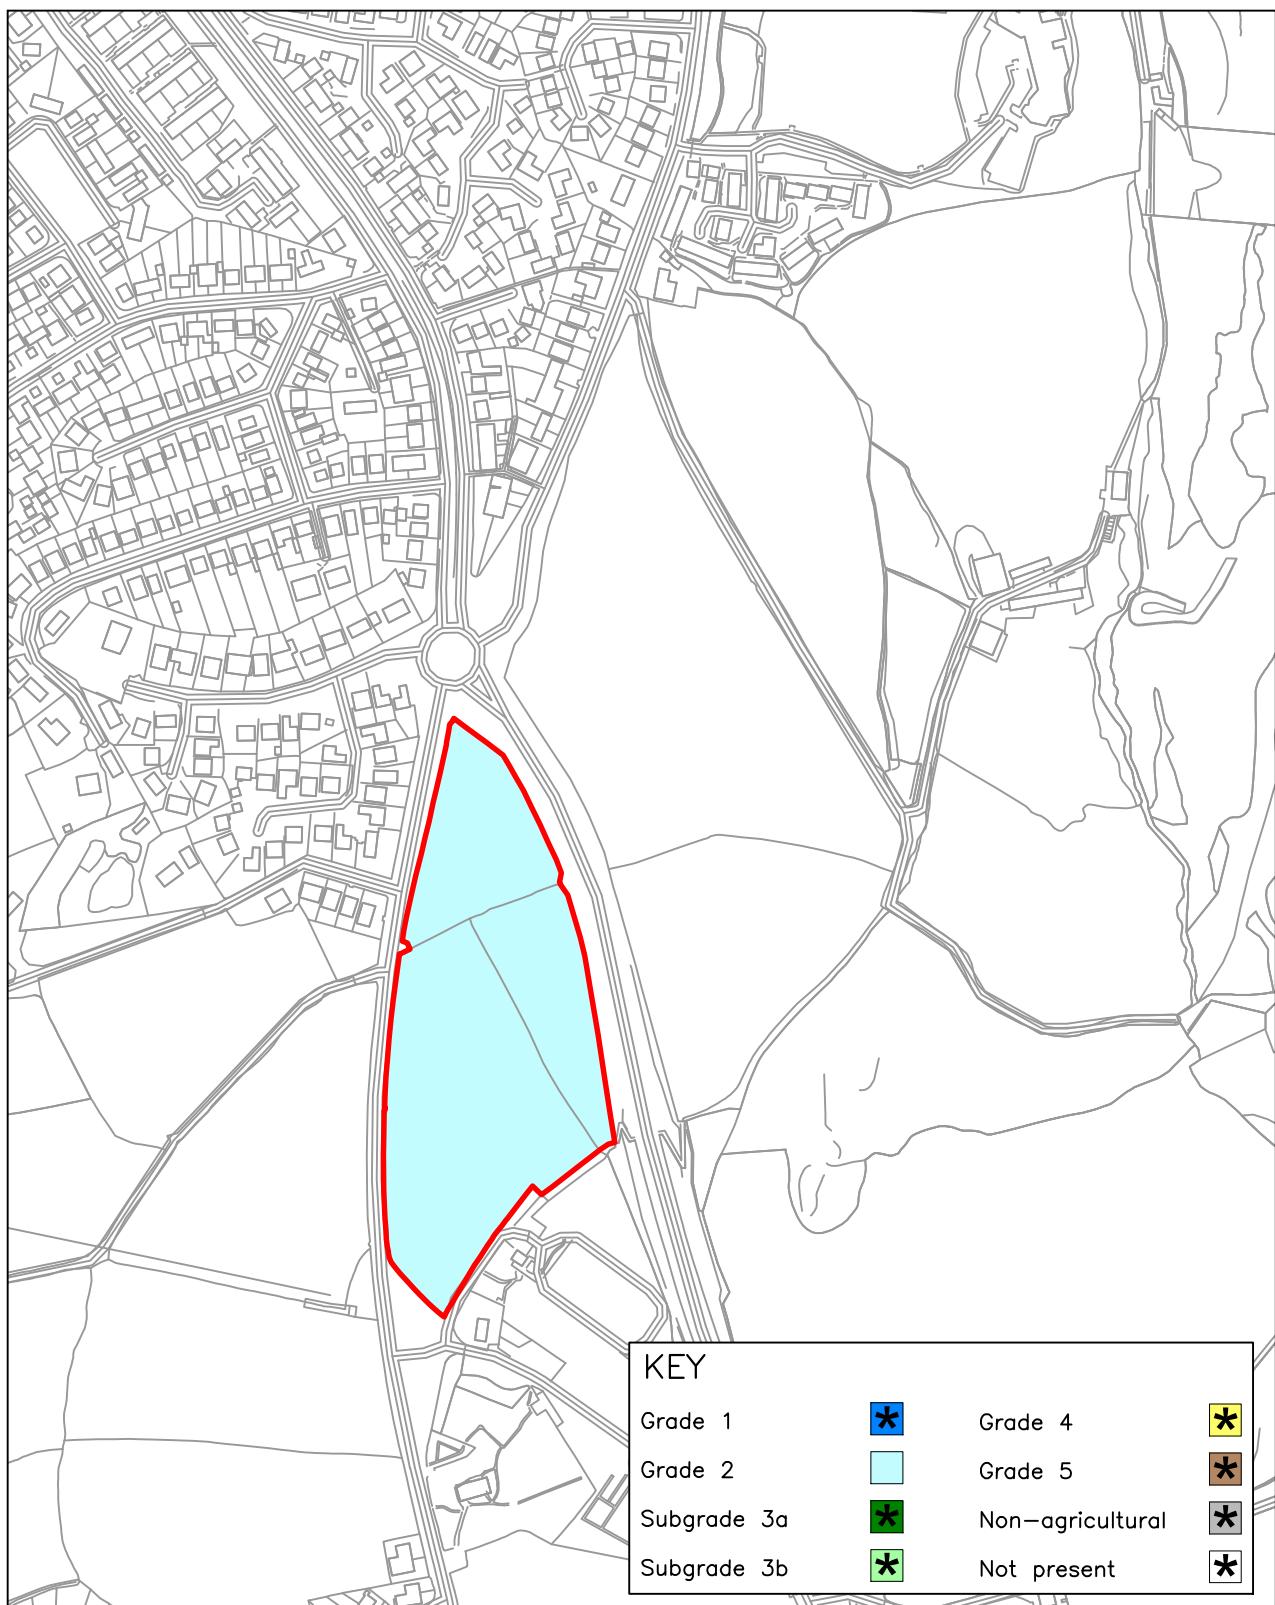
3.6 The main limitation to agricultural land quality is wetness which limits the ALC to Grade 2. There is one soil type present at the site.

3.9 The classification of the site is given in Table 2 and shown in Figure RAC/10492a/2.
