**Assessment of the significance of the impact of
development on historic landscape areas
(ASIDOHL)**

Land at Pentywyn Road, Llanrhos

Client	Anwyl Homes Ltd	
Site name	Land at Pentywyn Road, Llanrhos	
Report type	ASIDOHL	
Report reference	P00287.02A	
Report date	14 January 2025	
Prepared by	Helena Kelly, BSc, MIFA	
	Heritage Archaeology Harborough Innovation Centre Airfield Business Park, Leicester Rd, Market Harborough LE16 7WB	
Revision history	V.A	Client draft

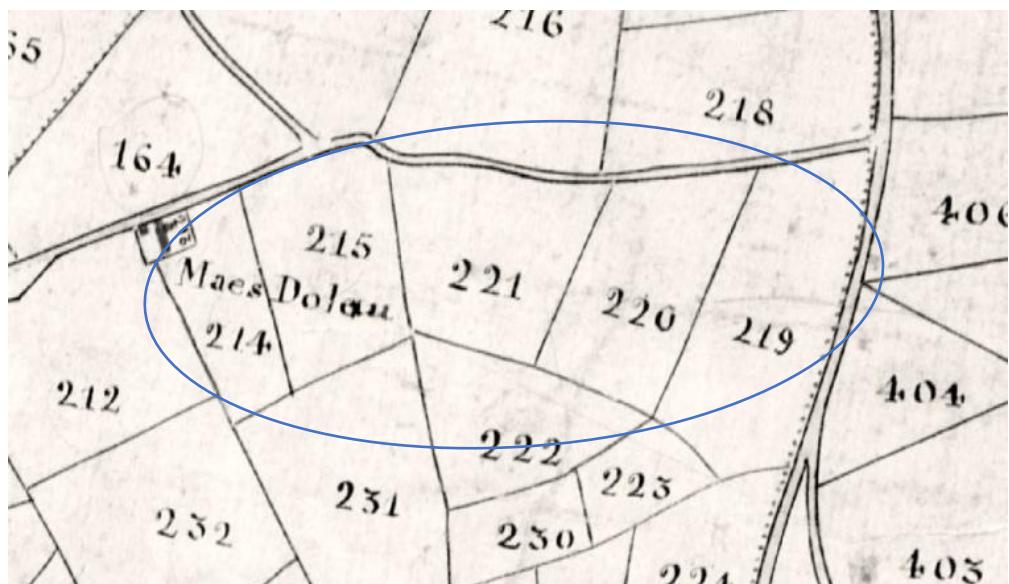
Figure 2: Tithe map for Eglwysrhos, 1846

1.25. The Tithe Apportionment for the parish of Eglwysrhos in the County of Carnarvonshire (dated 1846) records the land owner of the fields within the site as John Lloyd Jones, Esq. and the land occupier as John Jones. The farmhouse and steading at Maes Dolau was in the same ownership. The recorded field names were as follows:

- 214 – Tanyr ardd (garden field)
- 215 – Cae eithin (gorse field)
- 219 – Cae Pelment
- 220 – Cae Llwyd (grey field)
- 221 – Cae Llwyn (bush field)

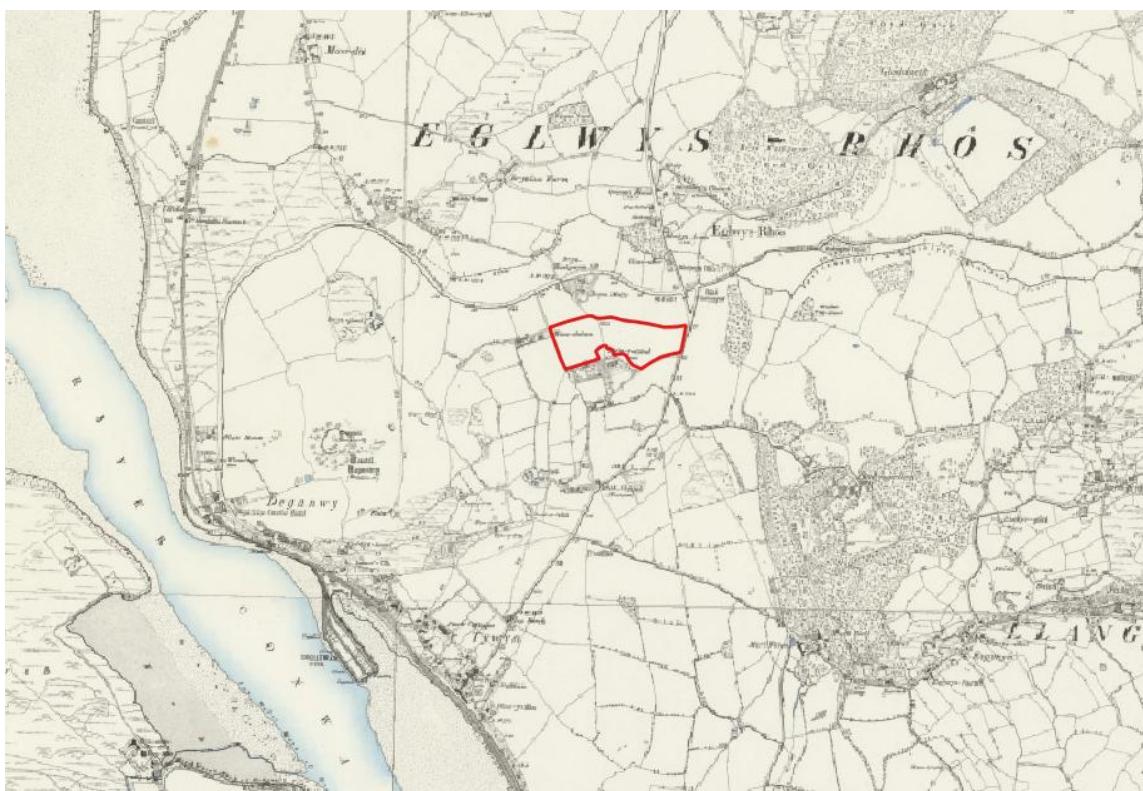
Figure 3: Ordnance Survey County Series, Caernarvonshire, 1888, 1:10,560 (reproduced with permission of the National Library of Scotland)

1.26. The first edition Ordnance Survey map shows the site with Bryn Mair constructed to the north and Ty'n-y-Coed to the south. A stone and well are depicted although neither is currently extant. The field pattern and road alignments had also been modified between the tithe map and first edition Ordnance Survey mapping. The settlements at Deganwy and Llandudno were beginning to develop by the later 19th century and are depicted on the later mapping.

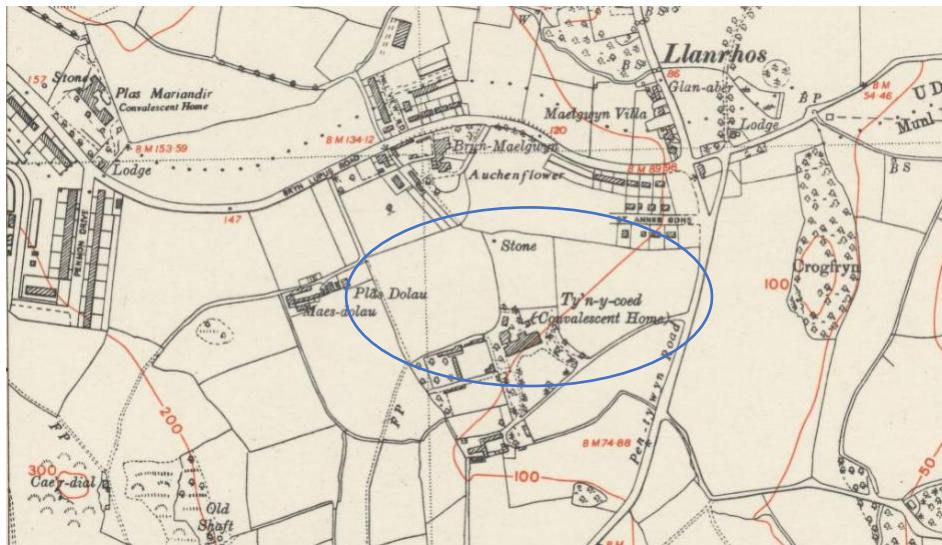
Figure 4: Ordnance Survey County Series, Caernarvonshire, 1953, 1:10,560 (reproduced with permission of the National Library of Scotland)

1.27. By the mid-20th century suburban development stretching to the south of Llandudno was beginning to include areas around Llanrhos village and the site.
